TUEN MUN - CHEK LAP KOK LINK
CONTRACT NO. HY/2013/12 –
NORTHERN CONNECTION TOLL PLAZA AND ASSOCIATED WORKS

48TH MONTHLY ENVIRONMENTAL MONITORING AND AUDIT (EM&A) REPORT – OCTOBER 2018

PREPARED FOR
CRBC AND KADEN JOINT VENTURE

Date	Reference No.	Prepared By	Certified By
12 November 2018	TCS00715/14/600/R0479v3	 Ben Tam (Environmental Consultant)	 T.W. Tam (Environmental Team Leader)

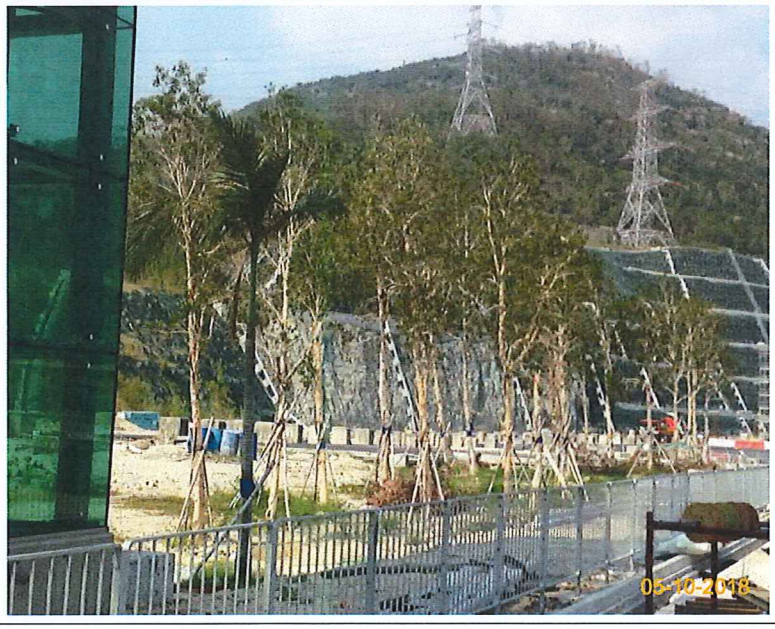
Item 1. Existing trees on boundary of the Project Area should be protected carefully during construction.

Item 2. Tree Transplanting works conducted on 22-May-17.

Item 4. Water spraying was provided for the stockpile at portion F

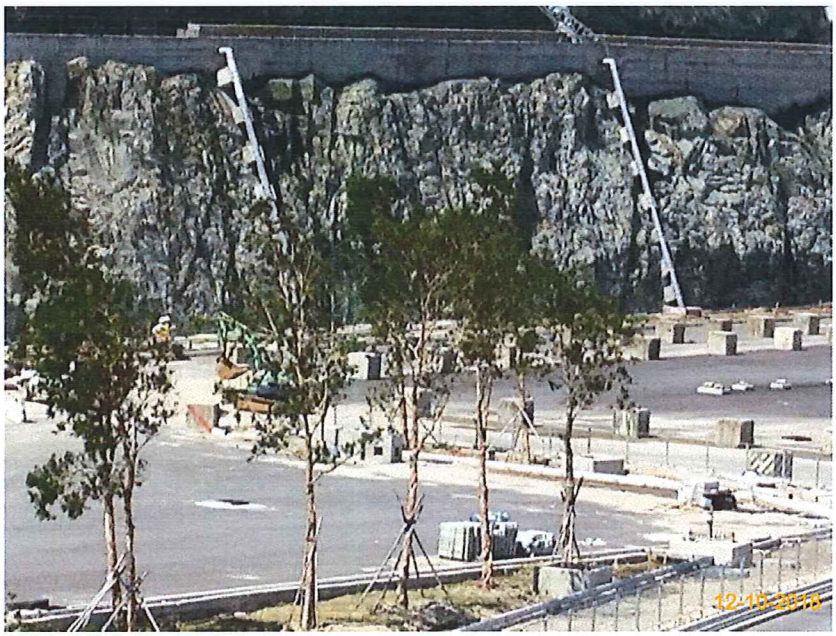
Item 1. Existing trees on boundary of the Project Area should be protected carefully during construction.

Item 2. Tree Transplanting works conducted on 22-May-17.

Item 4. Water spraying was provided for the stockpile at portion F

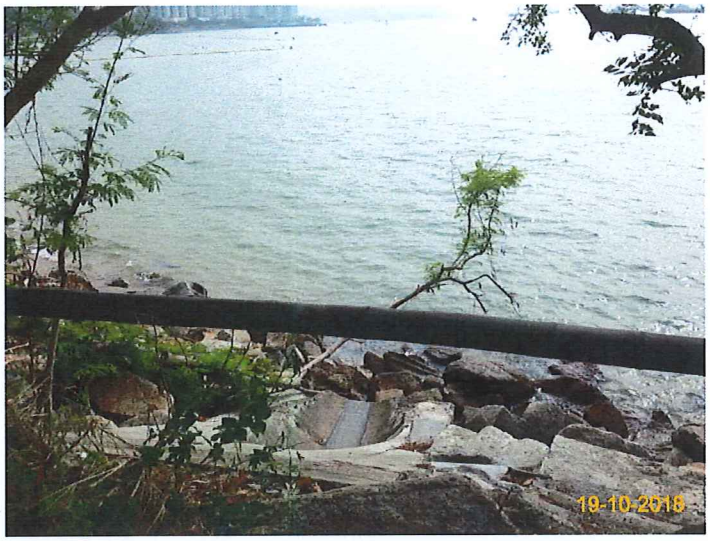
Item 5. Hoarding with panel around works area & Item 6. Temporary traffic management lighting.

Item 7. Ensure no run-off into water body.(Outfall 1)

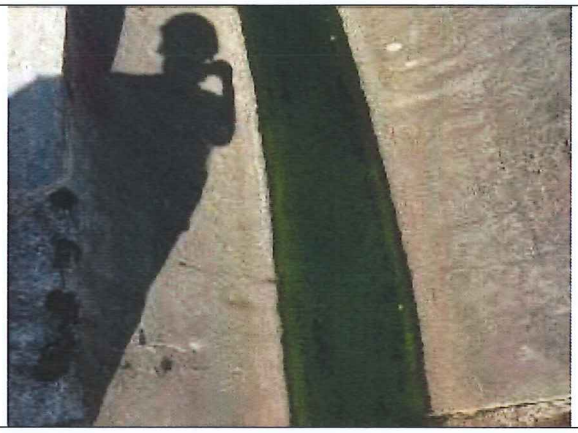
Inspection Date: 2018-10-08

Stream B Outfall: No water is discharging.

Outfall 1: Clean water is discharging.

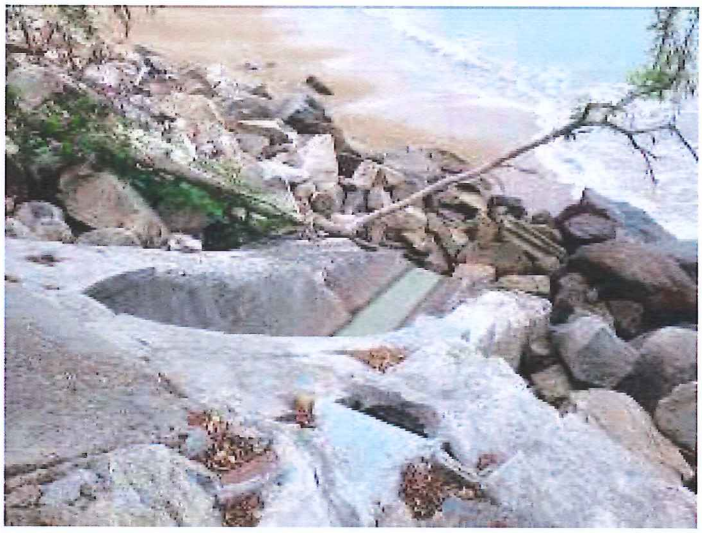
Inspection Date: 2018-10-12

Stream B Outfall: No water is discharging.

Outfall 1: Clean water is discharging.

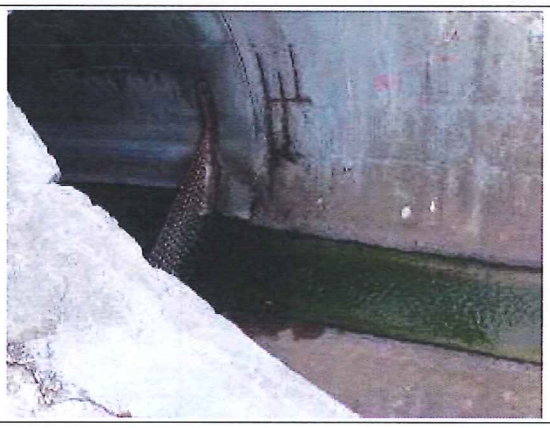
Inspection Date: 2018-10-15

Stream B Outfall: No water is discharging.

Outfall 1: Clean water is discharging.

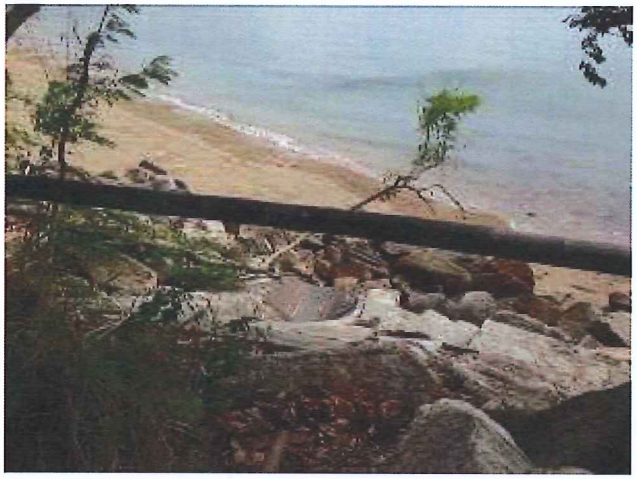
Inspection Date: 2018-10-31

Stream B Outfall: No water is discharging.

Outfall 1: No water is discharging.
