TUEN MUN - CHEK LAP KOK LINK
CONTRACT NO. HY/2013/12 –
NORTHERN CONNECTION TOLL PLAZA AND ASSOCIATED WORKS

49TH MONTHLY ENVIRONMENTAL MONITORING AND AUDIT (EM&A) REPORT – NOVEMBER 2018

PREPARED FOR
CRBC AND KADEN JOINT VENTURE

Date	Reference No.	Prepared By	Certified By
13 December 2018	TCS00715/14/600/R0490v2	 Ben Tam (Environmental Consultant)	 T.W. Tam (Environmental Team Leader)

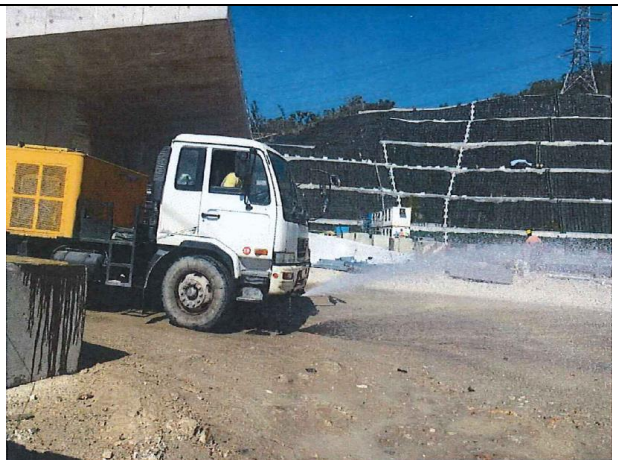
Photo 1 Watering of haul road by water truck to keep road surface wet

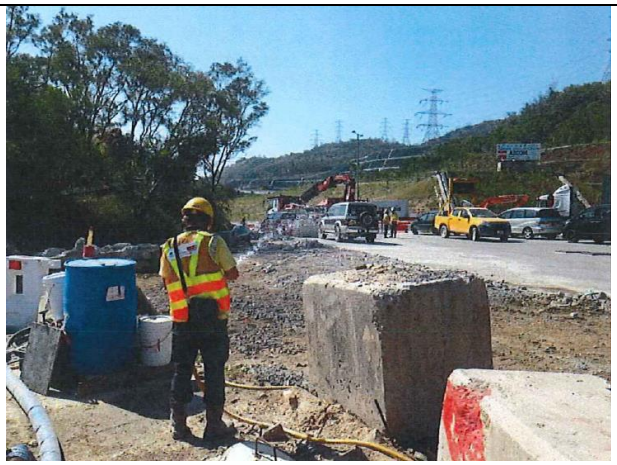
Photo 2 Water spraying by worker for un-accessible area.

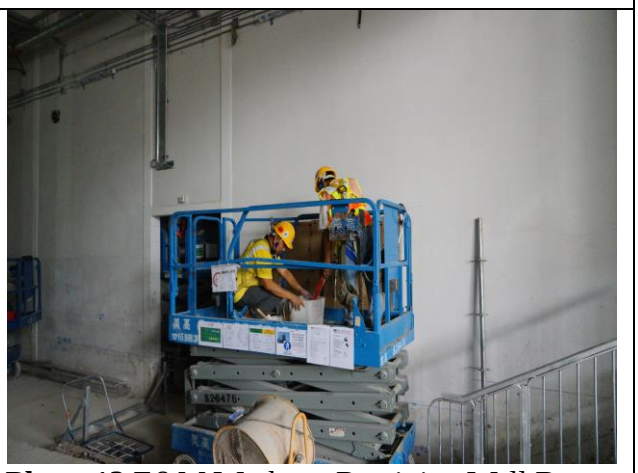
**Photo 12** E&M Works at Retaining Wall B

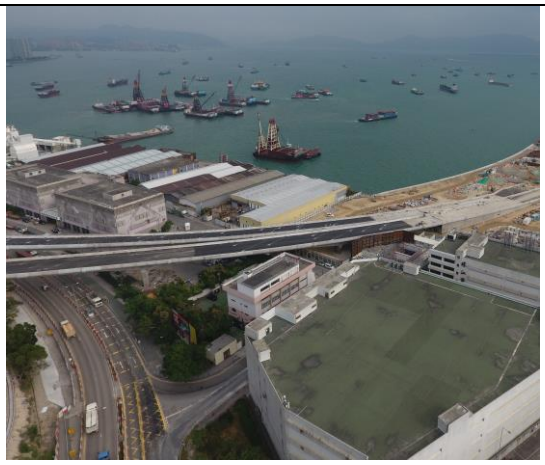
**Photo 14** Stockpile stored at Portion F was backfilled and most of the site area was hard paved

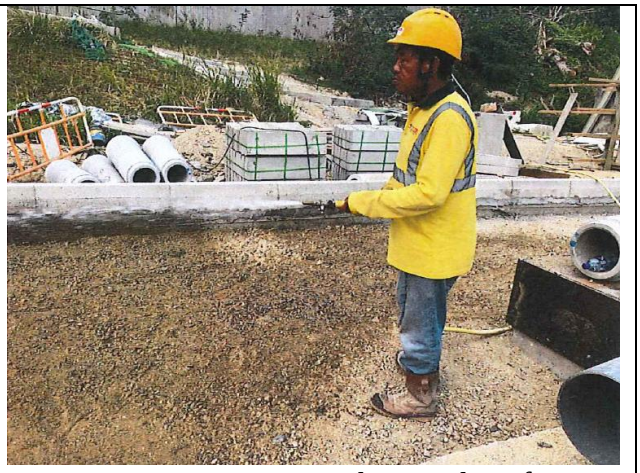
Photo 2 Water spraying by worker for un-accessible area.

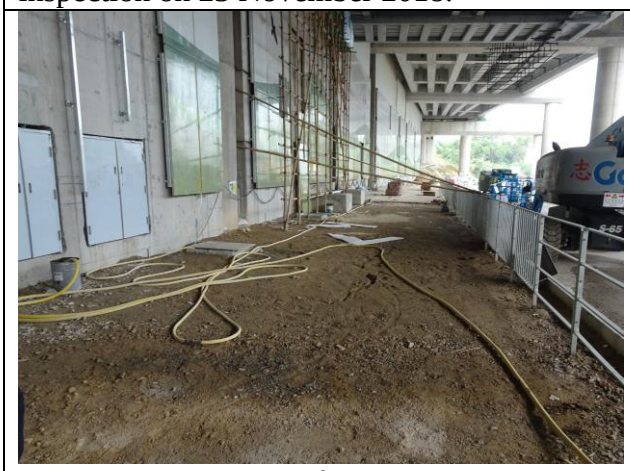
Photo 15 Installation of VE panels at Retaining Wall B

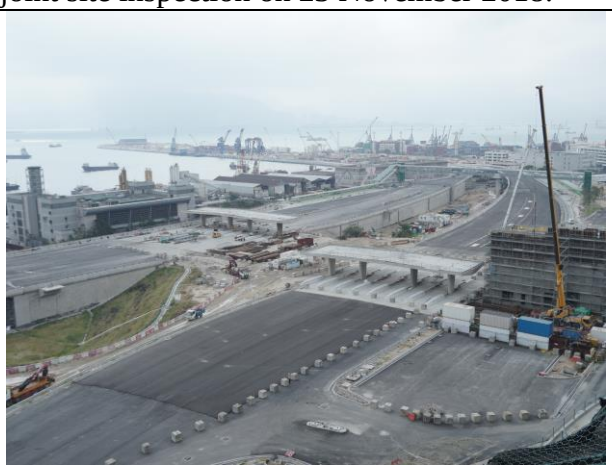
Photo 16 Road marking works at Bridge G

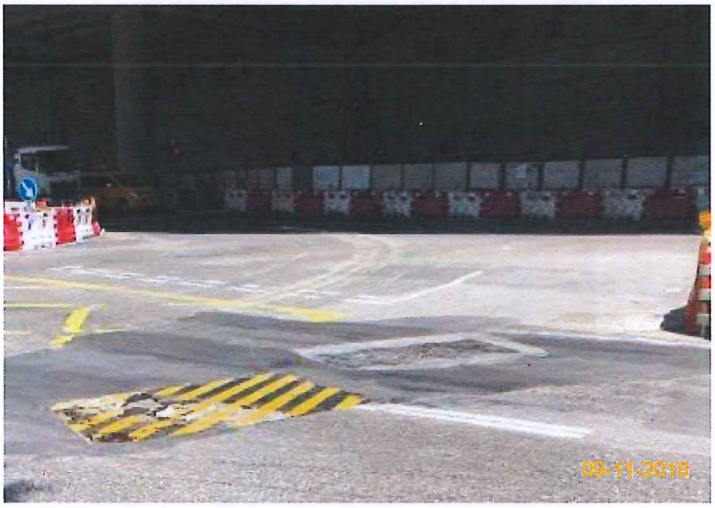
Item 5. Hoarding with panel around works area & Item 6. Temporary traffic management lighting.
