Contract No. HY/2012/08
Tuen Mun – Chek Lap Kok Link – Northern Connection Sub-sea Tunnel Section

Sixty-third Monthly Environmental Monitoring & Audit (EM&A) Report

15 February 2019

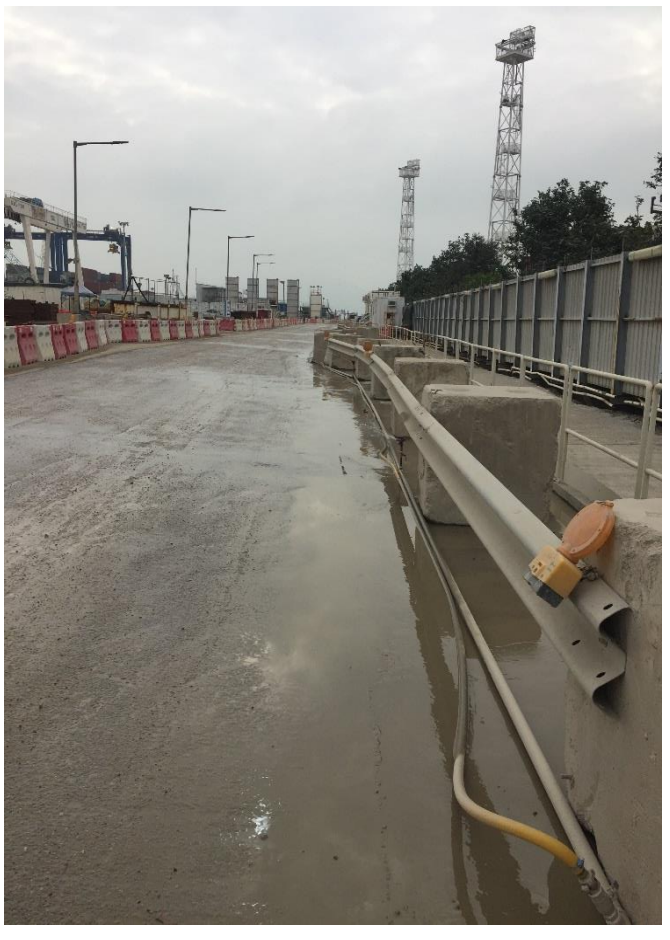
Water spraying was applied on the main haul road. (Works Area Portion N-A)
