Contract No. HY/2012/08
Tuen Mun – Chek Lap Kok Link – Northern Connection Sub-sea Tunnel Section

Sixty-fifth Monthly Environmental Monitoring & Audit (EM&A) Report

Contract No. HY/2012/08
TM-CLKL – Northern Connection Sub-sea Tunnel Section
65th Monthly EM&A Report for March 2019 (EP-354/2009/D)

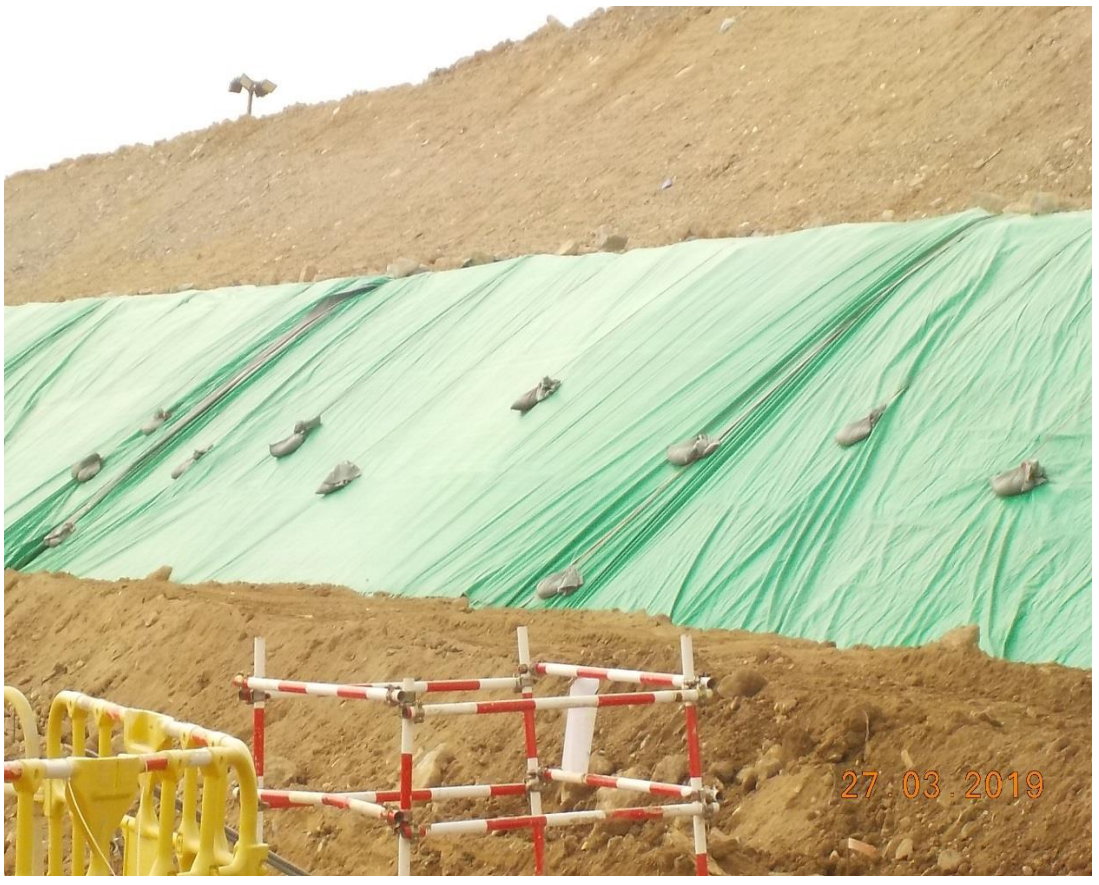
Exposed soil was covered by tarpaulin sheet to prevent dust. (Works Area Portion N-C)

Water spraying was applied at the main haul road to prevent dust. (Works Area Portion N-A)

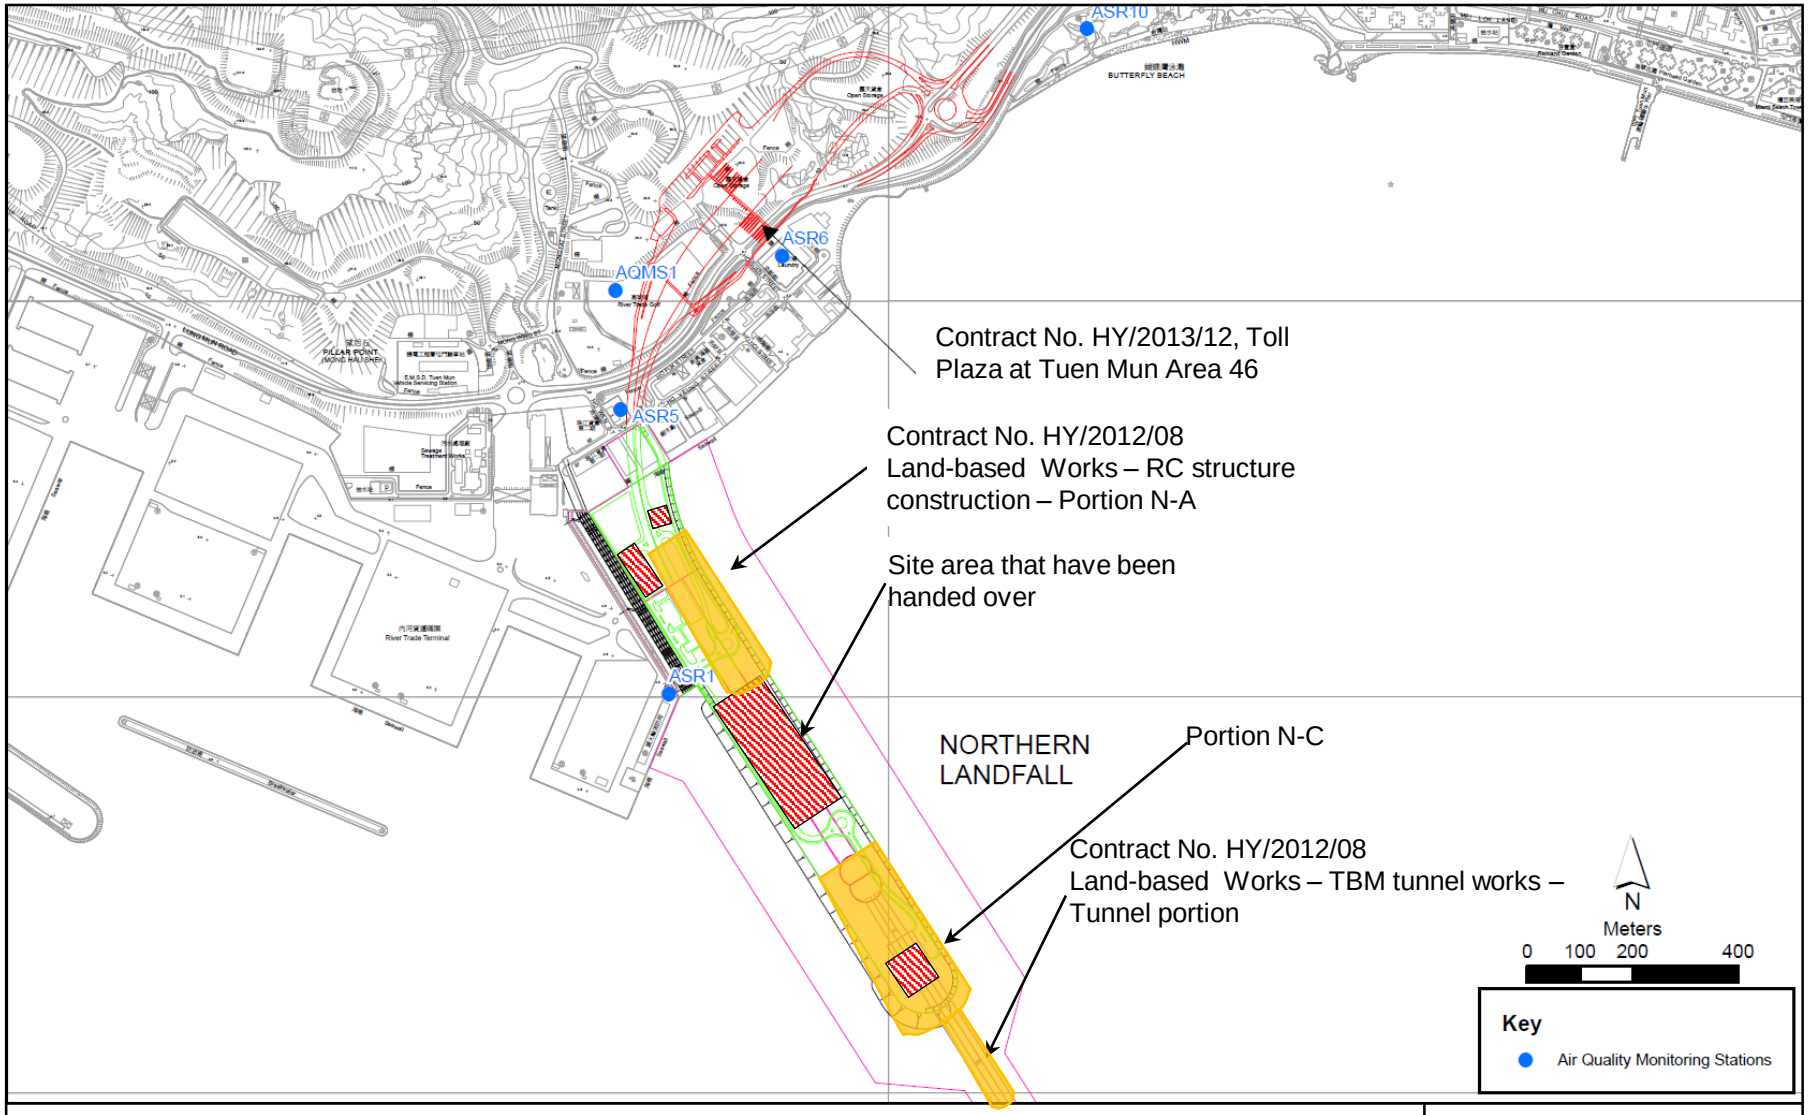
Figure 1

Log No.	**0212330_27March2019_1hrTSP_Station ASR1** **[Total No. of Exceedances = 1]**	
Date	27 March 2019 (Measured) 3 April 2019 (Laboratory results received by ERM)	
Monitoring Station	ASR1, ASR5, ASR6, ASR10 and AQMS1	
Parameter(s) with Exceedance(s)	1-hr TSP	
Action Levels	24-hr TSP (µg/m³)	ASR1 = 213 ASR5 = 238 AQMS1 = 213 ASR6 = 238 ASR10 = 214
	1-hr TSP (µg/m³)	ASR1 = 331 ASR5 = 340 AQMS1 = 335 ASR6 = 338 ASR10 = 337
Limit Levels	1-hr TSP (µg/m³)	500
	24-hr TSP (µg/m³)	260
Measured Levels	Action Level Exceedance for 1-hr TSP is observed at ASR1 (412 µg/m3) during 1333 – 1433 hrs.	
Works Undertaken (at the time of monitoring event)	On 27 March 2019, TBM tunnel works was carried out at tunnel portion and RC structure construction was carried out at Portion N-A.	
Possible Reason for Action or Limit Level Exceedance(s)	The exceedance is unlikely to be due to this Contract, in view of the following: • According to the construction information provided by the Contractor, the majority of construction works on 27 March 2019 was TBM tunnel works and RC structure construction at Portion N-A. During the period of the land-based construction works, the Contractor has implemented the required mitigation measures as per the EP, approved EIA and Updated EM&A Manual (e.g. water spraying on exposed soil within the Project site and associated works areas; exposed soil covered by tarpaulin sheets). • The exceedance is unlikely to be due to this Contract as dust suppression measures were implemented properly on site. Water spraying was applied on site to prevent dust. • Recorded wind speed during the works period was zero. Dust generated from the construction works, if any, will be localized within the site area and was not likely to be dispersed to station ASR1. Based on the above, the exceedance is unlikely to be due to this Contract.

Indicative Construction Works Area on 27 March 2019

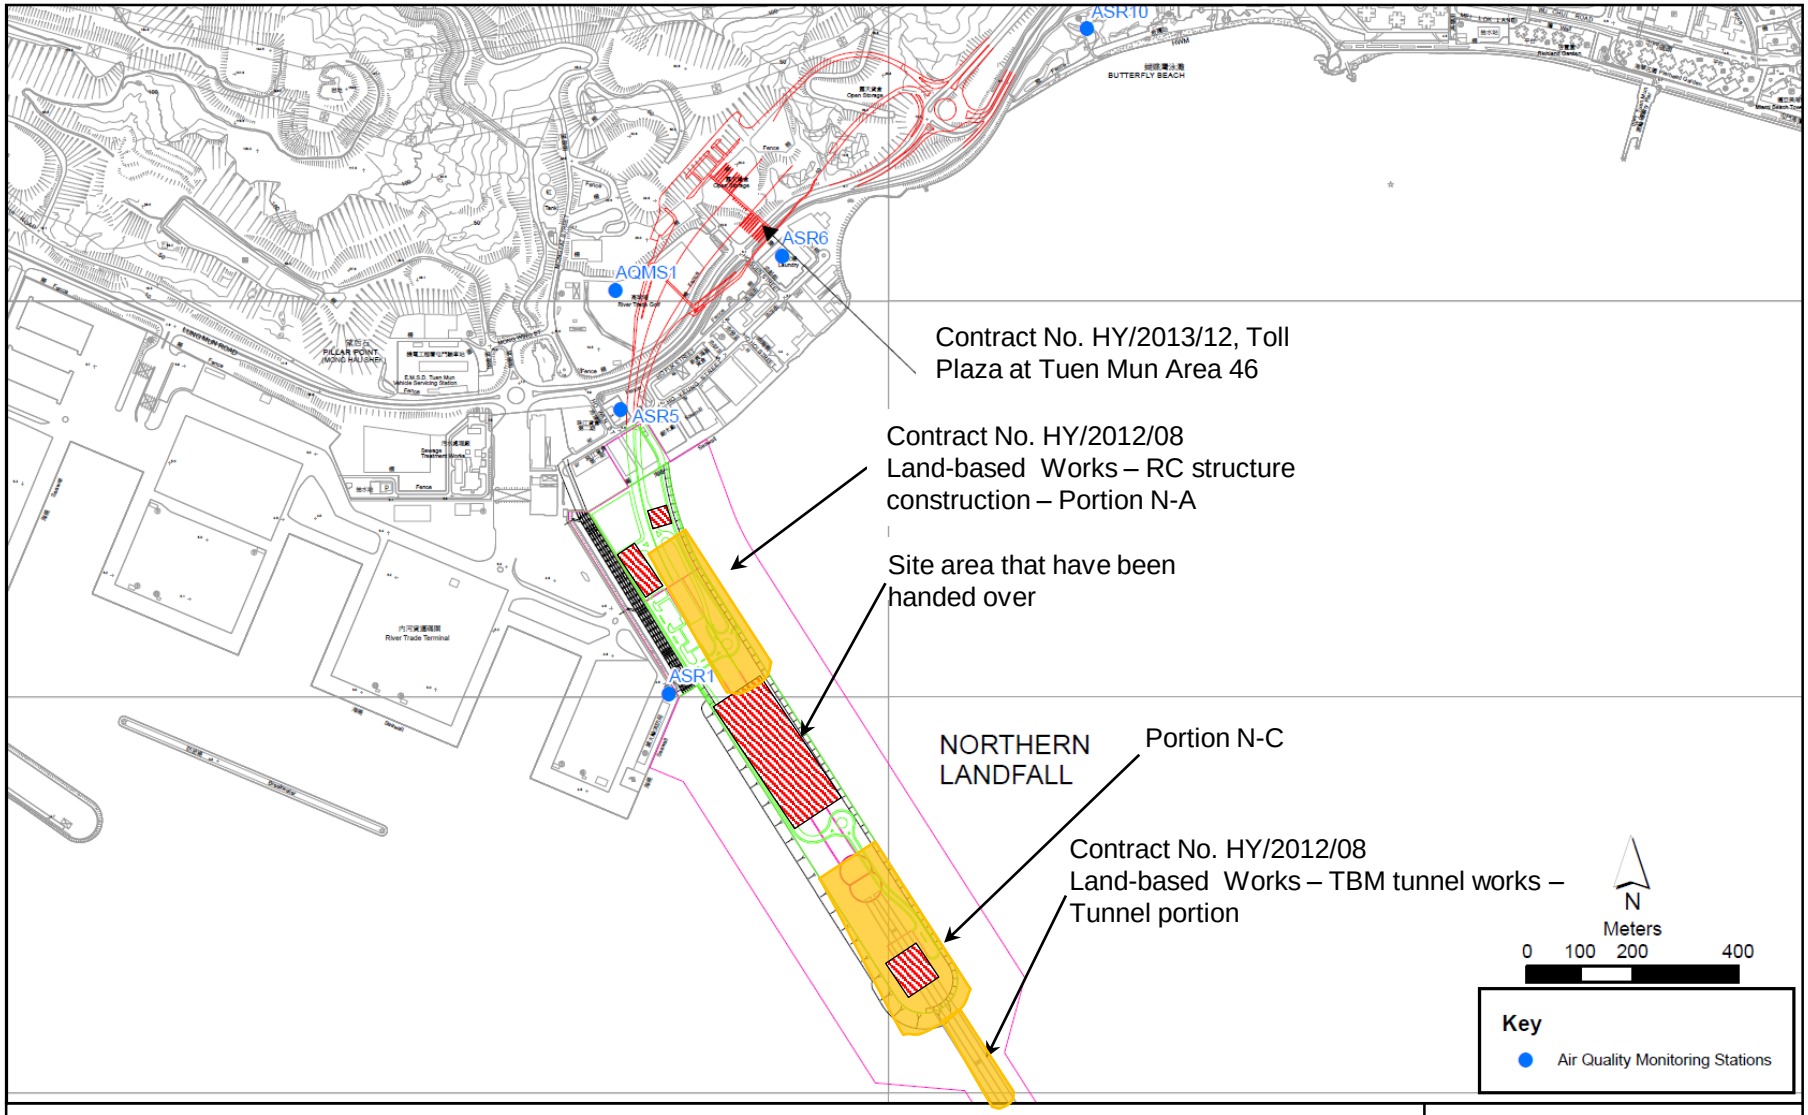
Figure 1

Log No.	**0212330_30March2019_1hrTSP_Station ASR1** **[Total No. of Exceedances = 1]**	
Date	30 March 2019 (Measured) 9 April 2019 (Laboratory results received by ERM)	
Monitoring Station	ASR1, ASR5, ASR6, ASR10 and AQMS1	
Parameter(s) with Exceedance(s)	1-hr TSP	
Action Levels	24-hr TSP (µg/m³)	ASR1 = 213 ASR5 = 238 AQMS1 = 213 ASR6 = 238 ASR10 = 214
	1-hr TSP (µg/m³)	ASR1 = 331 ASR5 = 340 AQMS1 = 335 ASR6 = 338 ASR10 = 337
Limit Levels	1-hr TSP (µg/m³)	500
	24-hr TSP (µg/m³)	260
Measured Levels	Action Level Exceedance for 1-hr TSP is observed at ASR1 (374 µg/m3) during 1048 – 1148 hrs.	
Works Undertaken (at the time of monitoring event)	On 30 March 2019, TBM tunnel works was carried out at tunnel portion and RC structure construction was carried out at Portion N-A.	
Possible Reason for Action or Limit Level Exceedance(s)	The exceedance is unlikely to be due to this Contract, in view of the following: • According to the construction information provided by the Contractor, the majority of construction works on 30 March 2019 was TBM tunnel works and RC structure construction at Portion N-A. During the period of the land-based construction works, the Contractor has implemented the required mitigation measures as per the EP, approved EIA and Updated EM&A Manual (e.g. water spraying on exposed soil within the Project site and associated works areas; exposed soil covered by tarpaulin sheets). • The exceedance is unlikely to be due to this Contract as dust suppression measures were implemented properly on site. Water spraying was applied on site to prevent dust. • With reference to the recorded wind direction (ranged between 110° and 114°, blowing from an easterly direction) and wind speed (1.8 m/s) during the works period, Stations ASR1 are located downstream to the construction works at Portion N-A. Based on the above, the exceedance is unlikely to be due to this Contract.

Indicative Construction Works Area on 30 March 2019
