Contract No. HY/2010/02

Hong Kong – Zhuhai – Macao Bridge
Hong Kong Boundary Crossing Facilities –
Reclamation Works

Monthly EM&A Report for July 2015

Version:	Rev. 0	Date:	14 August 2015

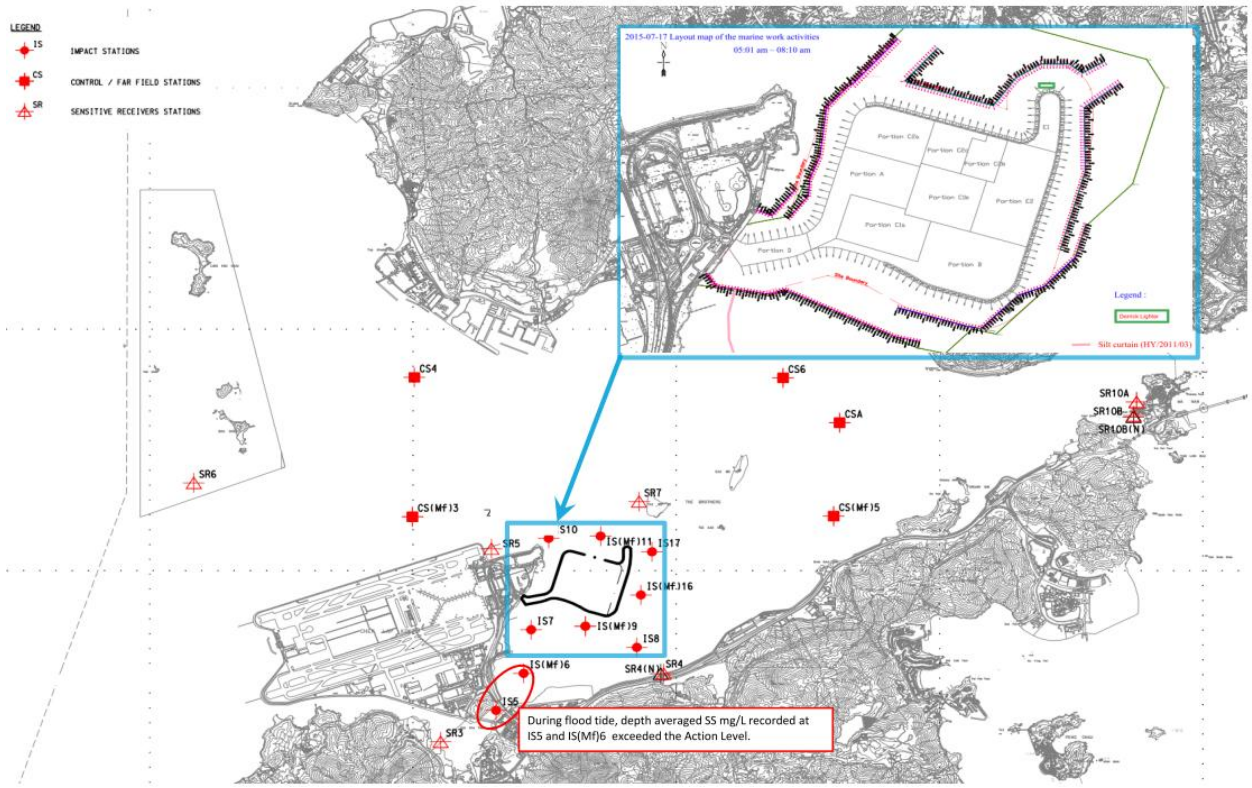
4.7.2.1 Below layout map shows no marine work was conducted at south and southwestern part of the HKBCF Reclamation Works during flood tide on 17 July 2015:

4.7.2.2 Exceedances recorded at IS5 and IS(Mf)6 during flood tide are unlikely due to marine based construction activities of the Project because:

4.7.2.3 Attached layout map shows no marine work was conducted at south and southwestern part of the HKBCF Reclamation Works during flood tide on 17 July 2015, therefore it is unlikely that the SS exceedances recorded at IS5 and IS(Mf)6 during flood tide are caused by HKBCF Reclamation Works.

4.7.2.6 With reference to the silt curtain checking record of 17 July 2015, defects such as disconnection of the silt curtain was not observed at south and southwestern part of the perimeter silt curtain which are close to the IS5 and IS(Mf)6.

4.7.2.10 Nevertheless, the Contractor was reminded to ensure provision of ongoing maintenance to the silt curtains and to carry out maintenance work once defects were found.
