AGREEMENT NO. CE 45/2008 (CE)
LIANTANG/HEUNG YUEN WAI
BOUNDARY CONTROL POINT AND ASSOCIATED WORKS

MONTHLY ENVIRONMENTAL MONITORING AND AUDIT REPORT (NO.47) – JUNE 2017

PREPARED FOR
CIVIL ENGINEERING AND DEVELOPMENT DEPARTMENT (CEDD)

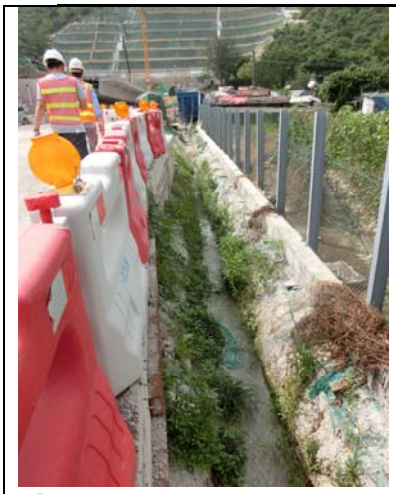
**Photo 11** Weekly joint site inspection by RE, Contractor, IEC and ET was conducted on 25 May 2017 for investigation. It was observed that wastewater treatment facilites were properly in place and the discharge water was clear.	 **Photo 12** Weekly joint site inspection by RE, Contractor, IEC and ET was conducted on 1 June 2017 for investigation. It was observed that wastewater treatment facilites were properly in place and the discharge water was clear.
