JOB NO.: TCS00694/13

AGREEMENT NO. CE 45/2008 (CE)
LIANTANG/HEUNG YUEN WAI
BOUNDARY CONTROL POINT AND ASSOCIATED WORKS

MONTHLY ENVIRONMENTAL MONITORING AND AUDIT REPORT (NO.52) – NOVEMBER 2017

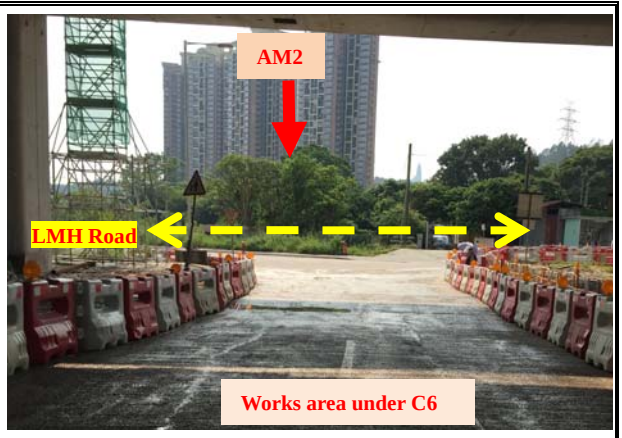
Photo 1

AM2 was located in a village house along Lin Ma Hang (LMH) Road and the closest works area was Bridge D – LMH under Contract 6.

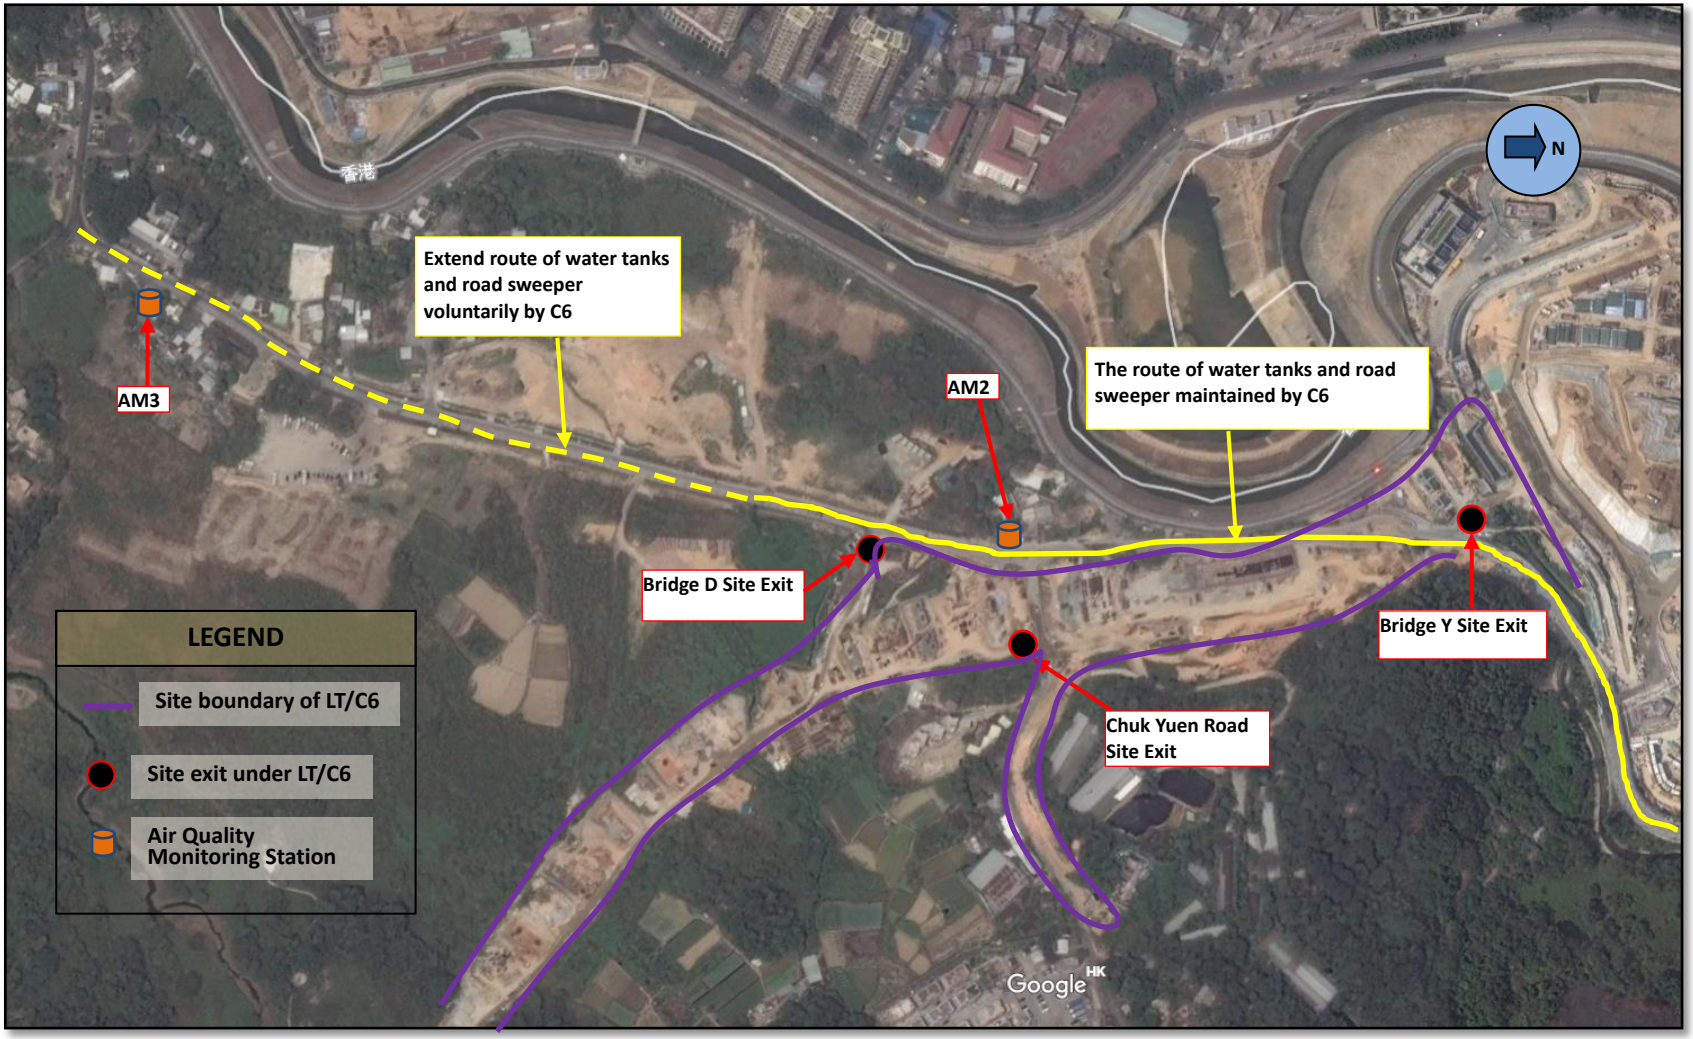
Figure 1 Layout of Air Quality Monitoring Locations AM2 and AM3

surface and minimize generation of muddy water during rain. ***(Photo 9 & 10)*** The route of water tanker and road sweeper are fully covered the works area of LT/C6 which shown in ***Figure 1***. (e) No dusty work and stockpile of dusty material was observed within the works area of C6. (f) Works area of LT/C6 was far away from the air quality monitoring station AM3. No adverse dust impact due to the project work was observed at AM3. 3. In our investigation, CCKJV has implemented dust mitigation measures to control the dust generated under the Project. Since there were many other heavy vehicles apart from the project using LMH Road which causing traffic dust problem especially during dry season. It is considered that the 24-hr TSP exceedances were a short-term impact due to traffic and unlikely caused by the works under the project. As advised by CCKJV, they will voluntarily extend the route of road cleaning by water tanker and road sweep to junction of Tai Kwu Ling Fire Station to suppress the fugitive dust due to traffic and resolve the dust concern by the nearby resident. 4. There were no exceedances recorded in the subsequent air quality monitoring in November 2017. Nevertheless, the Contractor should continually implement the dust mitigation measures in full gear as recommended in the implementation schedule for environmental mitigation measures in the EM&A Manual.

Photo 9
During the regular site inspection, it was observed that the road surface of LMH Road was wetted by water bowsers to suppress fugitive dust.

Photo 10
Road sweeper would also deploy by CCKJV to enhance the road cleaning work in order to remove debris and gravels on road surface.

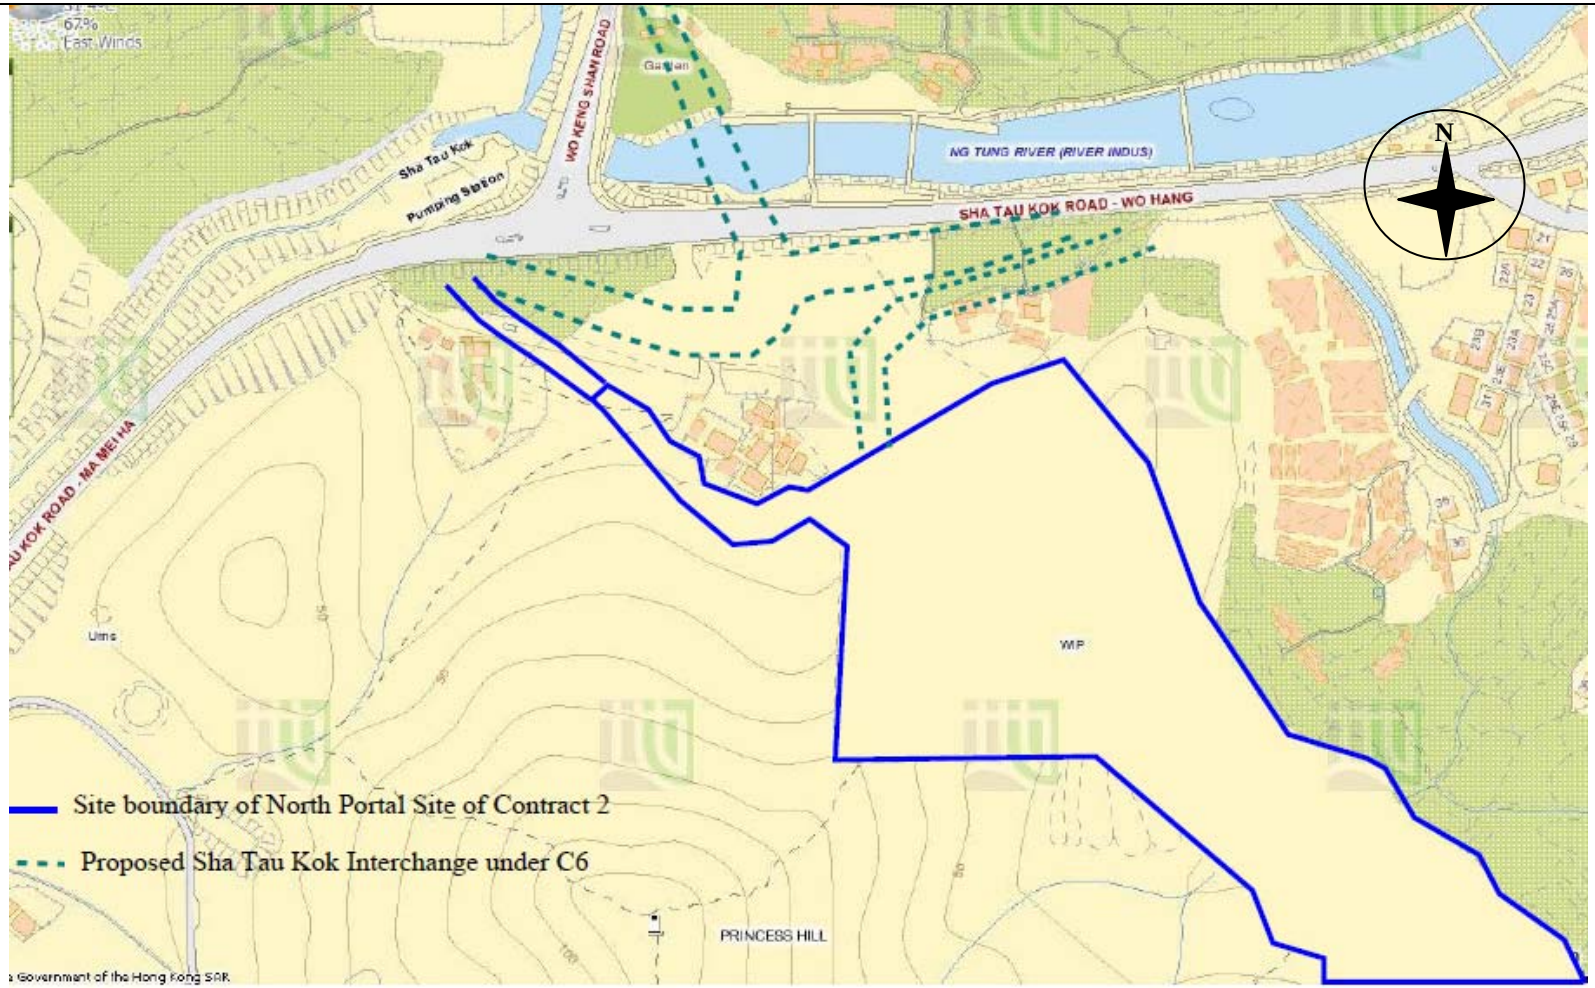
Figure 1 The Complaint Location

ES06 In this Reporting Period, one (1) documented environmental complaint was received regarding the air quality issues under the EM&A Programme. Subsequent joint site inspection was carried out for investigation of the complaint. The investigation report revealed that the Contractors have properly implemented dust mitigation measures and no adverse dust impact caused by the construction site was observed. It was considered that the complaint was related to traffic dust from public road which frequent use by dump truck and heavy vehicle in dry season
