AGREEMENT NO. CE 45/2008 (CE)
LIANTANG/HEUNG YUEN WAI
BOUNDARY CONTROL POINT AND ASSOCIATED WORKS

MONTHLY ENVIRONMENTAL MONITORING AND AUDIT REPORT (NO.62) – SEPTEMBER 2018

PREPARED FOR
CIVIL ENGINEERING AND DEVELOPMENT DEPARTMENT (CEDD)

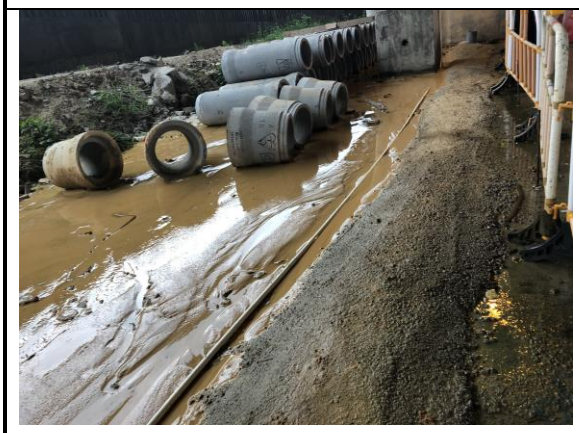
Photo 3
During site inspection on 30 August 2018, silt was observed along the public road near Bridge Y and CCKJV was advised to provide proper mitigation measures to avoid accumulation of silt and maintain the public road clean and tidy.
