JOB NO.: TCS00694/13

AGREEMENT NO. CE 45/2008 (CE)
LIANTANG/HEUNG YUEN WAI
BOUNDARY CONTROL POINT AND ASSOCIATED WORKS

MONTHLY ENVIRONMENTAL MONITORING AND AUDIT REPORT (NO.65) – DECEMBER 2018

PREPARED FOR
CIVIL ENGINEERING AND DEVELOPMENT DEPARTMENT (CEDD)

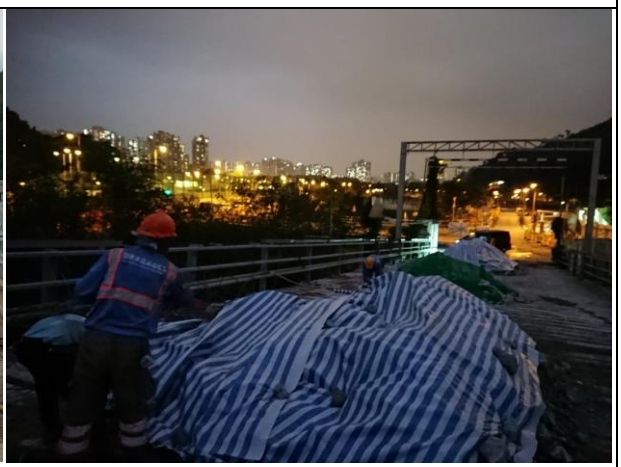
Photo 6
Cover the exposed stockpile with tarpaulin by the end of the day.

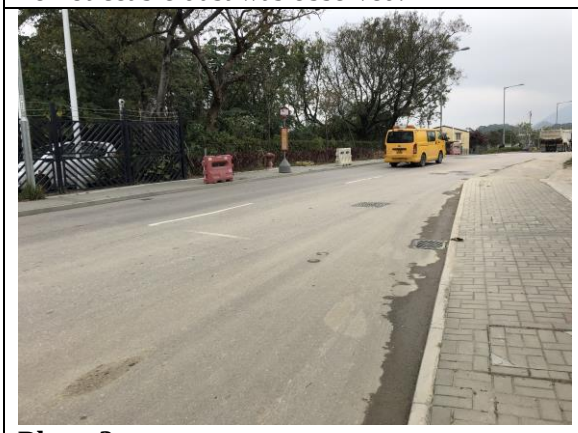
Photo 3
Roadside debris and small amount of gravels were found at the edge of the road near Ta Kwu Ling Police Station.
