JOB NO.: TCS00694/13

AGREEMENT NO. CE 45/2008 (CE)
LIANTANG/ HEUNG YUEN WAI
BOUNDARY CONTROL POINT AND ASSOCIATED WORKS

MONTHLY ENVIRONMENTAL MONITORING AND AUDIT REPORT (NO.71) – JUNE 2019

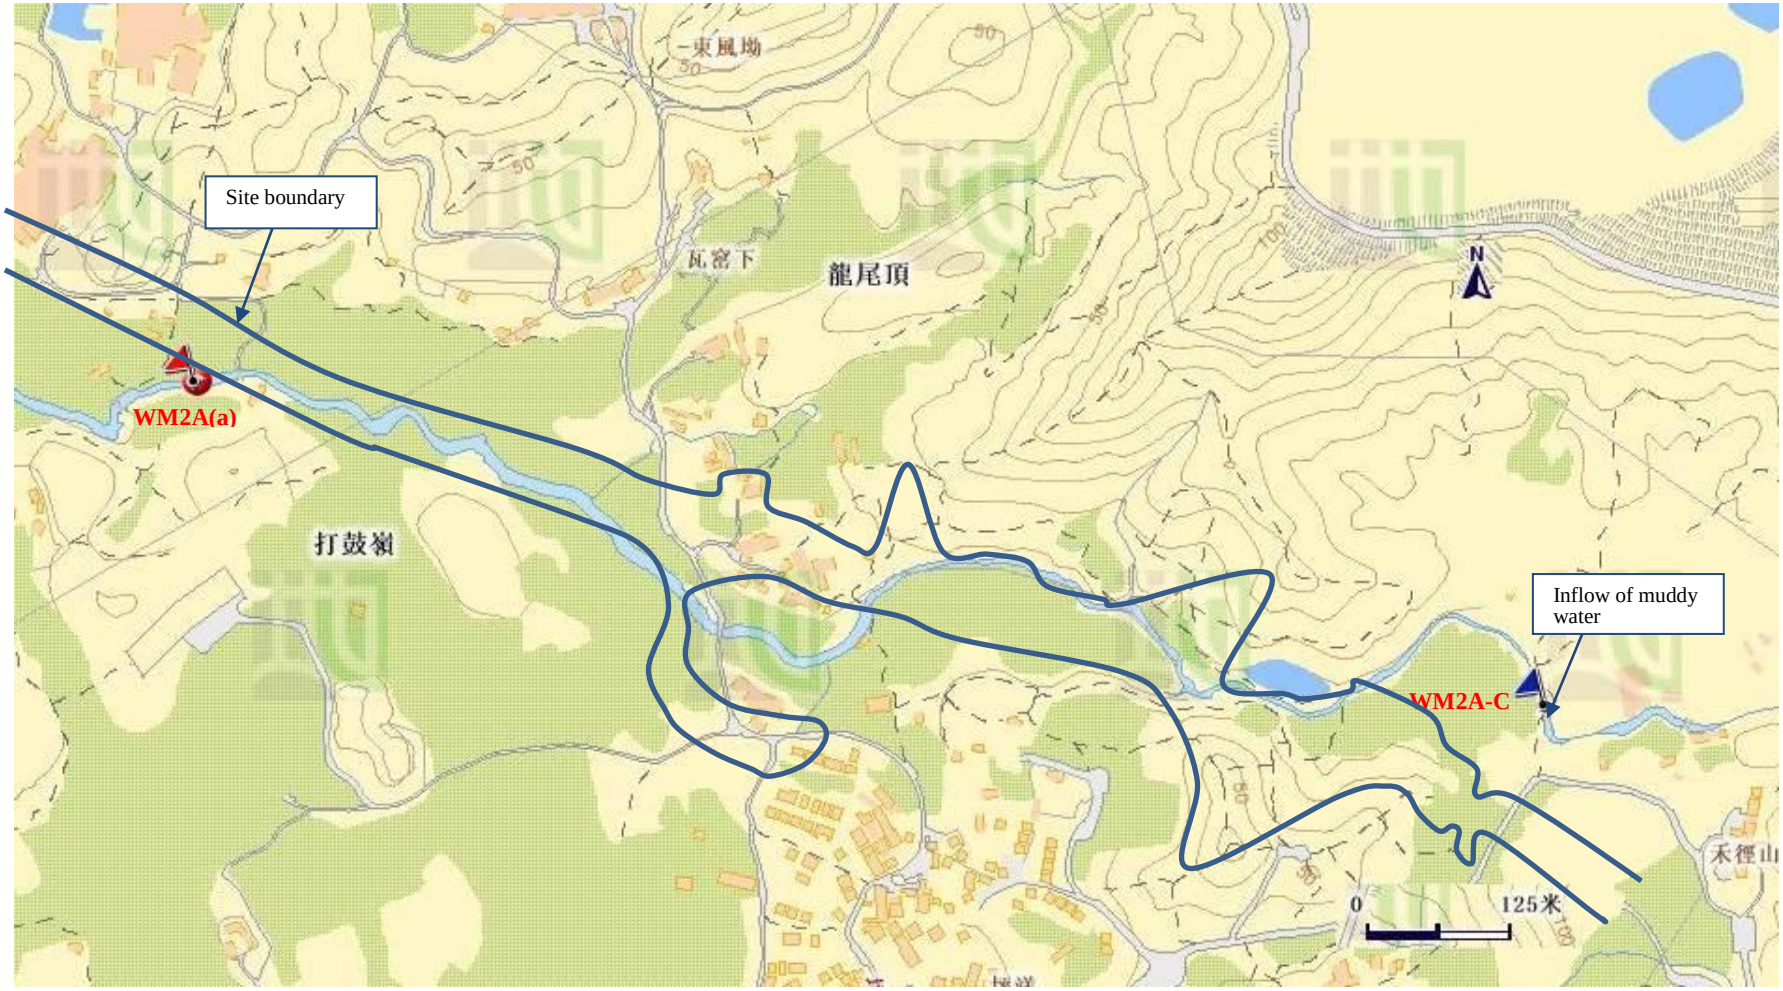
Figure 1 Location Map for Water Quality Monitoring Locations WM2A(a), WM2A-Control and work area under Contract

**Photo 1** On 26 June 2019, the water quality at WM2A was turbid.	 **Photo 2** On 26 June 2019, the water quality at WM2A-C was slightly turbid.
 **Photo 3** As advised by CCKJV, in the early morning of 26 June 2019, inflow of muddy water was observed from upstream of WM2A-C which affecting the water quality of the river course.	 **Photo 4** Open slopes were covered with tarpaulin sheet as far as practicable to minimize muddy runoff.

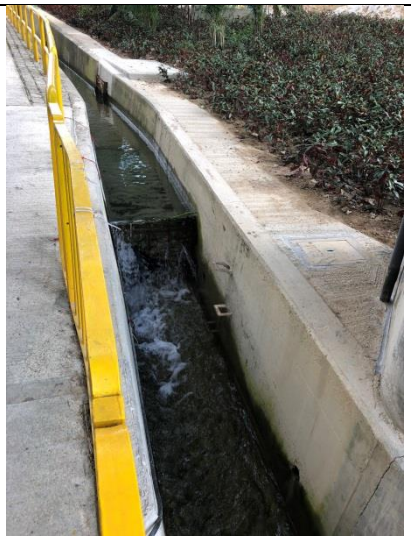
Hydroseeding was applied on the exposed slope.

The water flowing from the permanent drainage was clear.

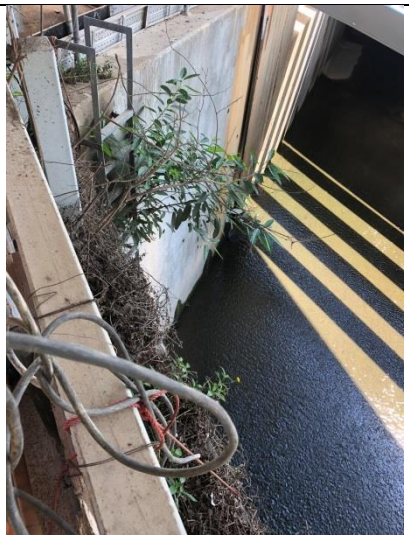
Wastewater treatment facility was properly implemented.

The discharge from wastewater treatment facility was clear

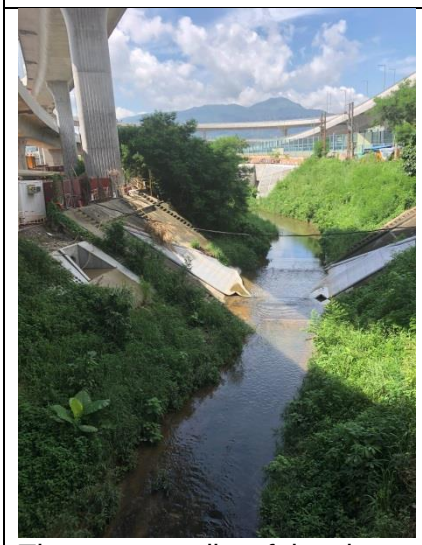
The water quality of the channel adjacent to the site was clear.

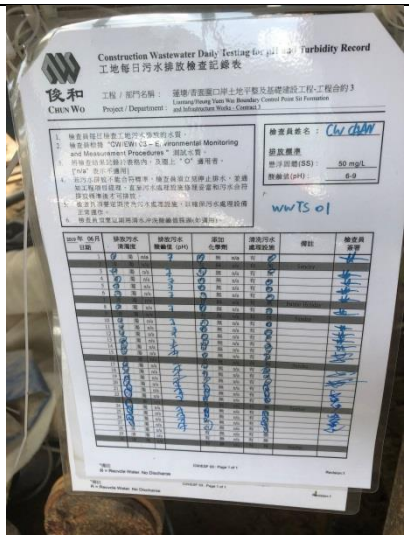
Daily checking of discharge quality was implemented.

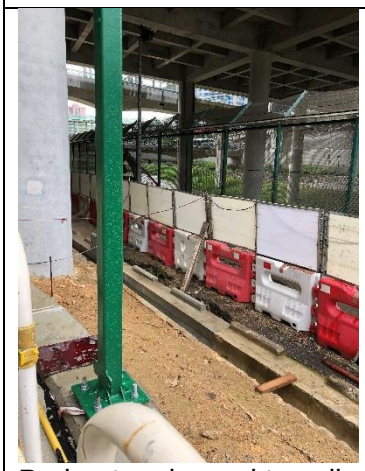
Perimeter channel to collect site runoff.

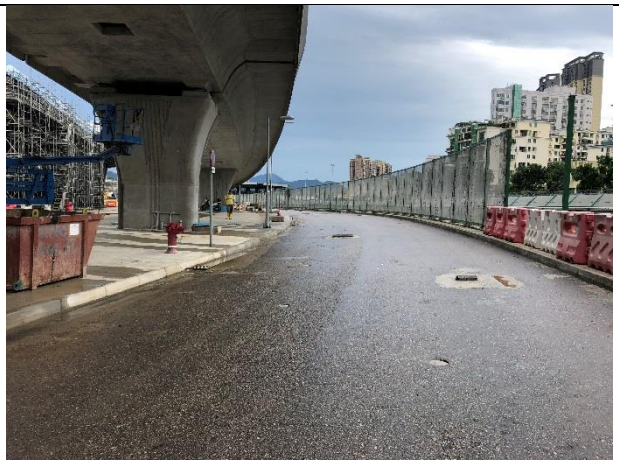
The site area was hard paved and no adverse water quality impact was observed.

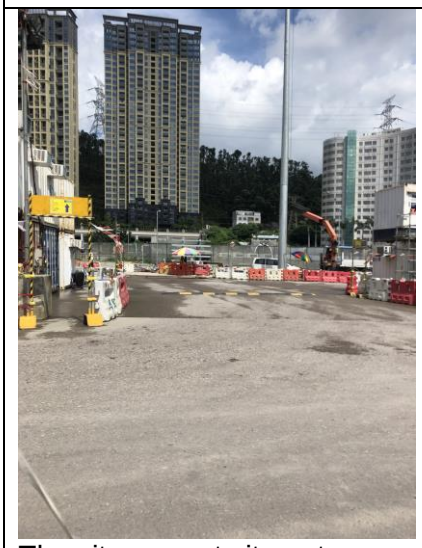
The site area at site entrance was hard paved and no adverse water quality impact was observed.
