AGREEMENT NO. CE 45/2008 (CE)
LIANTANG/ HEUNG YUEN WAI
BOUNDARY CONTROL POINT AND ASSOCIATED WORKS

MONTHLY ENVIRONMENTAL MONITORING AND AUDIT REPORT (NO.77) – DECEMBER 2019

PREPARED FOR
CIVIL ENGINEERING AND DEVELOPMENT DEPARTMENT (CEDD)

Date	Reference No.	Prepared By	Certified By
13 January 2020	TCS00694/13/600/R2307v2		
		Nicola Hon (Environmental Consultant)	Tam Tak Wing (Environmental Team Leader)

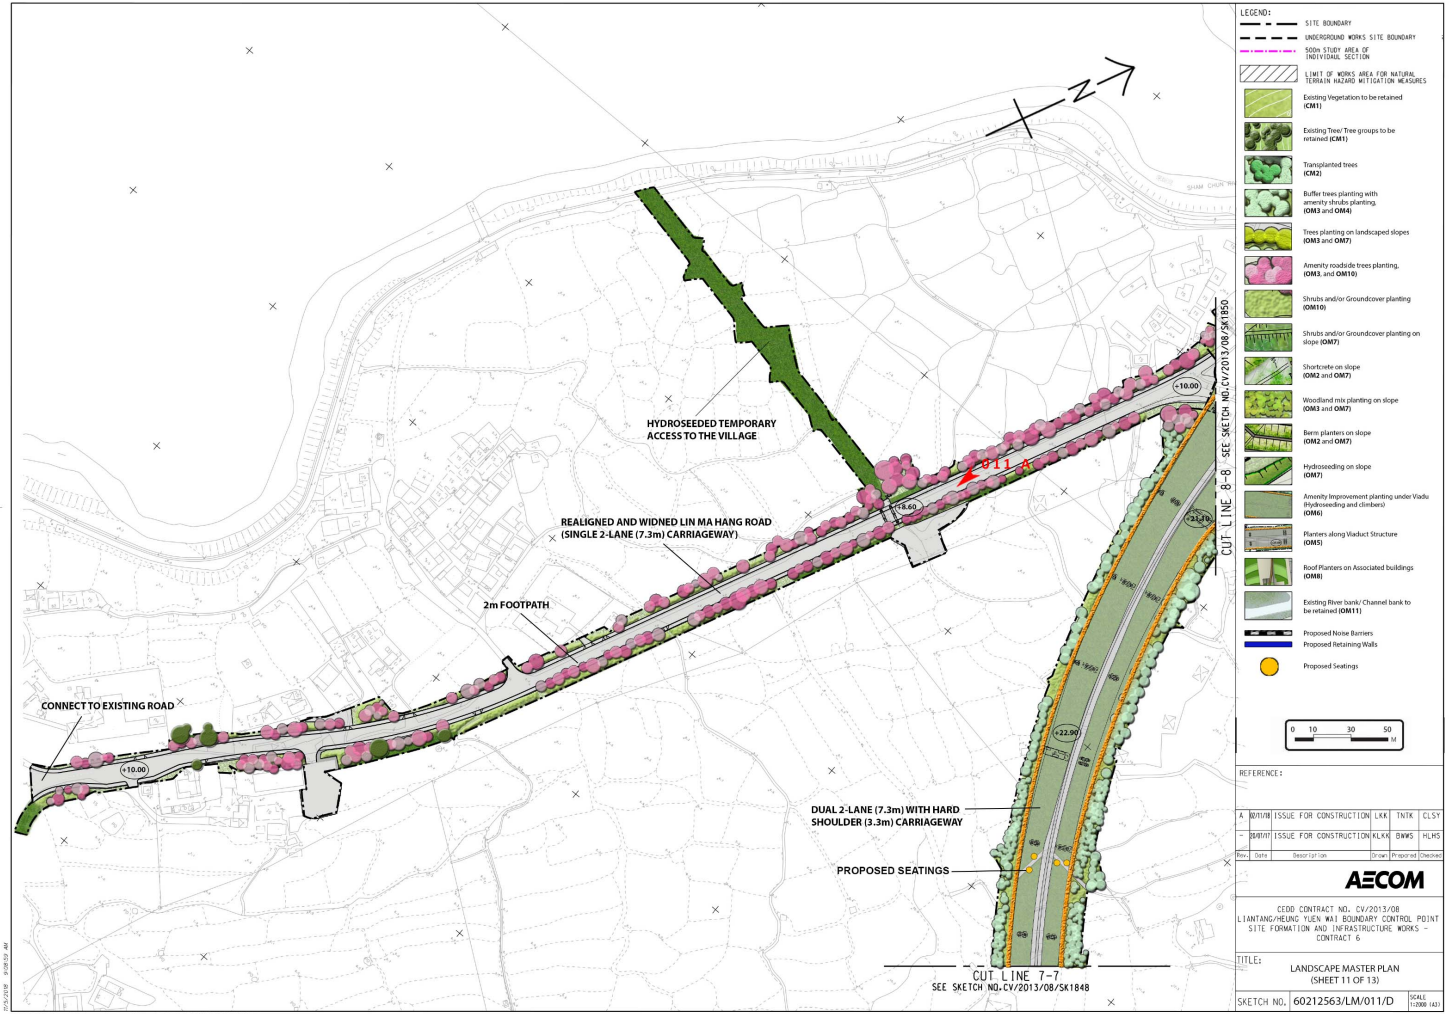
Amenity Roadside Trees Planting (OM3 & OM10)
Shrubs and/or Groundcover Planting (OM10)

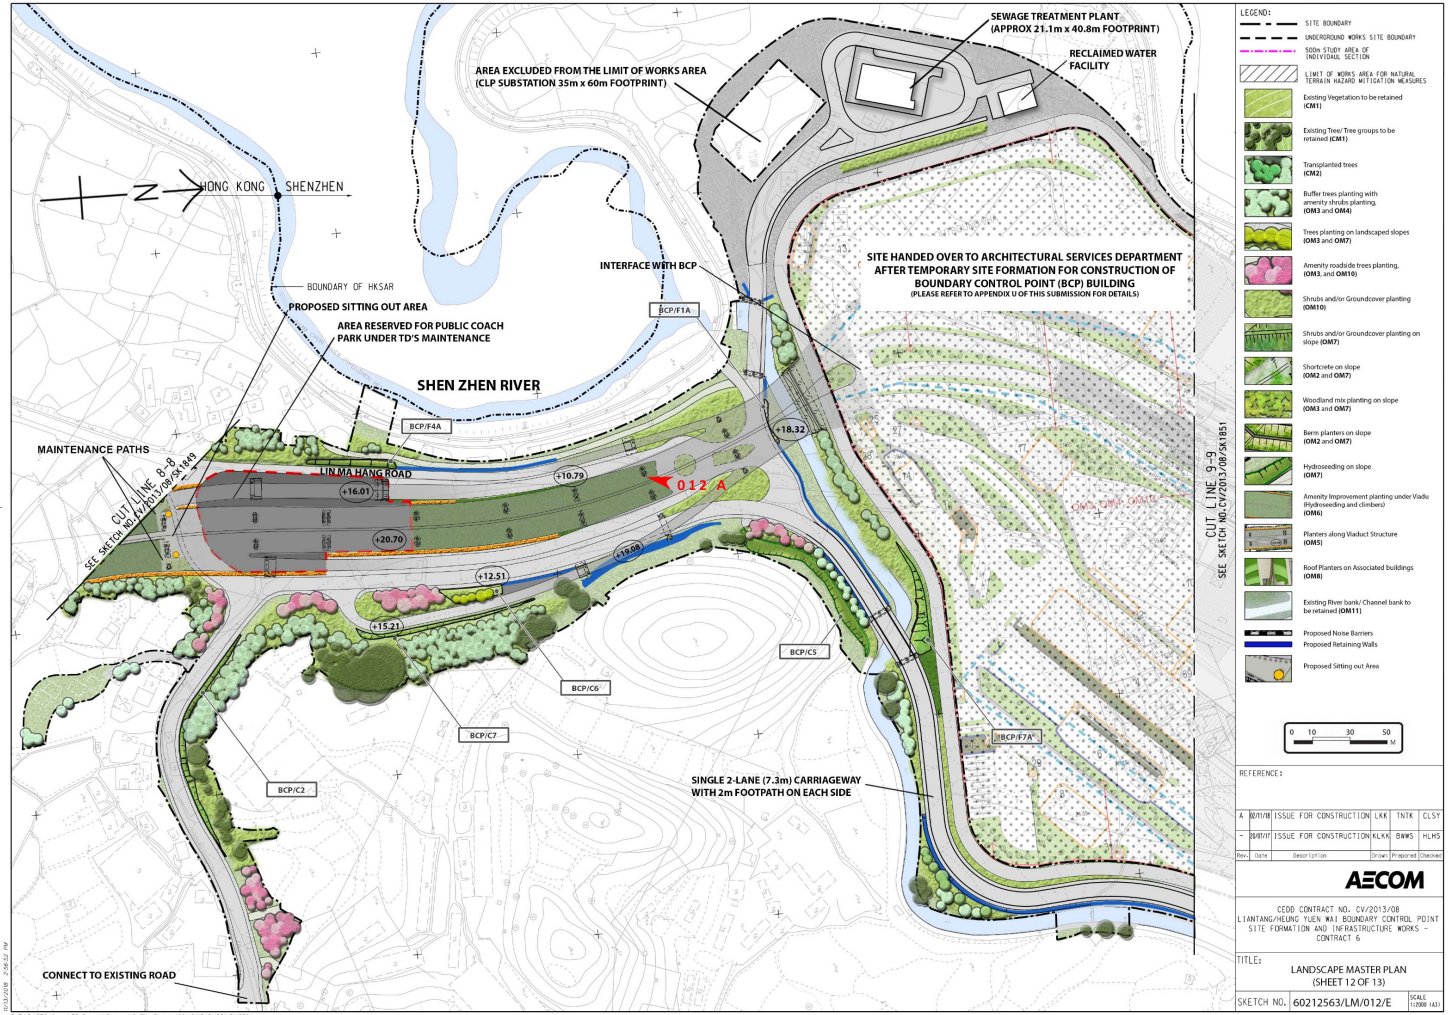
012 A

Amenity Improvement Planting under Viaduct (Hydroseeding and Climbers) (OM6)

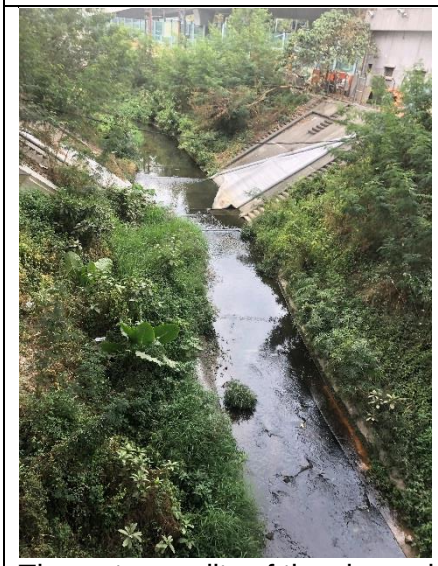
The water quality of the channel adjacent to the site was clear.

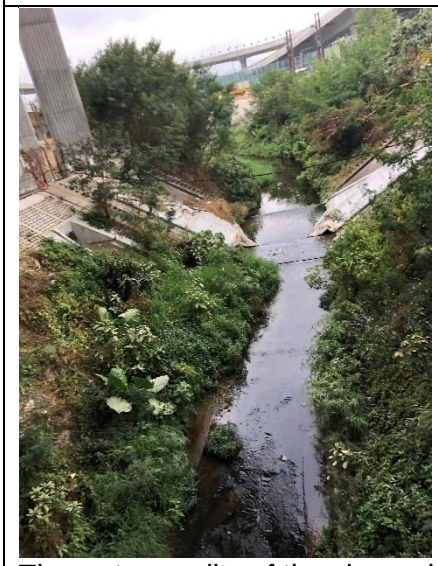
The water quality of the channel adjacent to the site was clear.

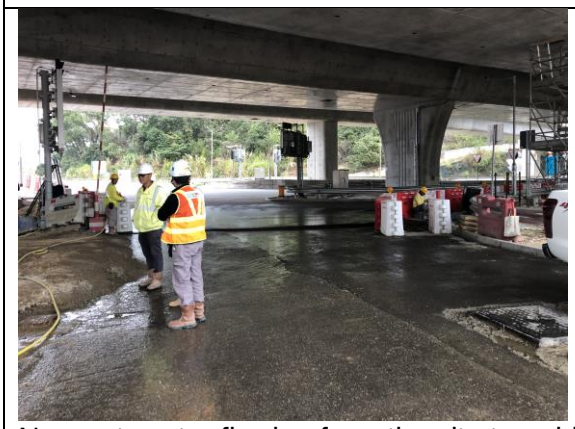
No wastewater flowing from the site to public road was observed.

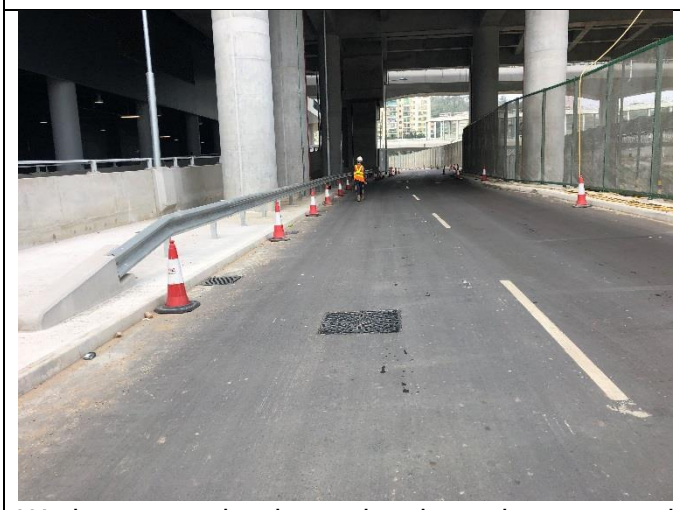
Work area was hard paved and no adverse water impact was observed.

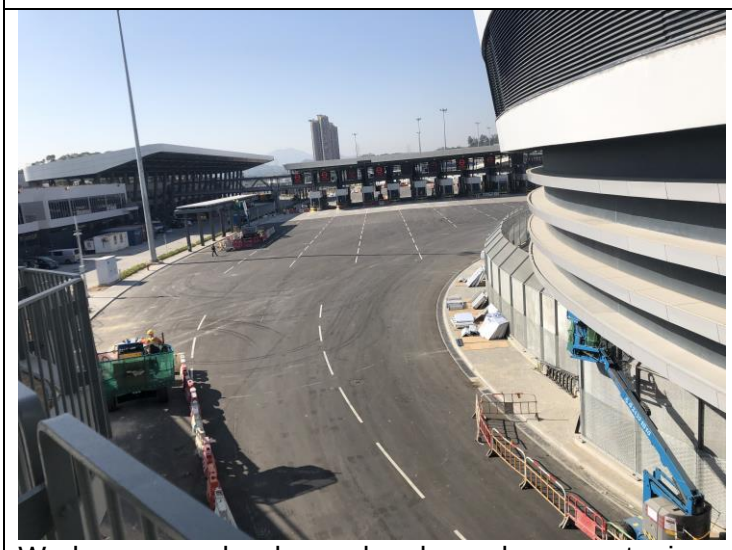
Work area was hard paved and no adverse water impact was observed.

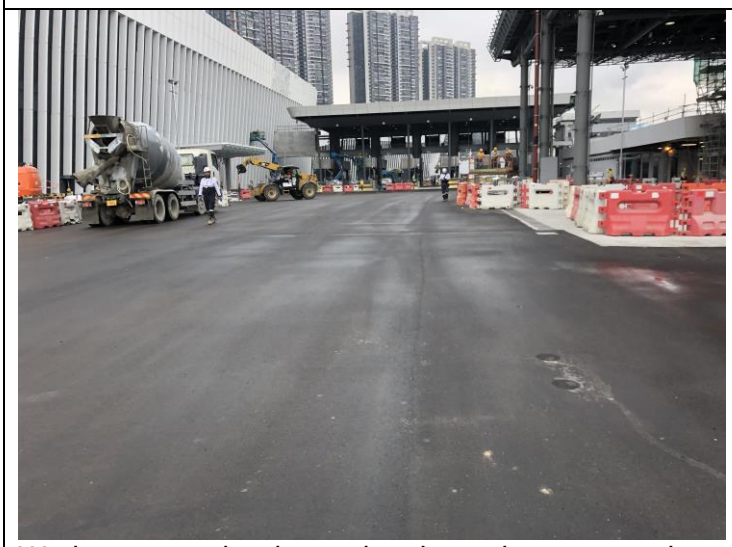
Work area was hard paved and no adverse water impact was observed.
