Sheung Shui to Lok Ma Chau Spur Line

Monthly EM&A Report for Kwu Tung Station

(April 2023)

Contract 1633 –Alteration and Addition Works at Kwu Tung for East Rail Line Protection Works

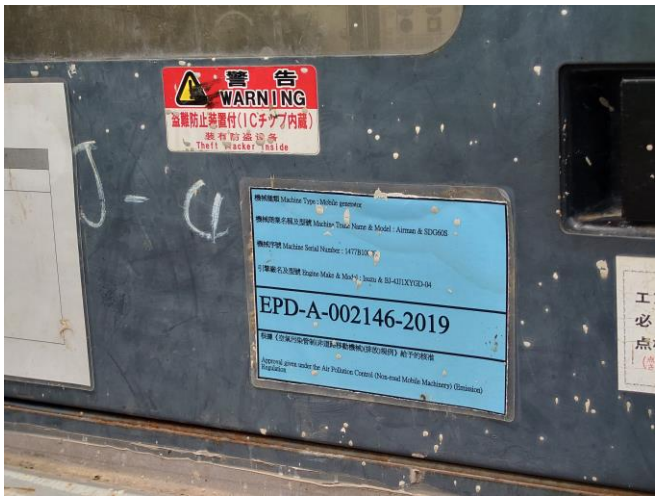
**Ref no.:** 230424-R01 **Impact:** *Air Quality* (B 26) **Detail:** Faded NRMM label should be replaced.
