Ocean Park Master Redevelopment Project

Monthly Environmental Monitoring & Audit Report – December 2007

Environmental Permit No. EP-249/2006/A - Condition 3.4

Submitted by Maunsell Consultants Asia Ltd on 12-01-2008

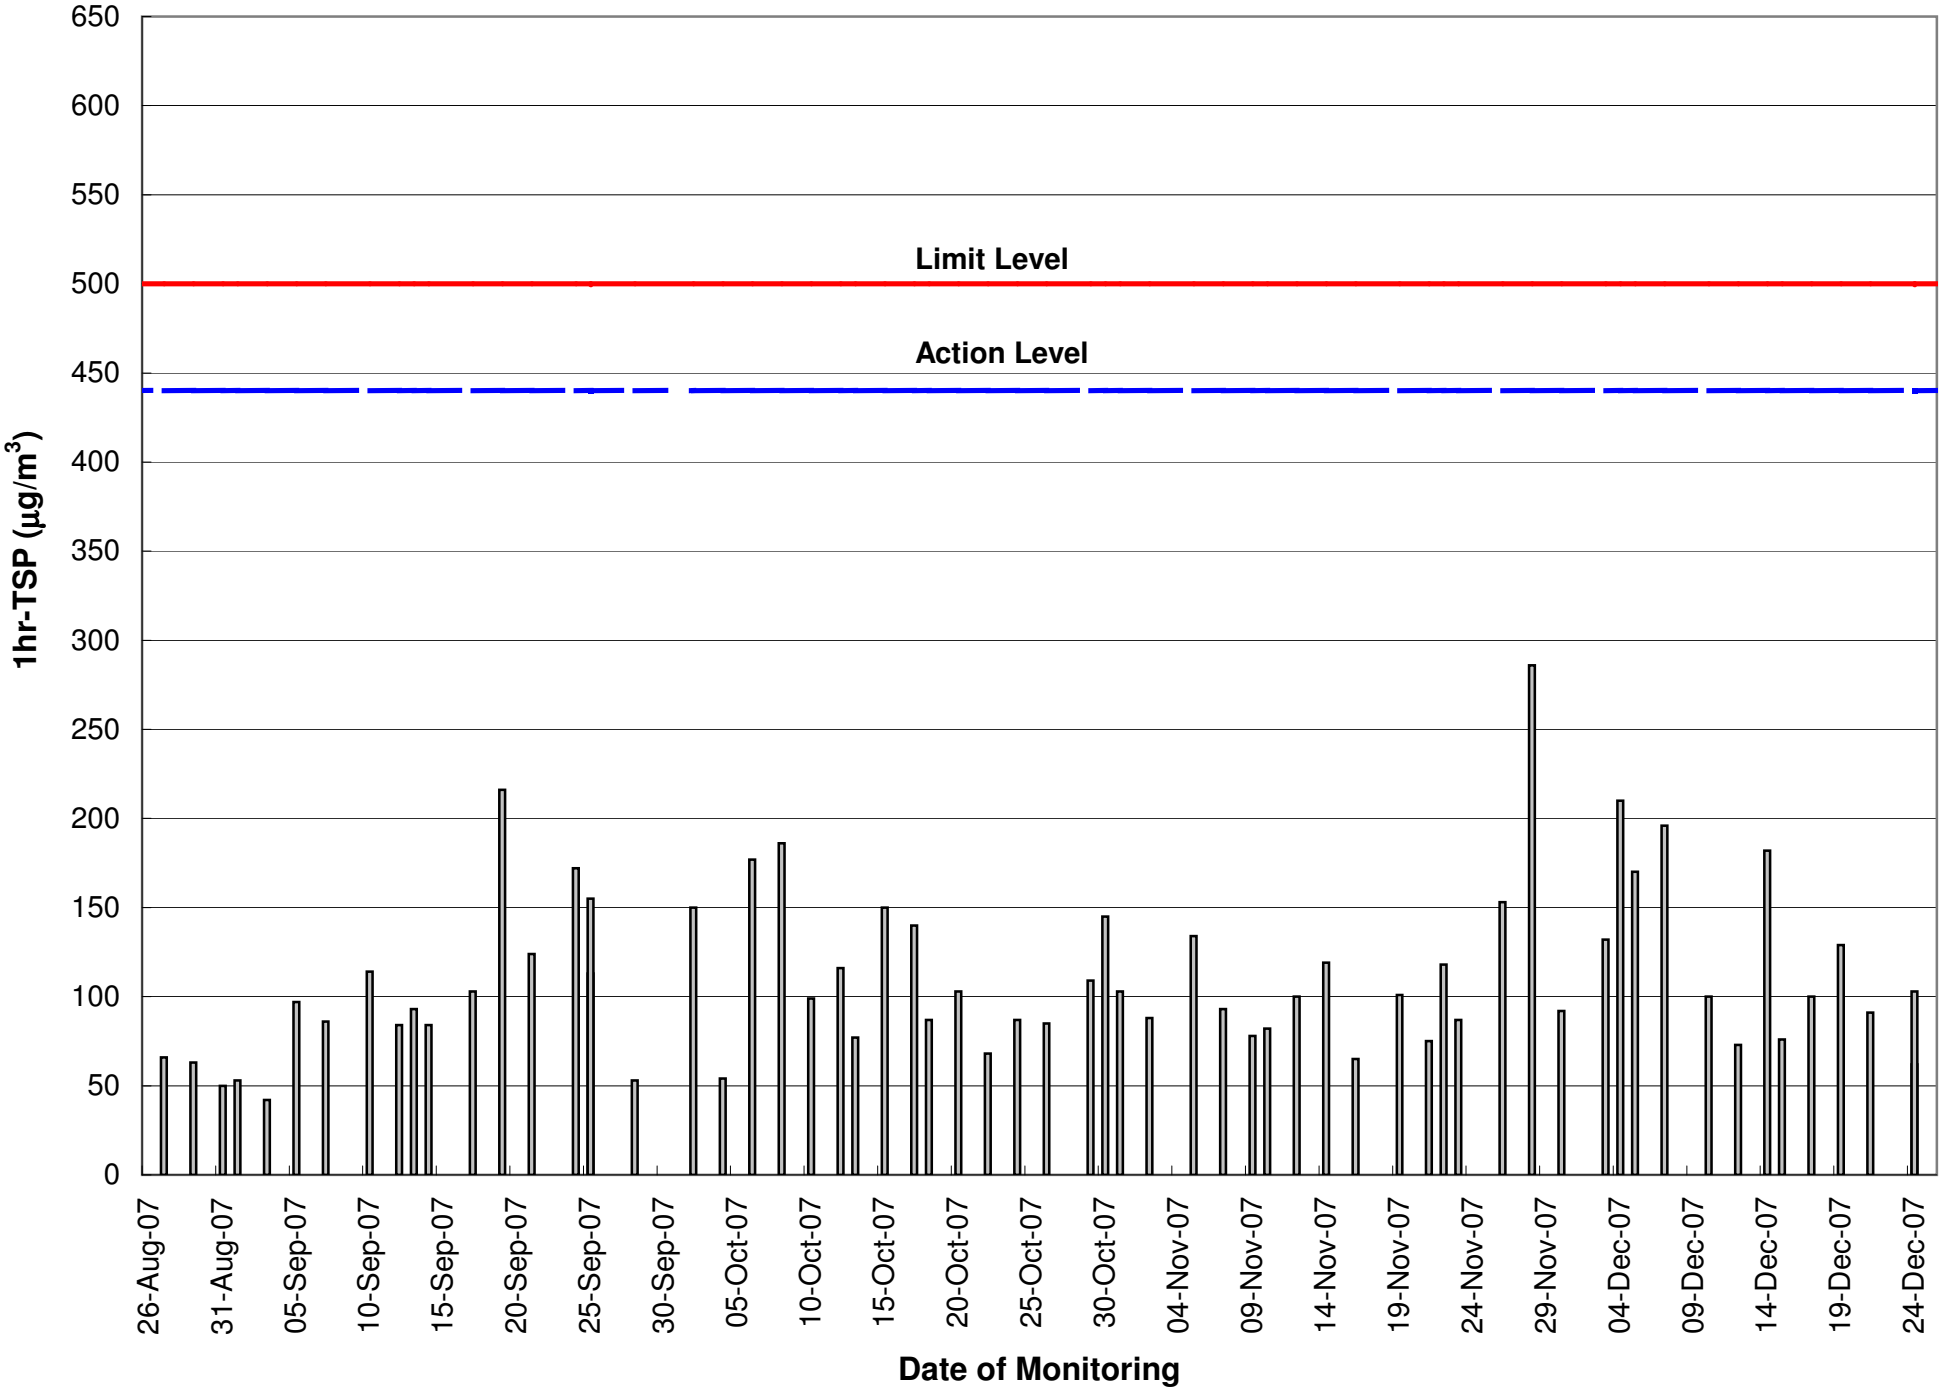
Figure C.1 1-hr TSP monitoring results of Monitoring Station AM1

X – denotes no measurement due to power supply failure
