Ocean Park Master Redevelopment Project

Monthly Environmental Monitoring & Audit Report – January 2008

Environmental Permit No. EP-249/2006/A - Condition 3.4

Submitted by Maunsell Consultants Asia Ltd on 12-02-2008

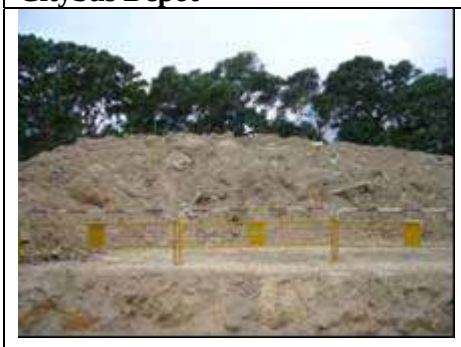
P1050436 & P1050437: The permanent drainage channels and catchpits were accumulated with mud and debris. The Contractor shall ensure they are clear of blockage at all times.	P1050438 & P1050466: A few gully pits and catchpit outlets within the site were not provided with sandbags. The Contractor shall ensure discharge of muddy surface runoff into public drains were avoided.
Citybus Depot

P1050459 & P1050461: Stockpiles of dusty materials were idled and uncovered. The Contractor shall ensure they are compacted and covered by tarpaulin sheets or other means to suppress dust.

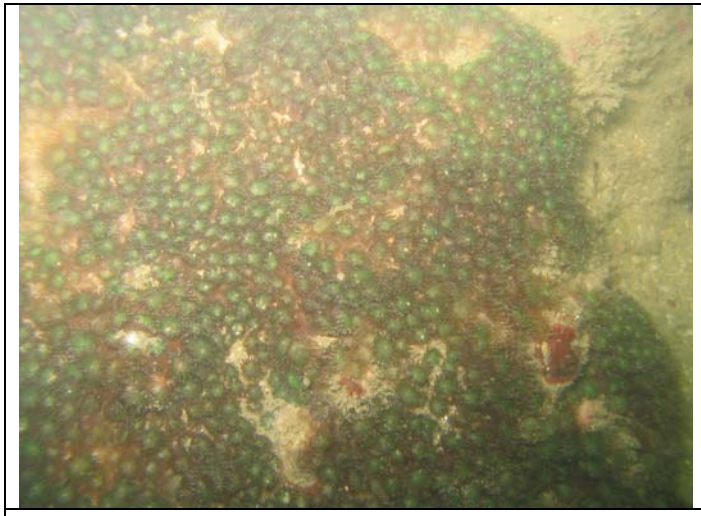
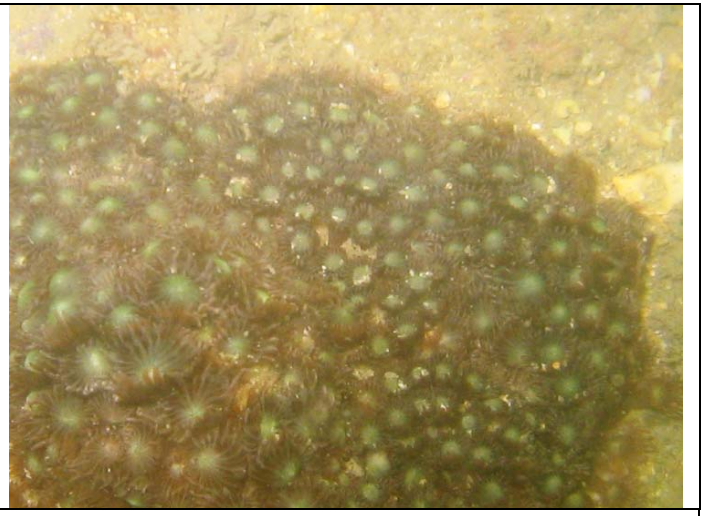
b) Please indicate the shrunken Balloon Flower in Photo 4.	Noted. The photo would be provided accordingly in the next report.			
3	EPD	Appendix F – Monthly Report (Nov '07)		Photos E1-E3, E5 & E6 – The tagged coral colonies at Site 4 as shown in photos do not look like *Goniopora strutchburyi*. Please check and amend.	Pictures from Site 4 were in lower quality due to the rough condition which make difficult the focusing process. The wavy condition was caused by the exposure of the site, as well as the peripheral transport during the survey. A supplement of close up pictures for the querying colonies E1 to E3, E5 and E6 are provided for better identification. The quality is not high but it could show the tentacles of the corals, which help identification. The problem is due to the limitation of the common marine photography method but NOT due to the identification. In conclusion, the tagged coral colonies at Site 4 were *Goniopora strutchburyi*.

E01 *Goniopora stutchburyi* (Close up)	E02 *Goniopora stutchburyi* (Close up)

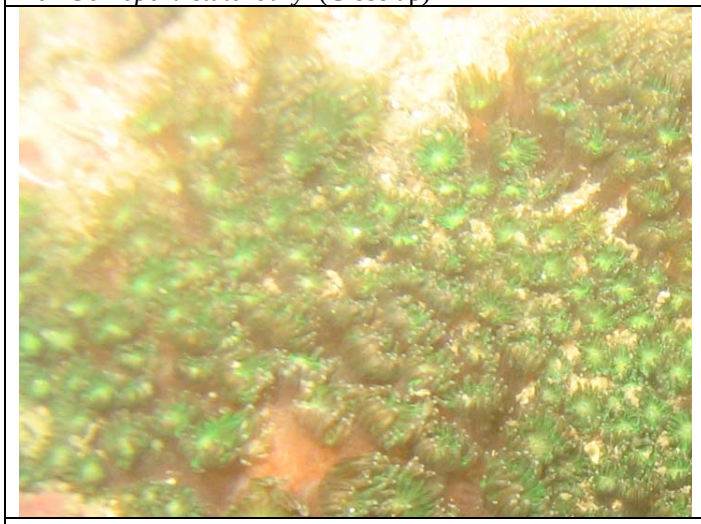
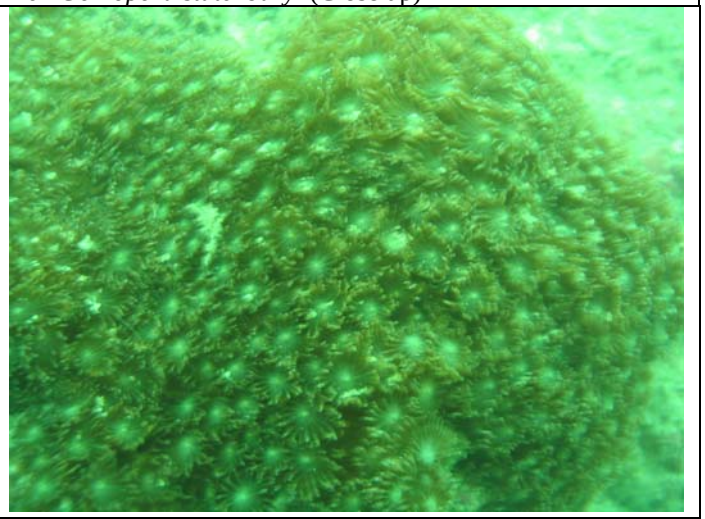
E03 *Goniopora stutchburyi* (Close up)	E05 *Goniopora stutchburyi* (Close up)

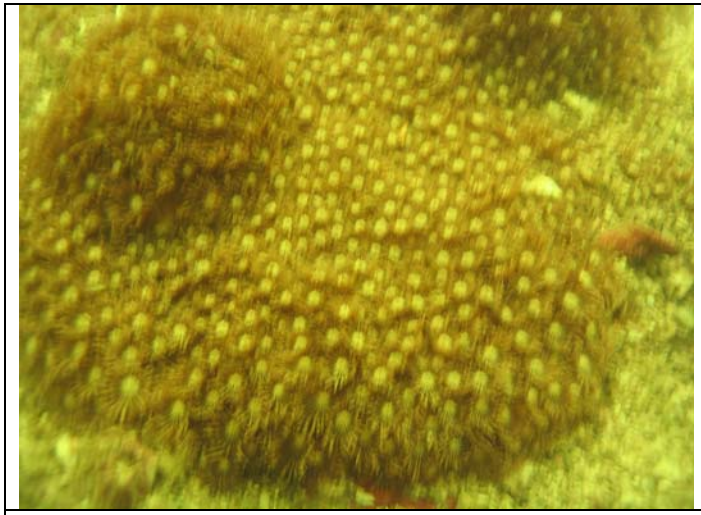
E06 *Goniopora stutchburyi* (Close up)
