Ocean Park Master Redevelopment Project

Monthly Environmental Monitoring & Audit Report – November 2008

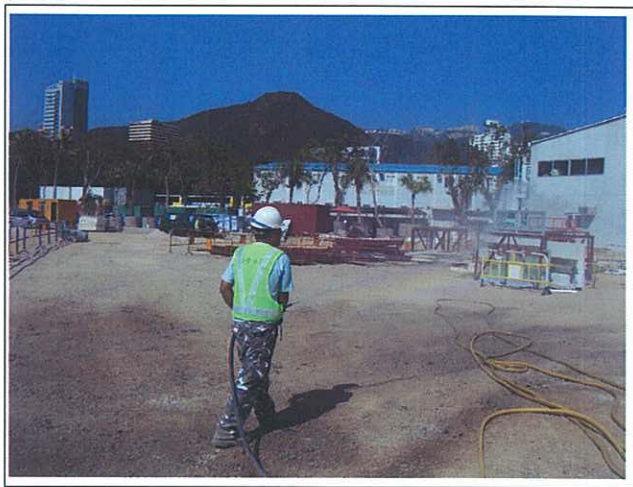
1.) The haul road was observed dry in the car park area.

1.) The haul road was sparyed water.

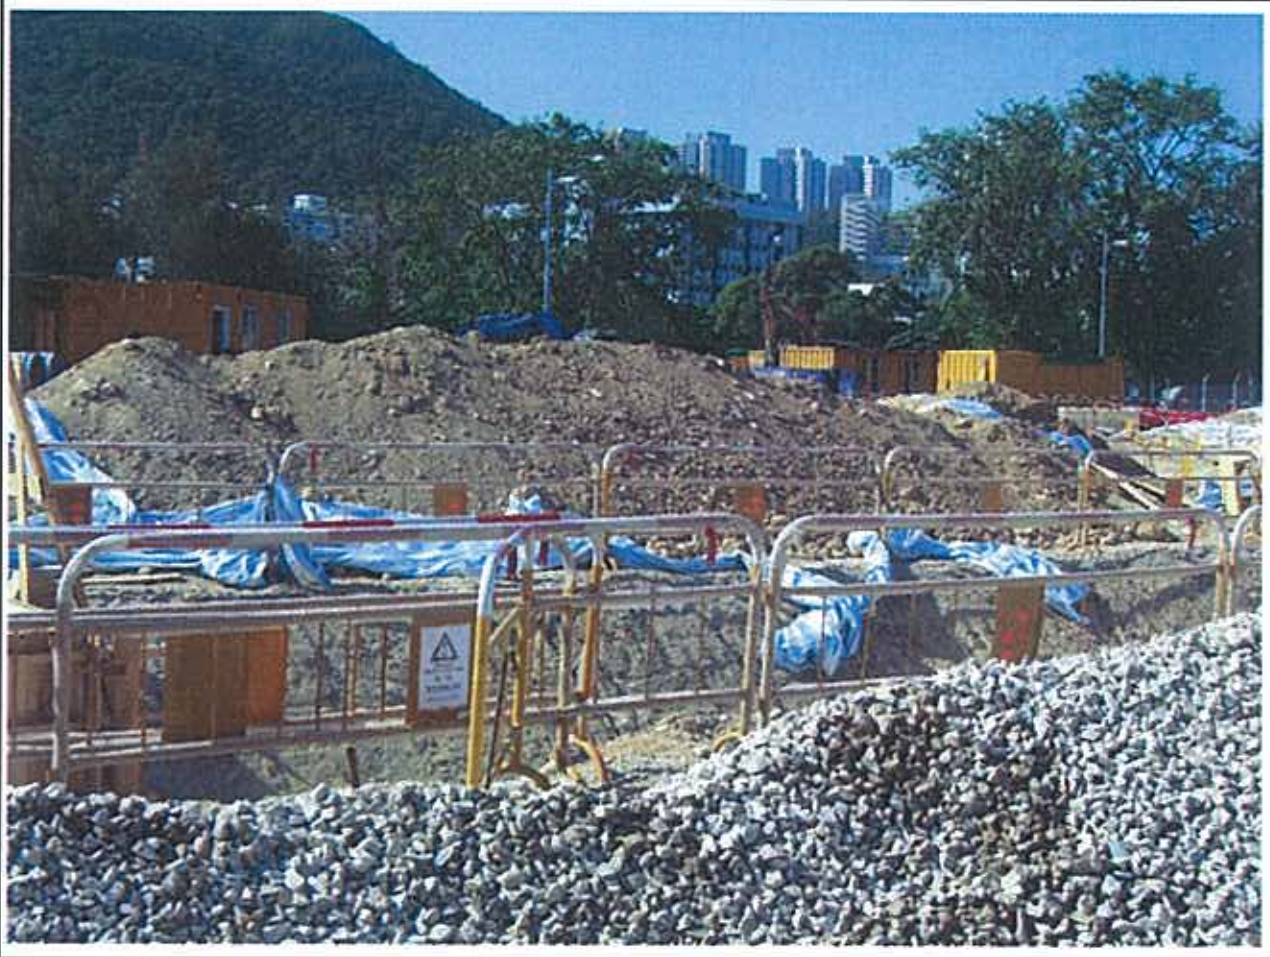
1.) The stockpile was observed without cover.

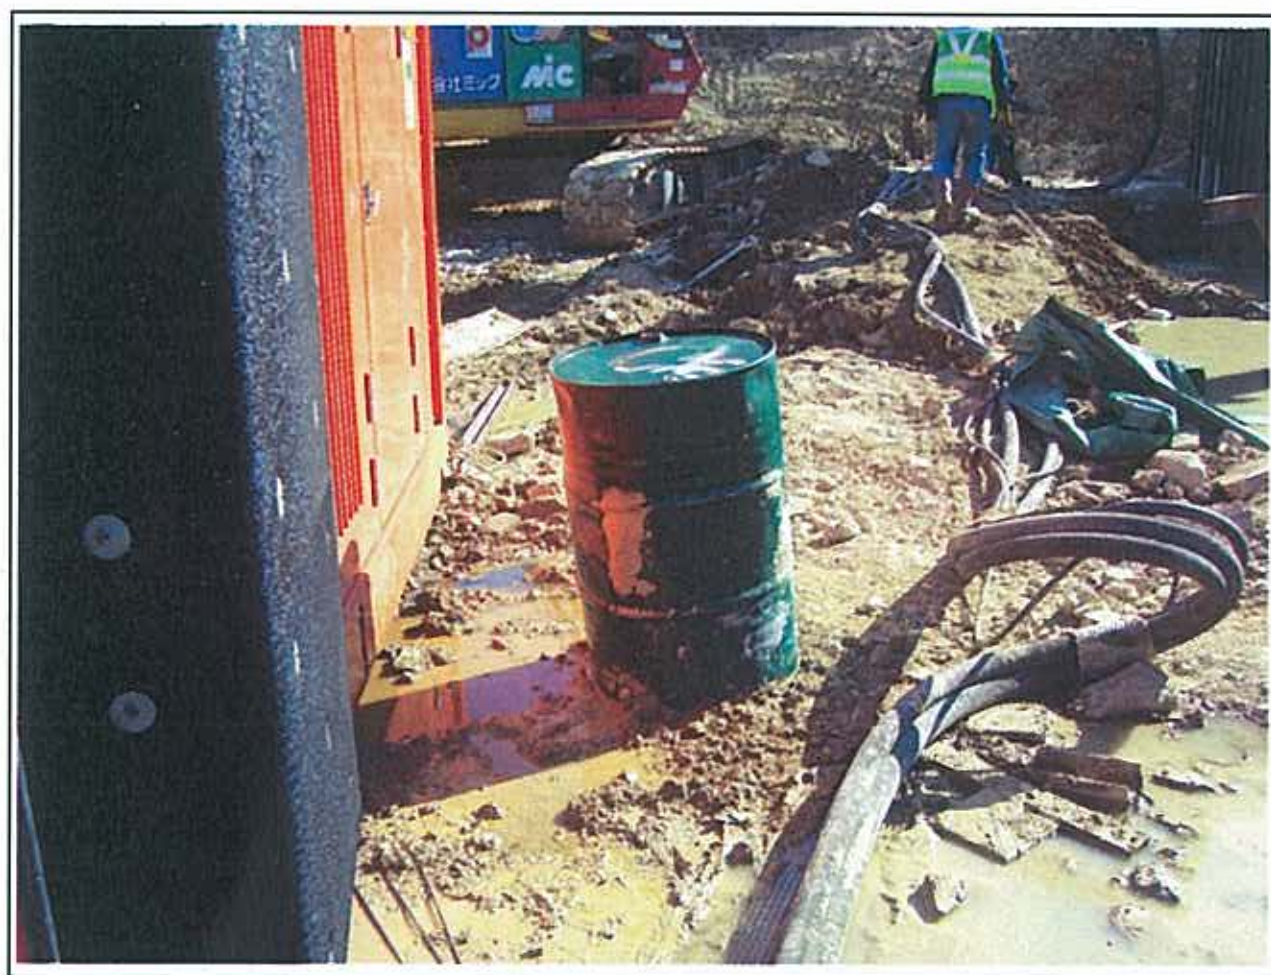
2.) The diesel drum was placed bare ground without drip tray.

2. The diesel drum was removed off-site.
