Ocean Park Master Redevelopment Project

Monthly Environmental Monitoring & Audit Report – February 2009

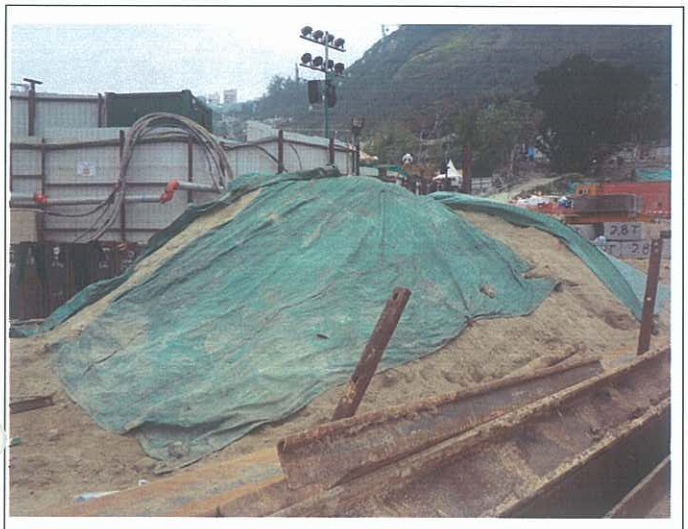
Inspection / Follow up Report No 022.

1.) The stockpile was covered.

2. Noise emission Label was displayed on Air compressor

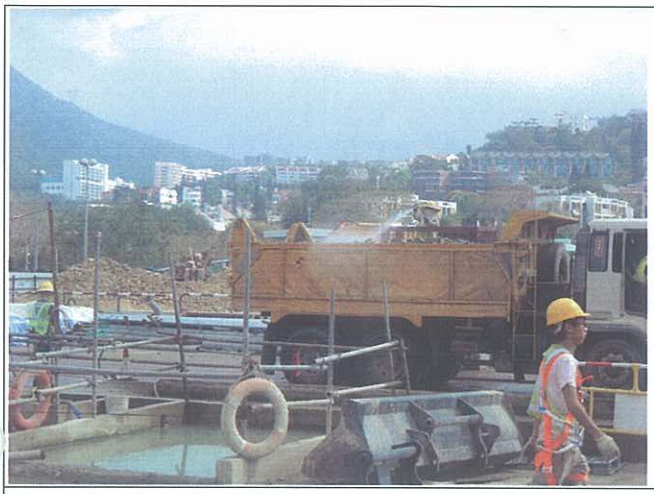
Inspection / Follow up Report No 023.

1.) Good practice: watering point was provided at site entrance to wet material
