Ocean Park Master Redevelopment Project

Monthly Environmental Monitoring & Audit Report – May 2009

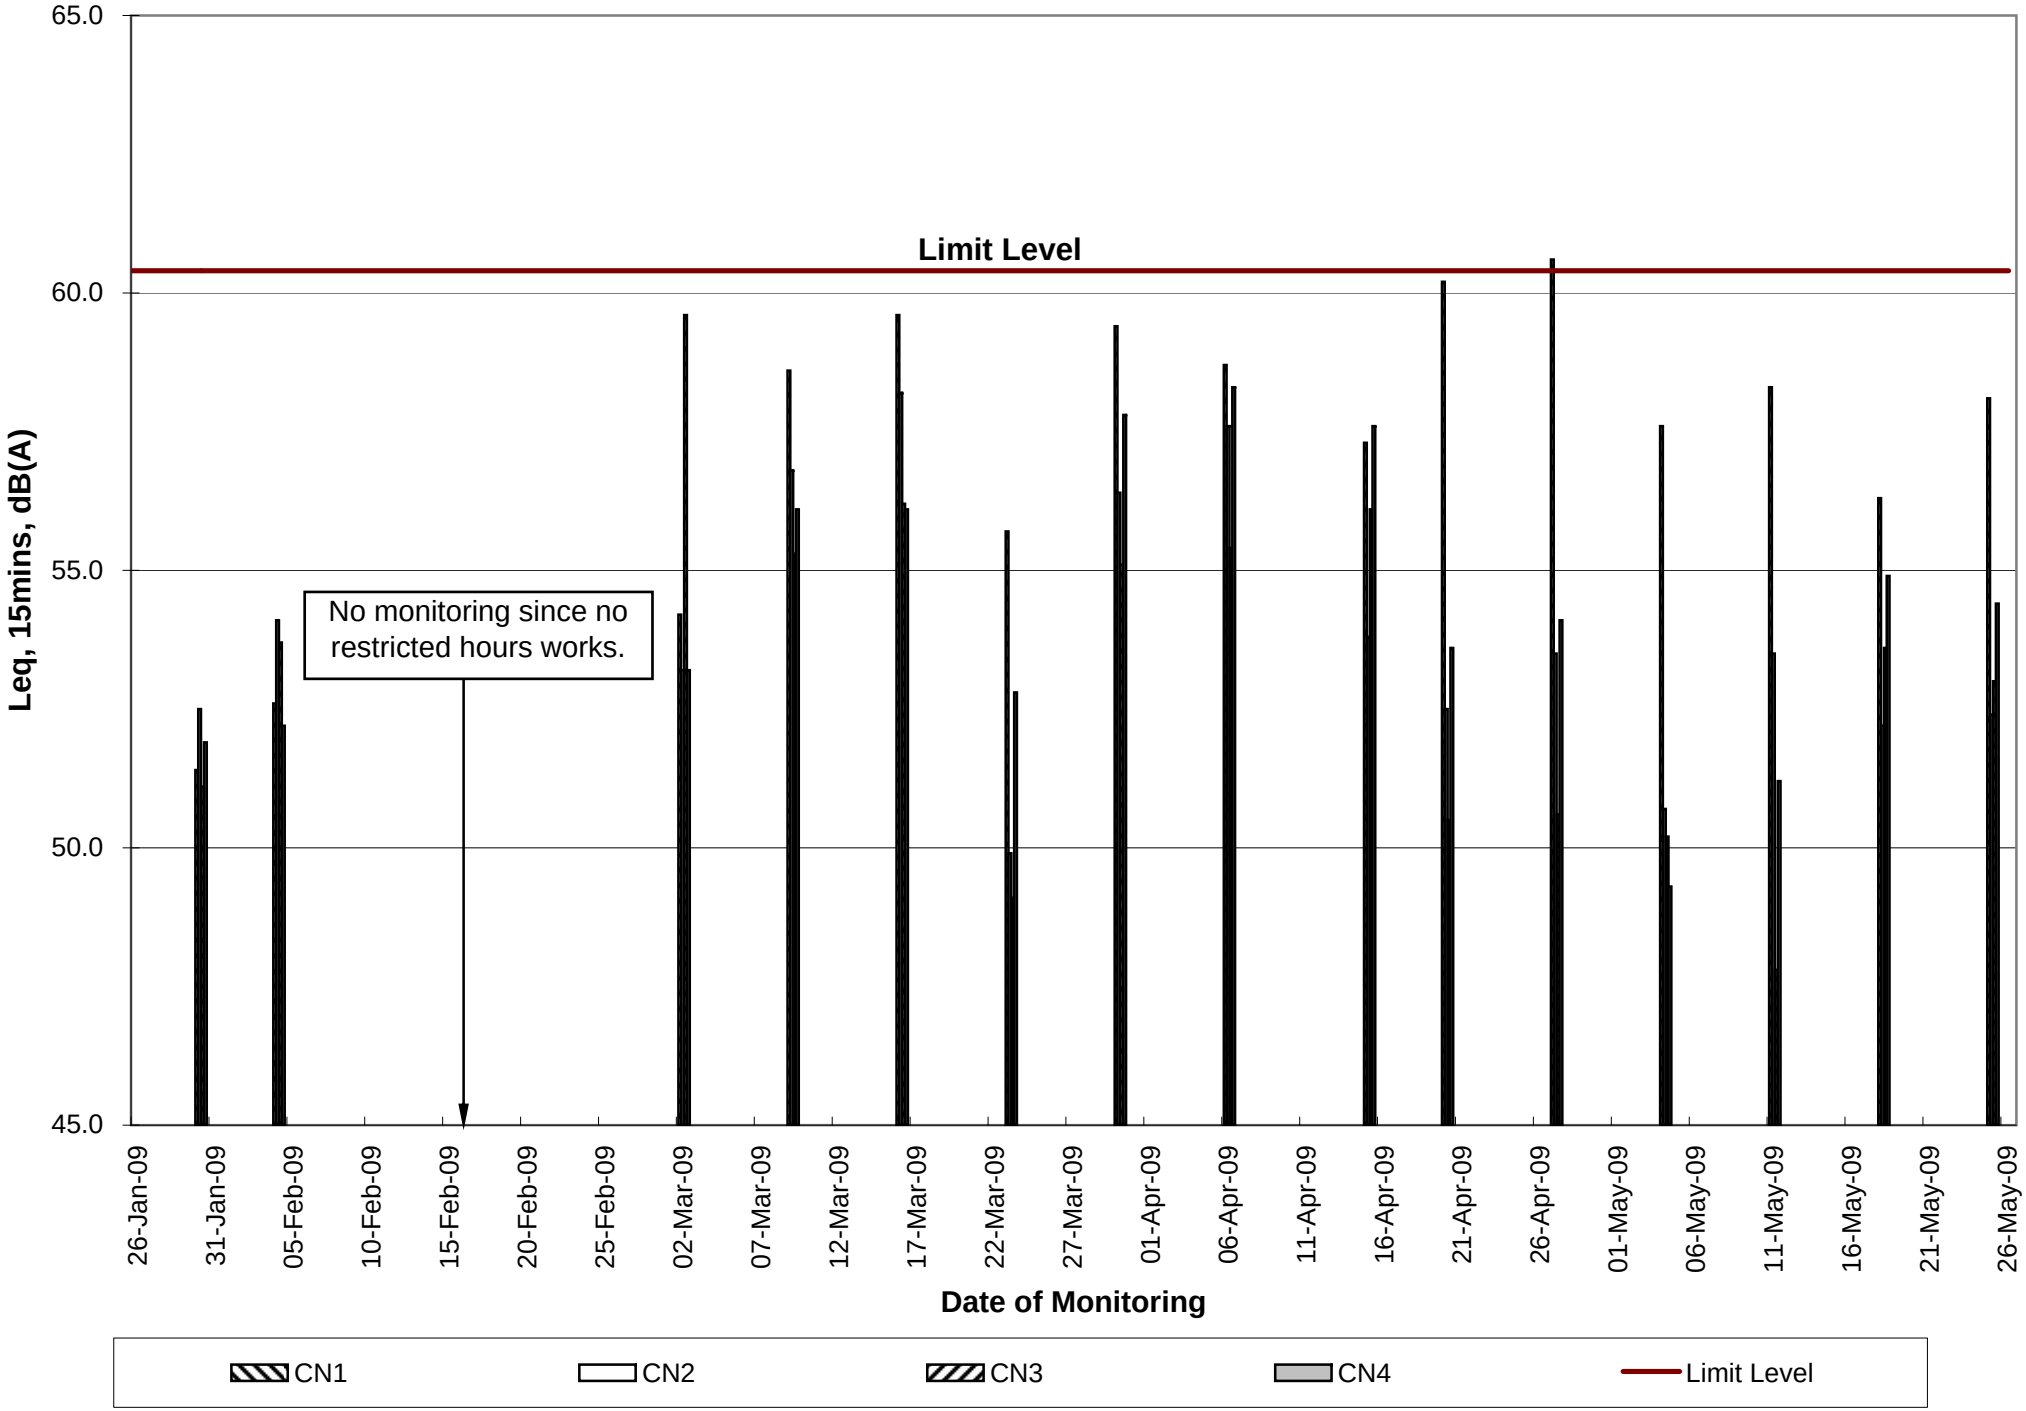
Fig D.2 - Evening Noise Monitoring Results of Monitoring Stations CN1, CN2, CN3 & CN4

One noise level (evening – 8:30 pm to 8:45 pm) was slightly exceeded (0.6 dB(A)) at the open area adjacent to Police Training School (CN1) on 27 April 2009 and it was probably due to the traffic noise. Only water pumps and waste water treatment plant were operated in these periods in accordance with Construction Noise Permit conditions.

* due to the traffic noise

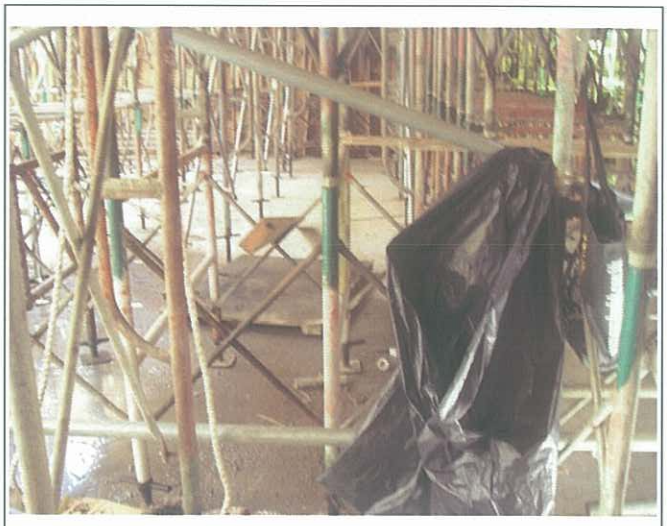
2.) General refuse was scattered on bare ground at 1/F of Entry Plaza.

2.) General refuse was removed.
