Ocean Park Master Redevelopment Project

Monthly EM&A Report – October 2010

Monthly Environmental Monitoring & Audit Report – October 2010

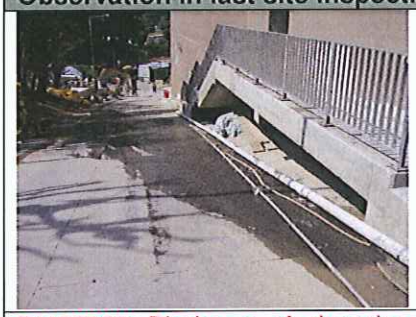
P1100790: Discharge of cleansing water was observed. The Contractor is reminded to provide sedimentation/treatment to wastewater generated from the site before discharge.	Closed - P1110084: Discharge of cleansing water was not observed.

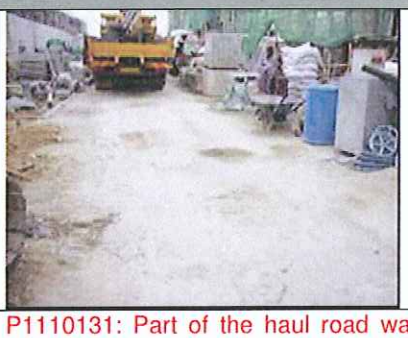
P1110125: A stockpile of excavated material was not covered with tarpaulin sheets or other means. The Contractor was recommended to cover it with tarpaulin sheets or other means to suppress dust.	P1110131: Part of the haul road was dry and dusty. The Contractor is reminded to provide watering more frequently to suppress dust along the entire haul road.

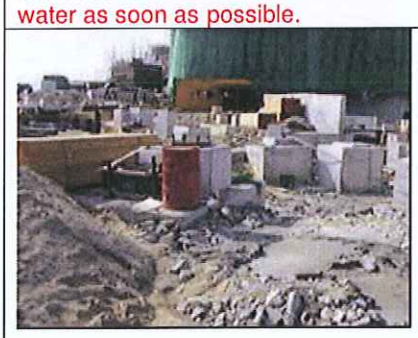
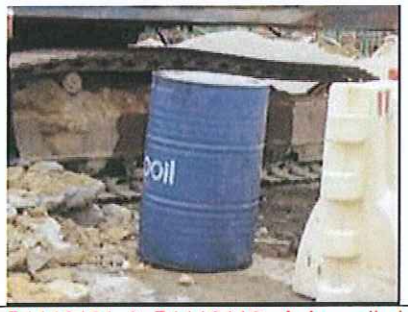
P1100803: Stagnant water was accumulated within the chemical waste storage area. The Contractor is reminded to remove the stagnant water as soon as possible.	Closed - P1110092: Stagnant water was not observed within the chemical waste storage area.

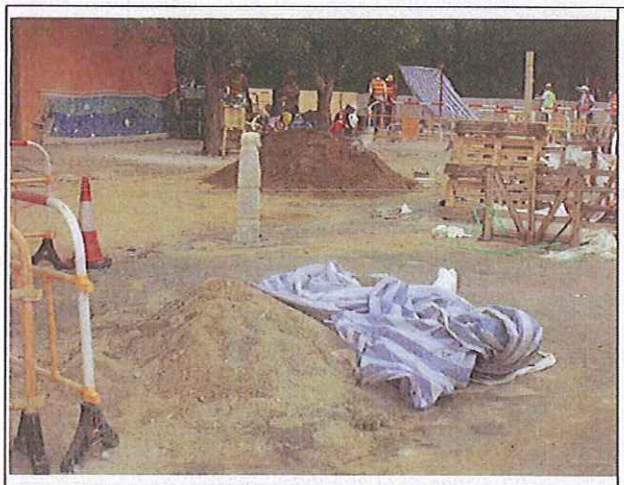
1. Stockpile of construction material was not covered near East Retail Shop on Entry Plaza Podium.	1. The contractor was reminded to cover stockpile completely with tarpaulin.

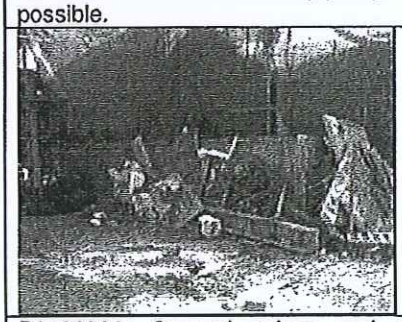
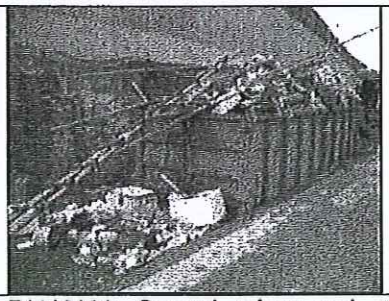
P1100836: General refuse and construction waste were accumulated on-site. The Contractor was reminded to remove them from site more frequently to avoid accumulation.	P1110124: General refuse and construction waste were accumulated on-site. The Contractor was reminded to remove them from site more frequently to avoid accumulation.

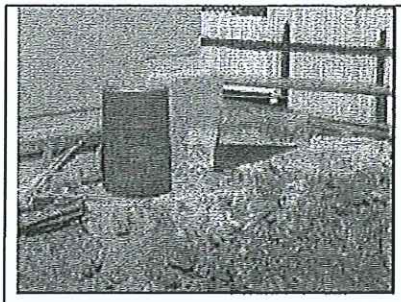
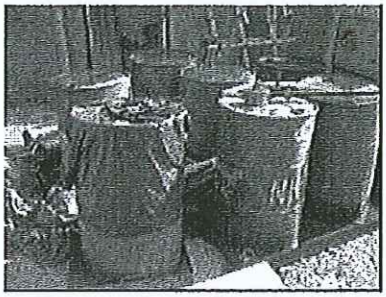
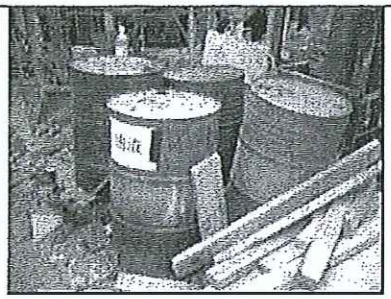
P1100822 & P1100827: An oil drum was not provided with drip tray while the drip trays with oil drums were accumulated with water. The Contractor is reminded to provide drip trays to all oil drums on site to avoid oil spillage and remove water accumulated in drip trays with oil drums.	P1110120: A few diesel drums were not provided with drip trays. The Contractor is reminded to provide drip trays to all oil drums on site to avoid oil spillage.

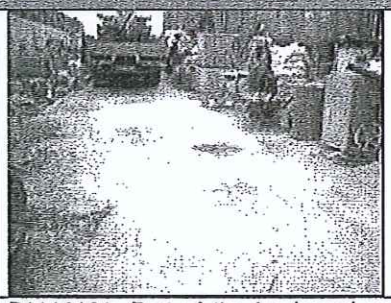
P1110125: A stockpile of excavated material was not covered with tarpaulin sheets or other means. The Contractor was recommended to cover it with tarpaulin sheets or other means to suppress dust.	P1110131: Part of the haul road was dry and dusty. The Contractor is reminded to provide watering more frequently to suppress dust along the entire haul road.

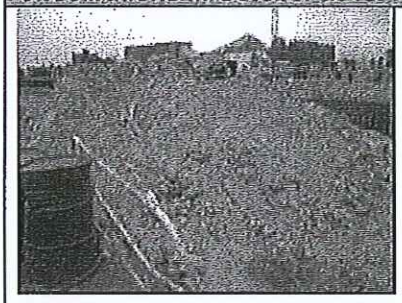
P1100819: Part of the haul road was dry and dusty. The Contractor is reminded to provide watering more frequently to suppress dust.	P1110104 & P1110108: Part of the haul road was dry and dusty. The Contractor is reminded to provide watering more frequently to suppress dust along the entire haul road.

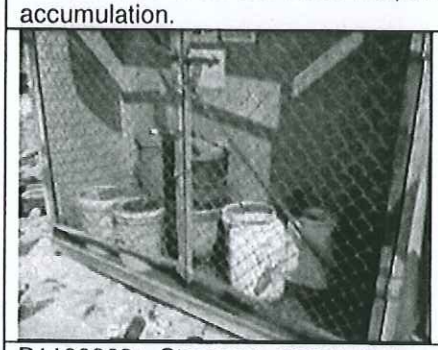
P1100811: General refuse were scattered around the site. The Contractor is reminded to remove them from site more frequently to avoid accumulation.	P1110107: General refuse were scattered around the site. The Contractor is reminded to remove them from site more frequently to avoid accumulation.

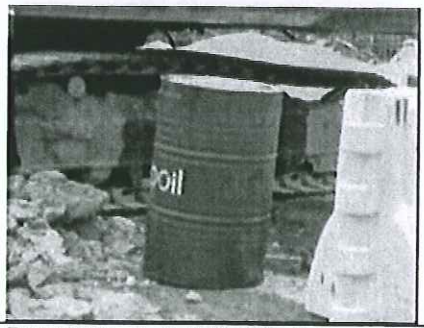
P1100803: Stagnant water was accumulated within the chemical waste storage area. The Contractor is reminded to remove the stagnant water as soon as possible.	Closed - P1110092: Stagnant water was not observed within the chemical waste storage area.

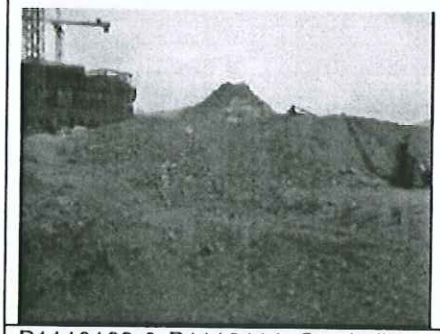
P1100819: Part of the haul road was dry and dusty. The Contractor is reminded to provide watering more frequently to suppress dust.	P1110104 & P1110108: Part of the haul road was dry and dusty. The Contractor is reminded to provide watering more frequently to suppress dust along the entire haul road.
