Ocean Park Master Redevelopment Project
EP-249/2006A – Condition 3.4 of Monthly EM & A Report (November 2010)

Ocean Park Master Redevelopment Project
Contract P007
Independent Environmental Checker

MONTHLY SITE INSPECTION CHECKLIST

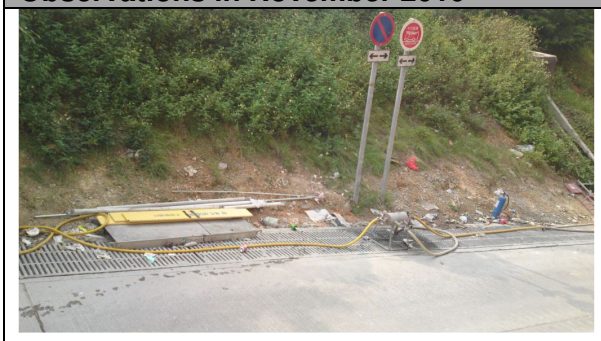
11192010465: General refuses were observed on the surface channel. The Contractor was reminded to clean up the on-site general refuses, especially the general refuses nearby the surface channel.	11192010476, 11192010477 and 11192010478: Stockpiles, cement bags were observed not covered. Haul road was dry and dusty. The Contractor was reminded to cover stockpiles and on site cement bags and increase the frequency of water spraying at the Entry Plaza in order to reduce dust generation.

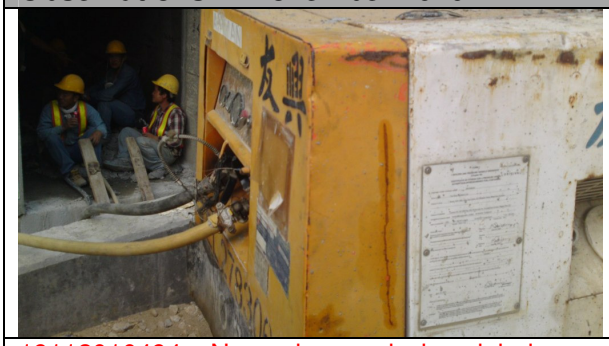
19112010494: No noise emission label was observed on the air compressor. The Contractor was reminded not using the air compressor without noise emission label.

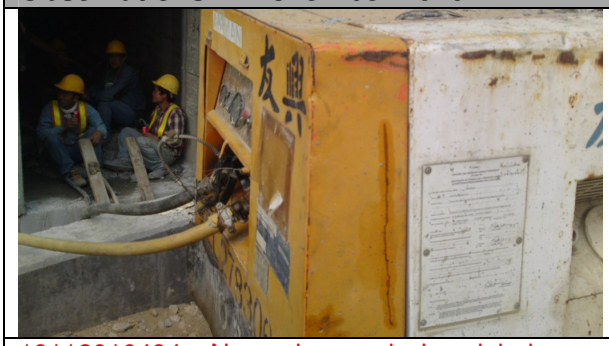
19112010494: No noise emission label was observed on the air compressor. The Contractor was reminded not using the air compressor without noise emission label.
