99th Consolidated Monthly EM&A Report (January 2025)

0087/16/ED/1247 [00]

Contact No. KLN/2016/05 - Independent Environmental Checker for Contract No. KL/2015/02 Kai Tak Development- Stage 5A Infrastructure at Former North Apron Area

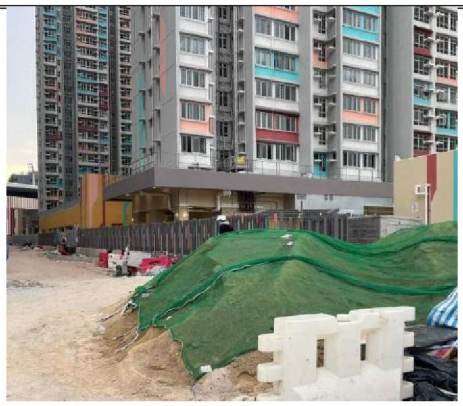
Inspection Date	Key Observations	Recommendations / Actions	Close-out Date / Status
28 Jan 2025	 Observation: Stockpiles should be fully covered by impermeable sheeting to reduce dust emission.	 Action Taken: Stockpiles has been fully covered by impermeable sheeting to reduce dust emission.	Closed out on 6 Feb 2025
