100th Consolidated Monthly EM&A Report (February 2025)

0087/16/ED/1249 00

Contact No. KLN/2016/05 - Independent Environmental Checker for Contract No. KL/2015/02 Kai Tak Development- Stage 5A Infrastructure at Former North Apron Area

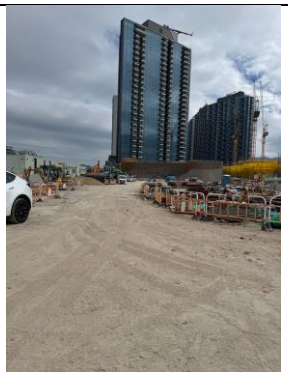
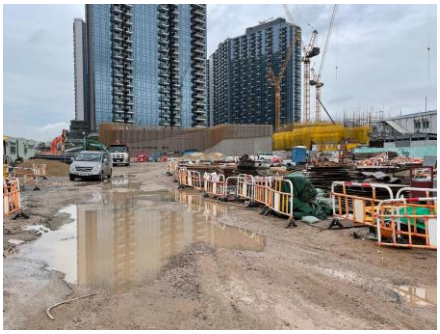
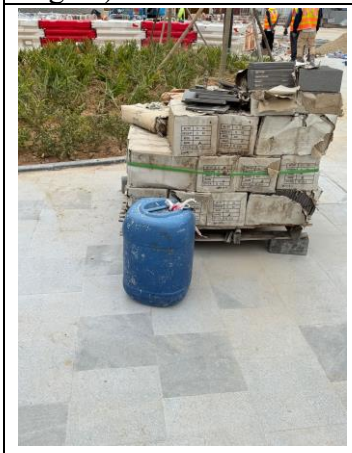
Table 6.1 Summary of site inspections observations during the reporting month

Inspection Date	Key Observations	Recommendations / Actions	Close-out Date / Status
06 February 2025	Reminder: The WPCO discharge licence has been experired on 30/9/2024. Please complete the renewal process asap, meanwhile ensure no improper discharge from the site.	Action Taken: The renewal process for the discharge license is in progress.	Pending
11 February 2025	 Observation: Main haul road outside the pumping station should be sprayed water regularly to suppress dust emission.	 Action Taken: Main haul road outside the pumping station have been sprayed water regularly to suppress dust emission.	Closed-out on 20 February 2025

Inspection Date	Key Observations	Recommendations / Actions	Close-out Date / Status
	 Observation: NRMM label should be displayed on the crawler aerial working platform (diesel engine).	 Action Taken: NRMM label have been displayed on the crawler aerial working platform (diesel engine).	Closed-out on 20 February 2025
	 Observation: Unknow chemical should be removed.	 Action Taken: Unknow chemical has been removed.	Closed-out on 20 February 2025
20 February 2025	 Observation: The stagnant water should be properly collected at Park 4.	 Action Taken: The stagnant water has been properly collected at Park 4.	Closed-out on 27 February 2025

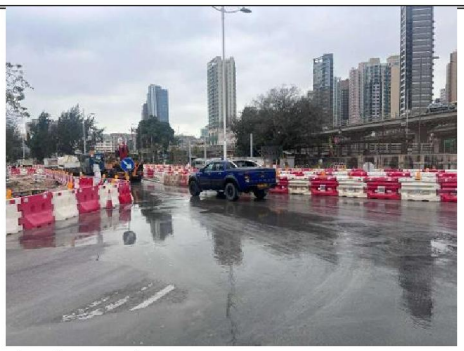
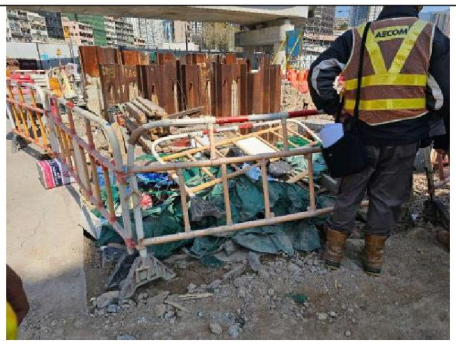
Inspection Date	Key Observations	Recommendations / Actions	Close-out Date / Status
20 Feb 2025	 Observation: Every vehicle should be washed to remove any dusty materials form its body and wheels before leaving the construction sites in L9 road.	 Action Taken: Every vehicle has been washed to remove any dusty materials form its body and wheels before leaving the construction sites.	Closed out on 27 Feb 2025
27 Feb 2025	 Observation: C&D waste found shall be removed timely to uphold the site hygiene conditions.	 Action Taken: C&D waste found has been removed timely to uphold the site hygiene conditions.	Closed out on 6 Mar 2025
