Service Contract No. NDO 04/2019 Environmental Team for Environmental Monitoring and Audit Works in Construction Phase for the First Phase Development of Kwu Tung North and Fanling North New Development Areas

Monthly Environmental Monitoring and Audit Report for June 2026

Monthly Environmental Monitoring and Audit Report No. 80 (June 2026)

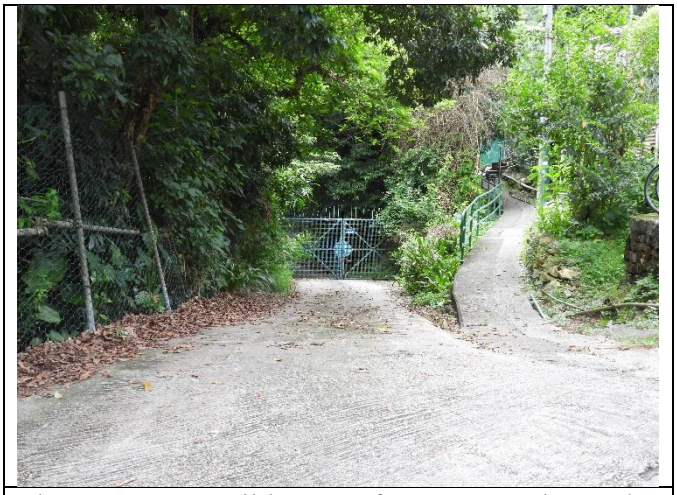
9.60 For the monitoring conducted on 10th June 2026 at Transect T5, a section of the transect route was found located within a private property and hence not accessible. The inaccessible part are shown in **Photo 1** below. The adjusted accessible transect route is shown in **Figure 11**.

Photo 1. Inaccessible part of transect T5 located within a private property.
