Civil Engineering and Development Department

Service Contract No. NDO 04/2019 Environmental Team for Environmental Monitoring and Audit Works in Construction Phase for the First Phase Development of Kwu Tung North and Fanling North New Development Areas

Monthly Environmental Monitoring and Audit Report for May 2021

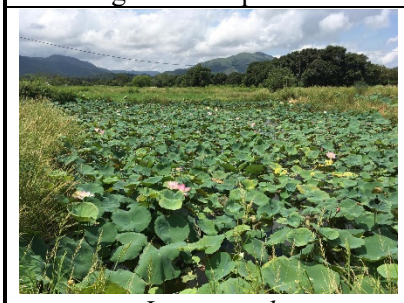
Table 10.5 Photographic Records of Site Activities in LVNP

Agricultural practice are continued in existing farmland to maintain habitats in Long Valley
