HONG KONG SECTION OF GUANGZHOU – SHENZHEN – HONG KONG EXPRESS RAIL LINK

Environmental Monitoring and Audit Report No.21

(November 2011)

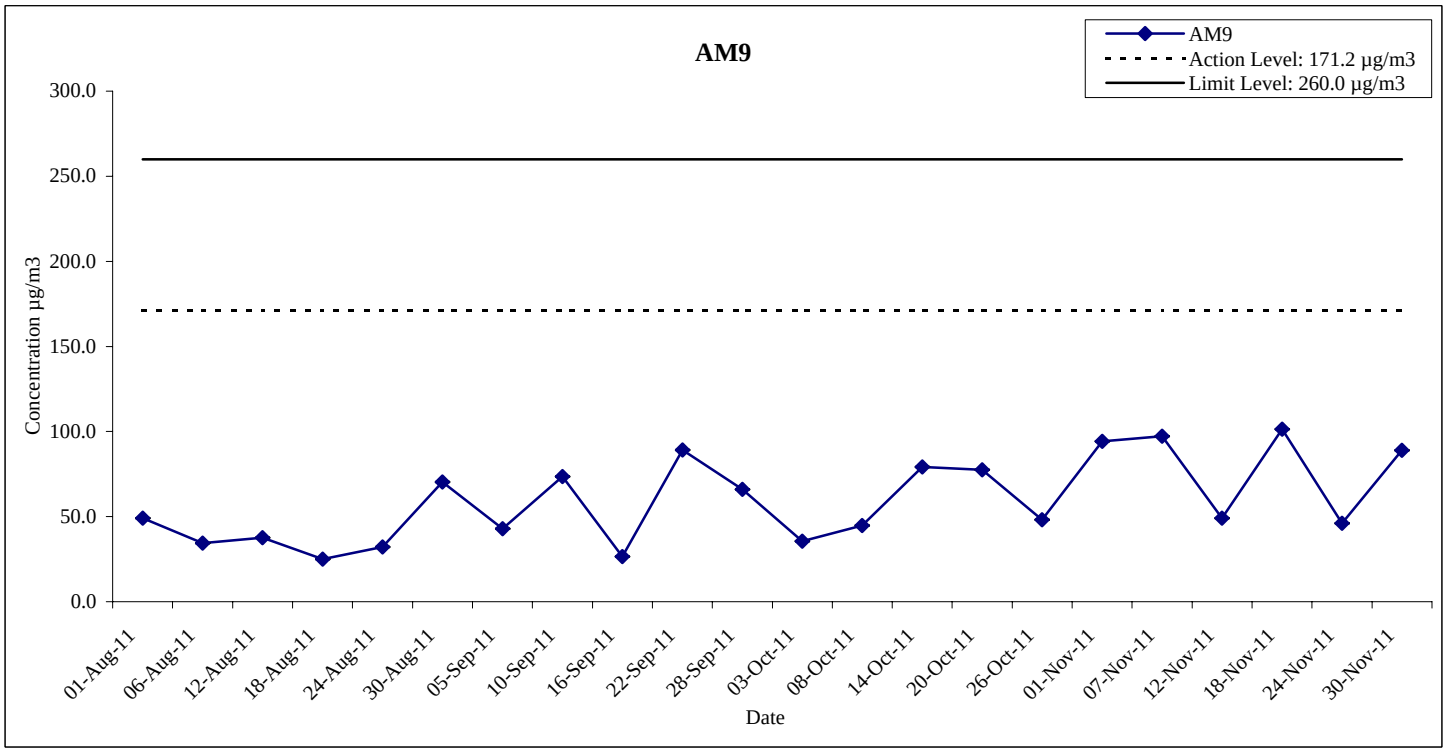
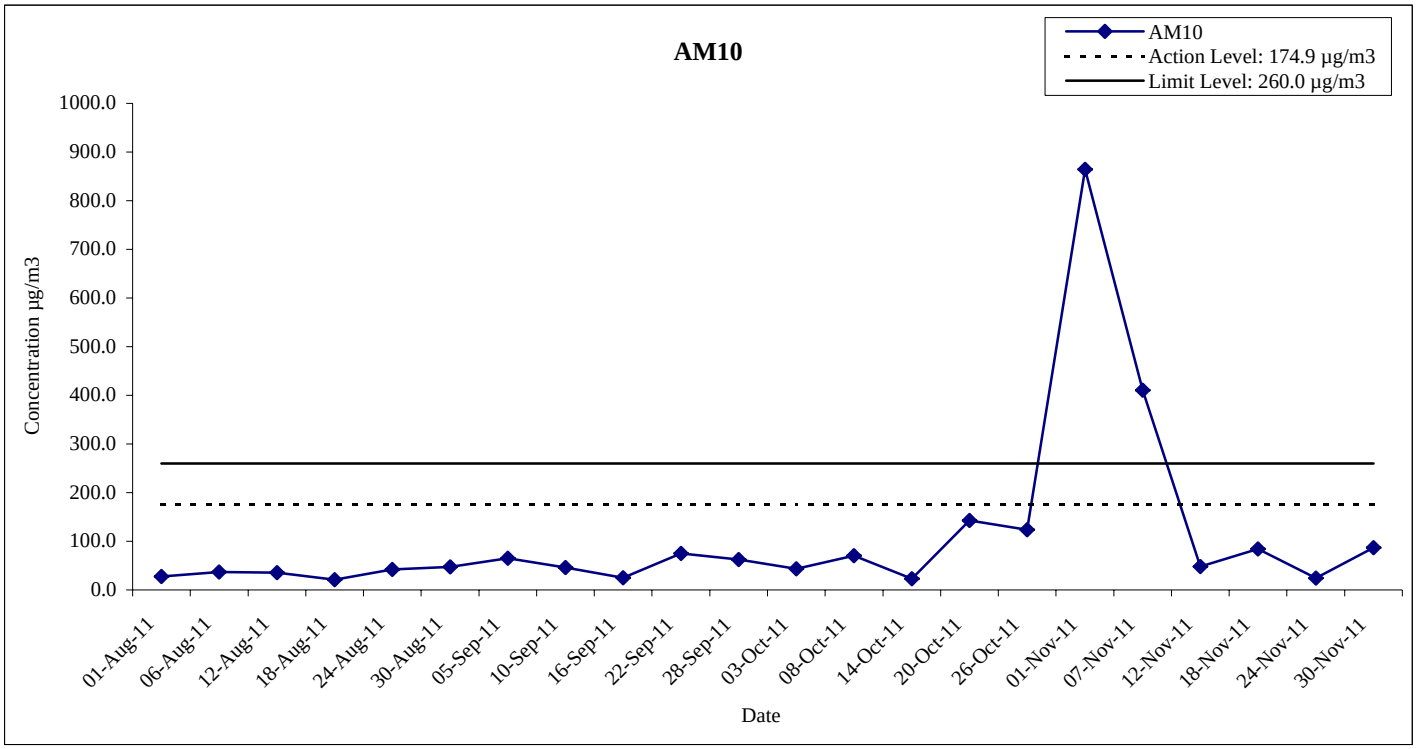
MTR	Hong Kong Section of Guangzhou-Shenzhen-Hong Kong Express Rail Link **Graphical Presentation of 24-hour TSP** **Monitoring Results for Location AM9 and AM10**	**Date**	**2011**
		APPENDIX	**F**

Two TSP Limit Level exceedances were recorded on AM10 on 1 and 7 November 2011 respectively. Actions stipulated under the Event and Action Plan (Table 9.4 of the EM&A Manual) were implemented. It was found that the exceedancse were likely caused by other project.

Remarks:
The reason causing the abnormal exceedance on 1 and 7 Nov 2011 is expected due to the excavation and pipe laying works by Towngas just next to AM10. It is not considered as XRL project related exceedance.

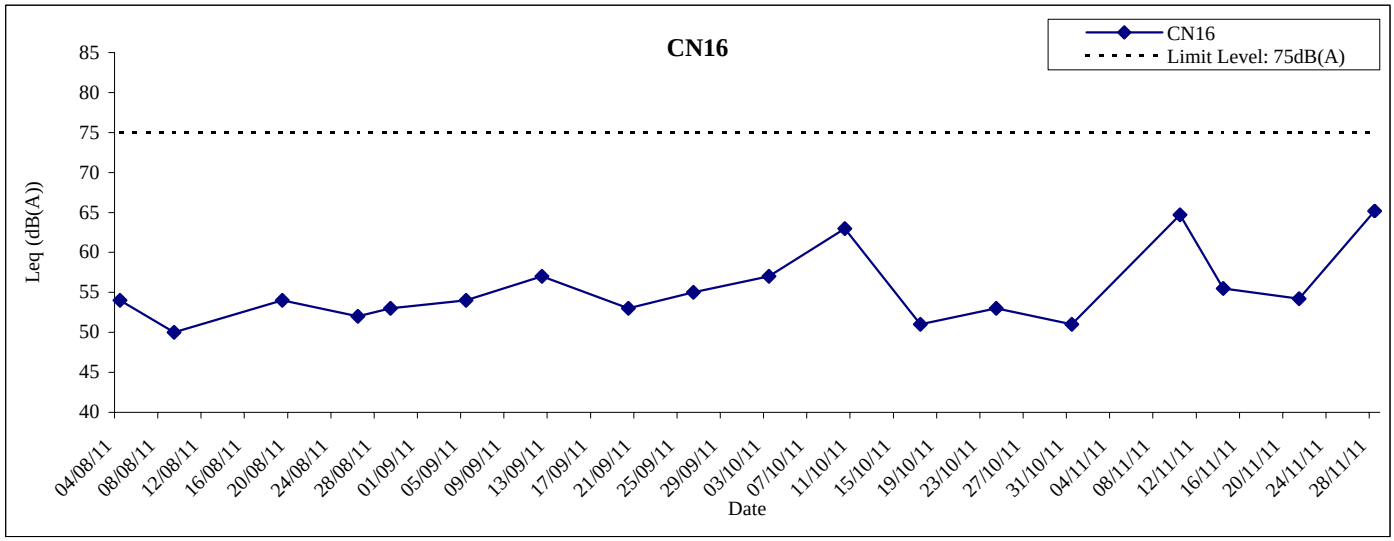
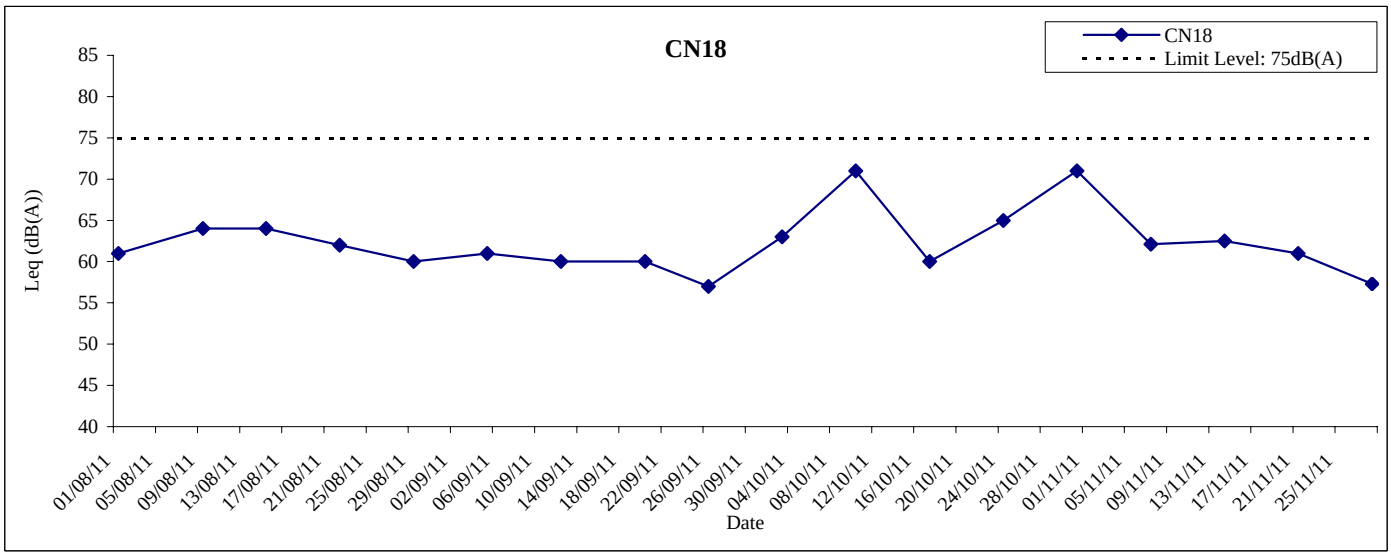
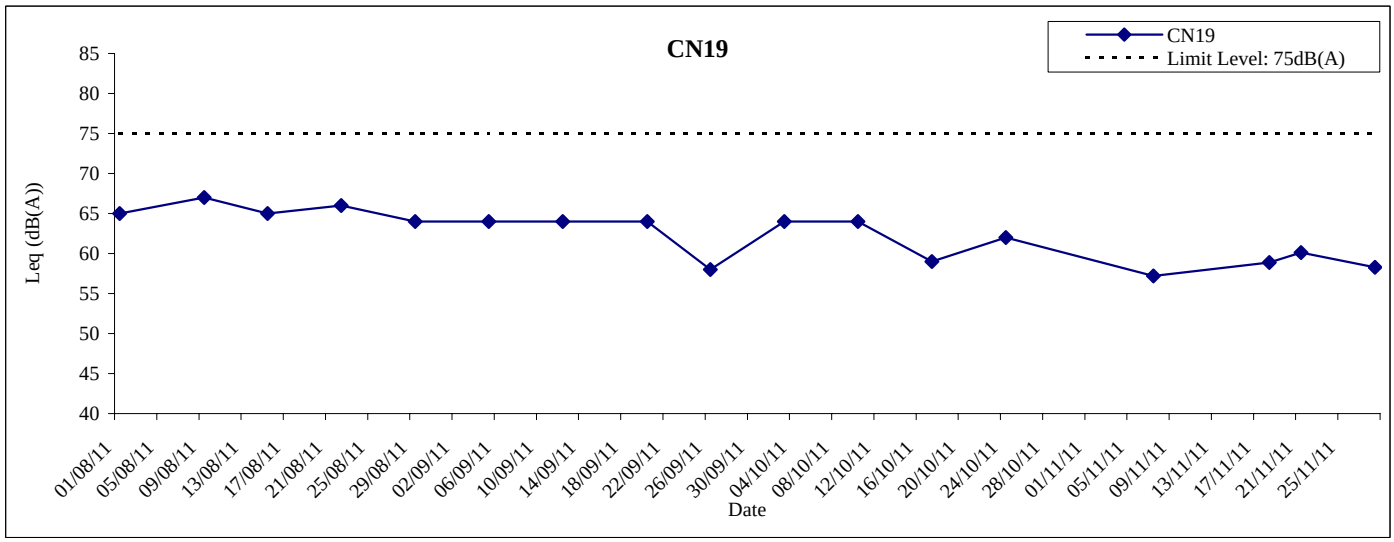
MTR	Hong Kong Section of Guangzhou-Shenzhen-Hong Kong Express Rail Link **Graphical Presentation of Noise** **Monitoring Results for Location CN16, CN18 and CN19**	**Date**	**2011**
		APPENDIX	**F**

A correction factor has been applied at CN19 to take into account the noise barrier effect. The correction factor was agreed with IEC according to Section 3.11 of the EM&A Manual.

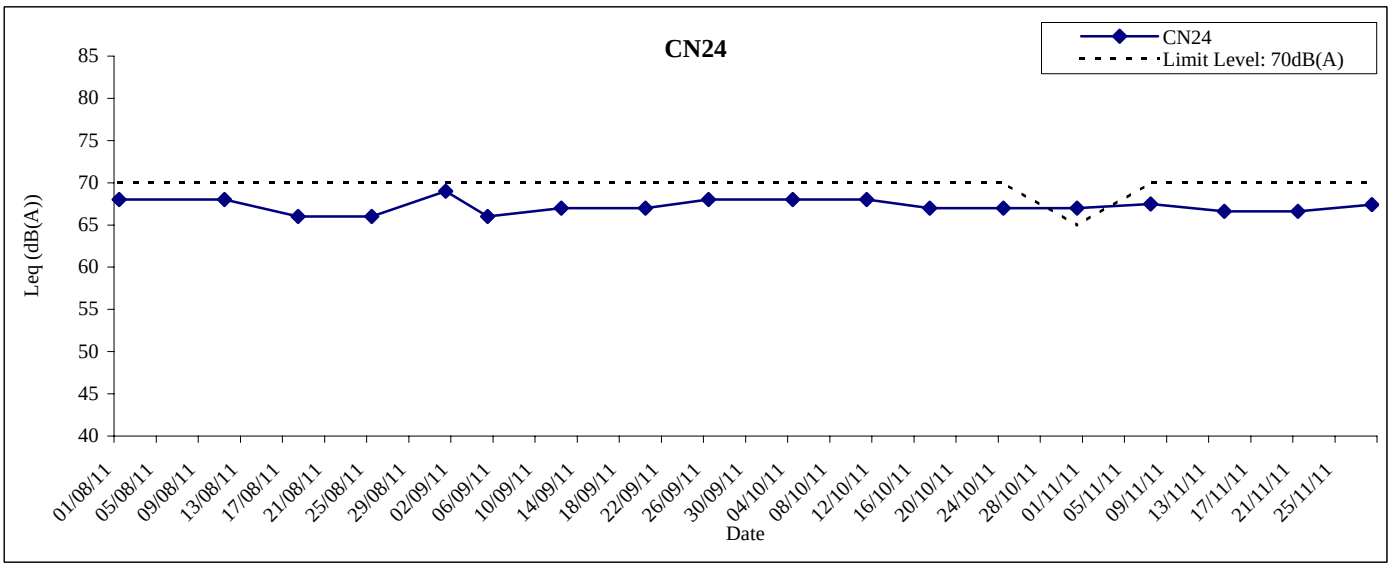
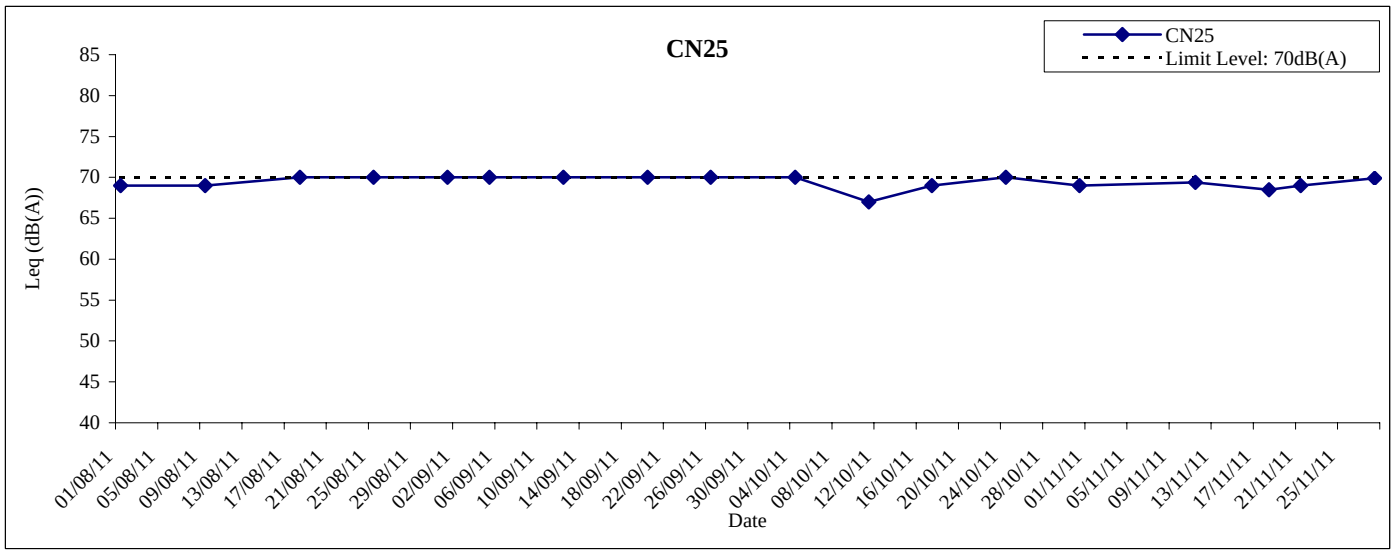
MTR	Hong Kong Section of Guangzhou-Shenzhen-Hong Kong Express Rail Link **Graphical Presentation of Noise** **Monitoring Results for Location CN23, CN24 and CN25**	**Date**	**2011**
		APPENDIX	**F**

- For CN 23, the monitoring dates on 3, 11, 17, 24 & 31 August 2011 were school holiday. Noise level measured was for reference only.
- For CN 24, as the monitoring results on 31 Oct 11 is equal or lower than the background noise level of 67dB(A), it is not classified as noise exceedance..
