MTR Corporation Limited

HONG KONG SECTION OF GUANGZHOU – SHENZHEN – HONG KONG EXPRESS RAIL LINK

Environmental Monitoring and Audit Report No. 24 (February 2012)

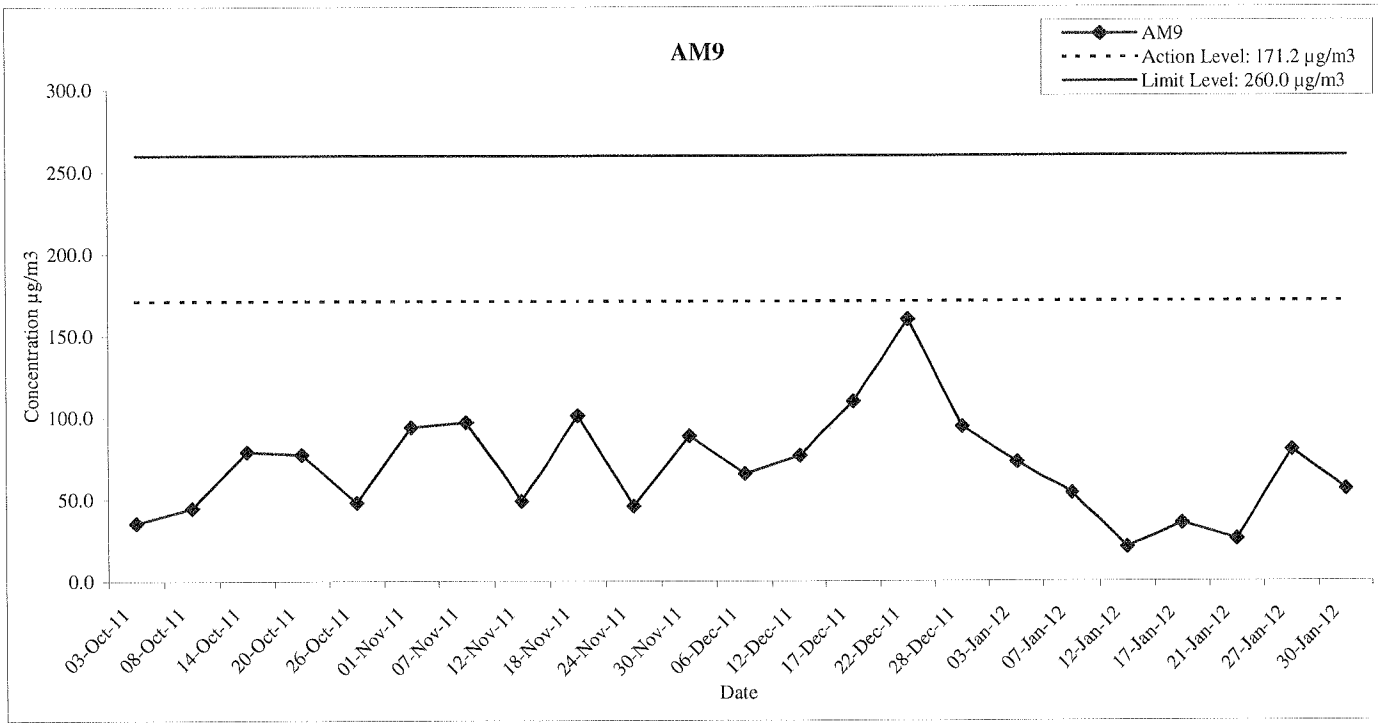
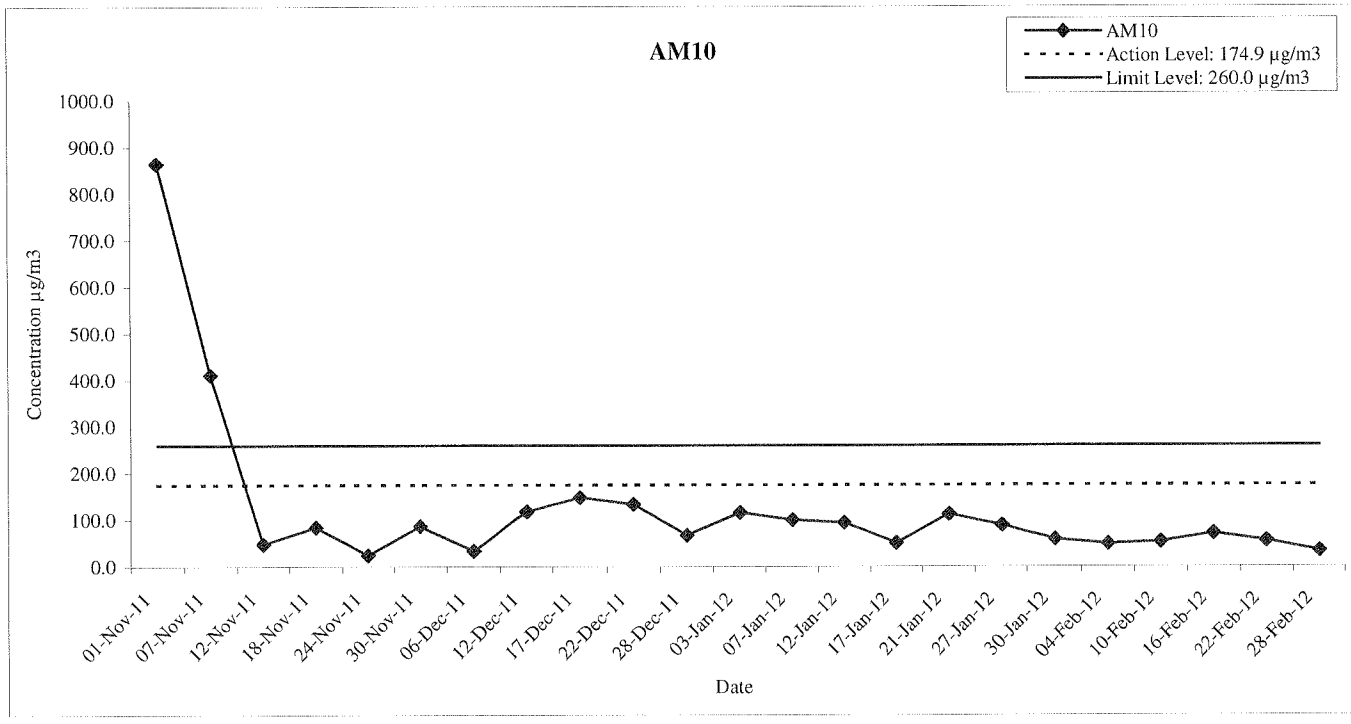
MTR	Hong Kong Section of Guangzhou-Shenzhen-Hong Kong Express Rail Link **Graphical Presentation of 24-hour TSP Monitoring Results for Location AM9 and AM10**	**Date**	**2012**
		APPENDIX	**F**

Remarks:
The reason causing the abnormal exceedance on 1 and 7 Nov 2011 is expected due to the excavation and pipe laying works by Towngas just next to AM10. It is not considered as XRL project related exceedance.

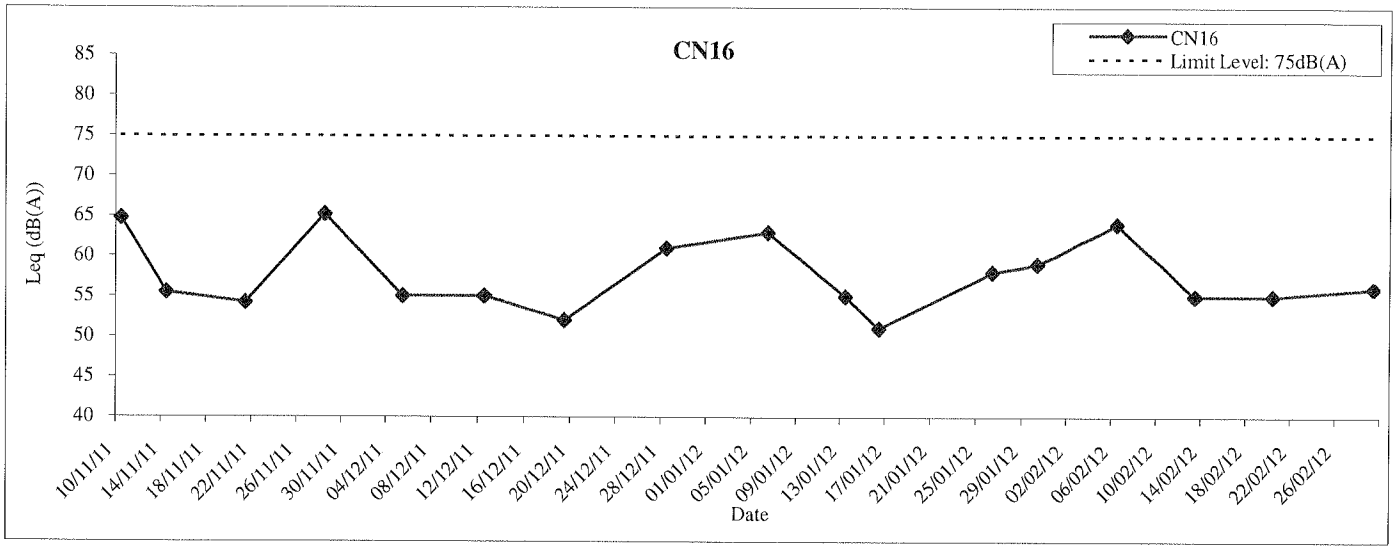
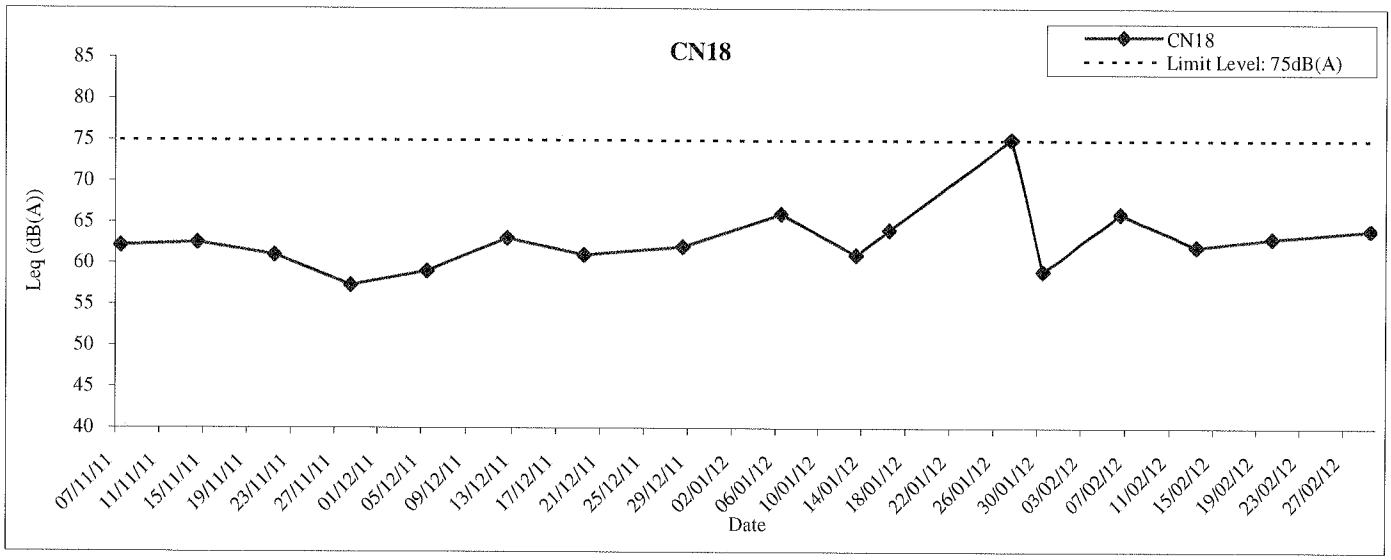
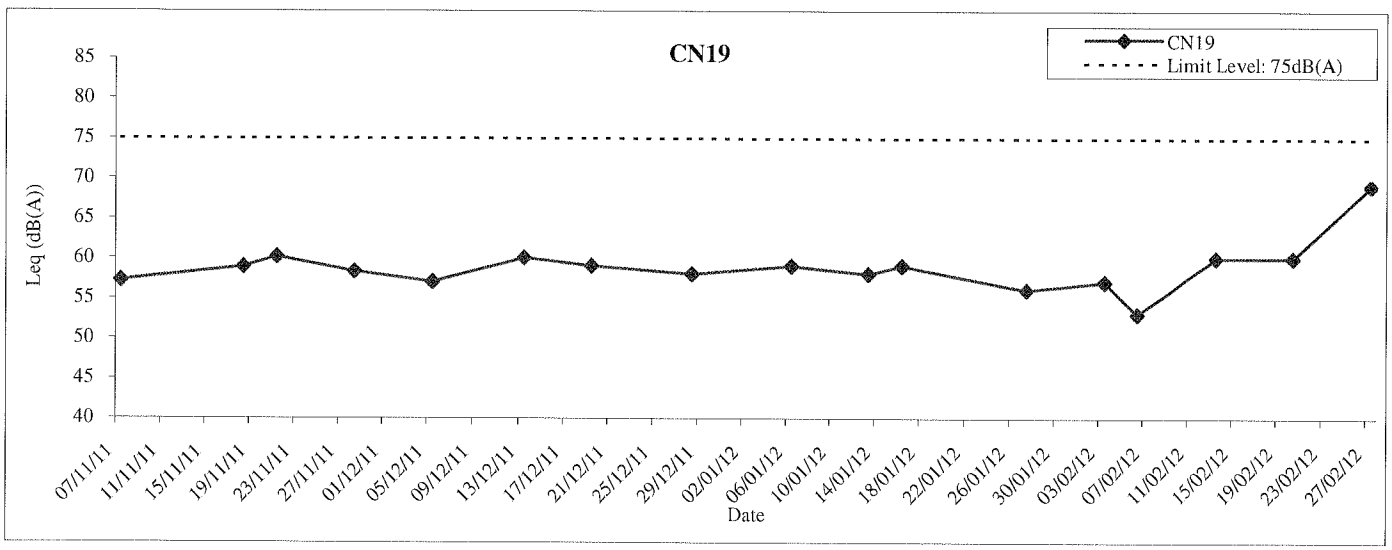
MTR	Hong Kong Section of Guangzhou-Shenzhen-Hong Kong Express Rail Link **Graphical Presentation of Noise** **Monitoring Results for Location CN16, CN18 and CN19**	**Date**	**2011**
		APPENDIX	**F**

A correction factor has been applied at CN19 to take into account the noise barrier effect. The correction factor was agreed with IEC according to Section 3.11 of the EM&A Manual.

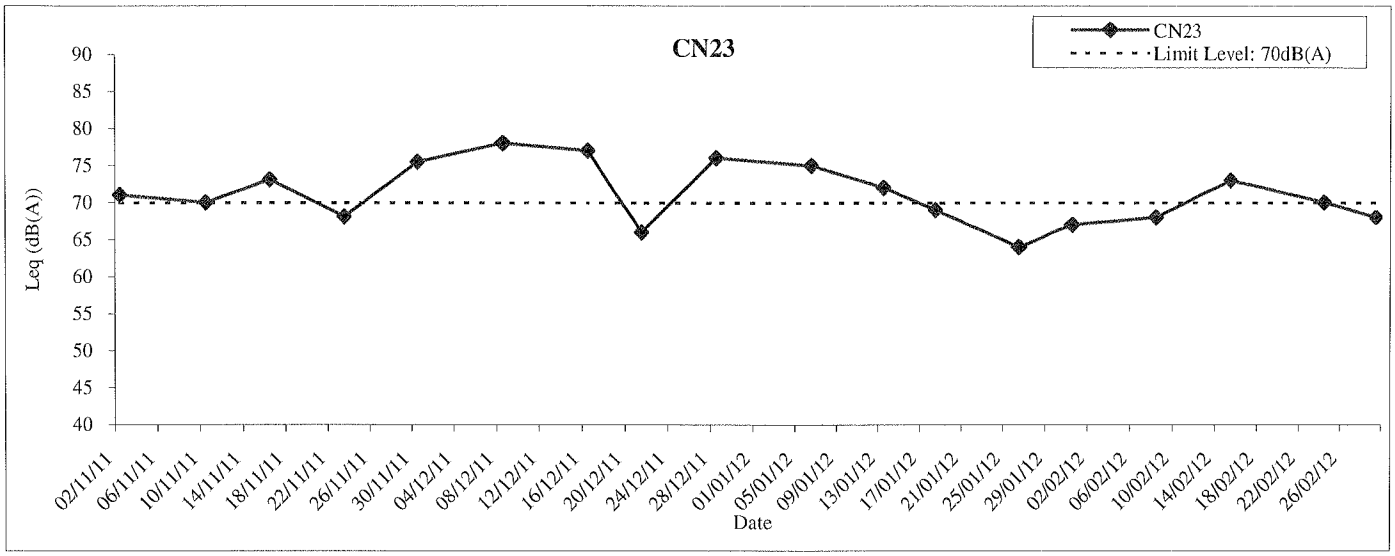
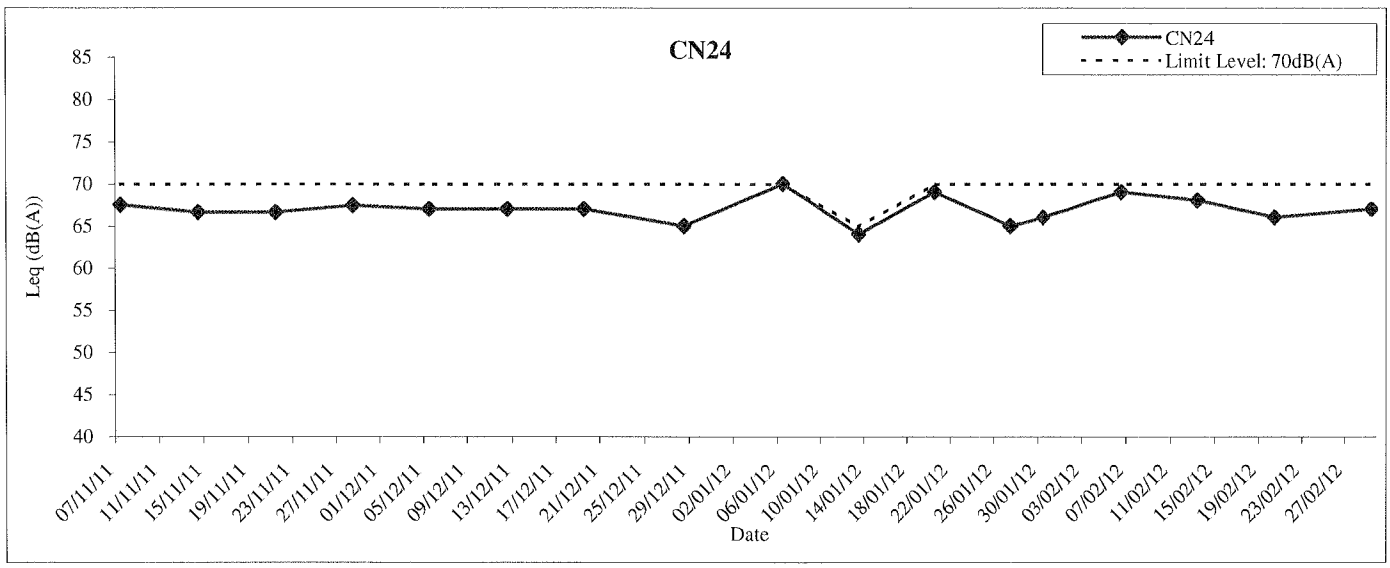
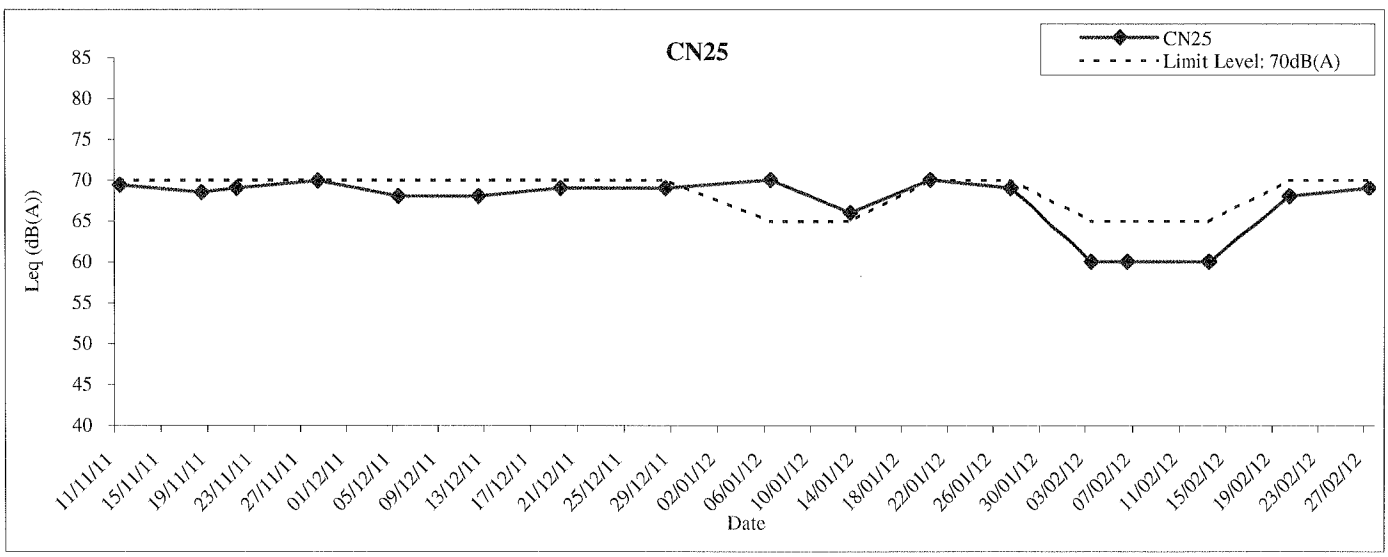
MTR	Hong Kong Section of Guangzhou-Shenzhen-Hong Kong Express Rail Link **Graphical Presentation of Noise** **Monitoring Results for Location CN23, CN24 and CN25**	**Date**	**2011**
		APPENDIX	**F**

-Noise limit level of CN23, CN24 & CN25, which are school, is 70dB(A) on normal weekdays and 65dB(A) during examination period.

- For CN 24, as the monitoring results on 31 Oct 11 is equal or lower than the background noise level of 67dB(A), it is not classified as noise exceedance..
