Hong Kong Section of Guangzhou-Shenzhen-Hong Kong Express Rail Link

Environmental Monitoring and Audit Report

(Environmental Permit No. EP-349/2009/F)

Environmental Monitoring and Audit Report No. 26 (April 2012)

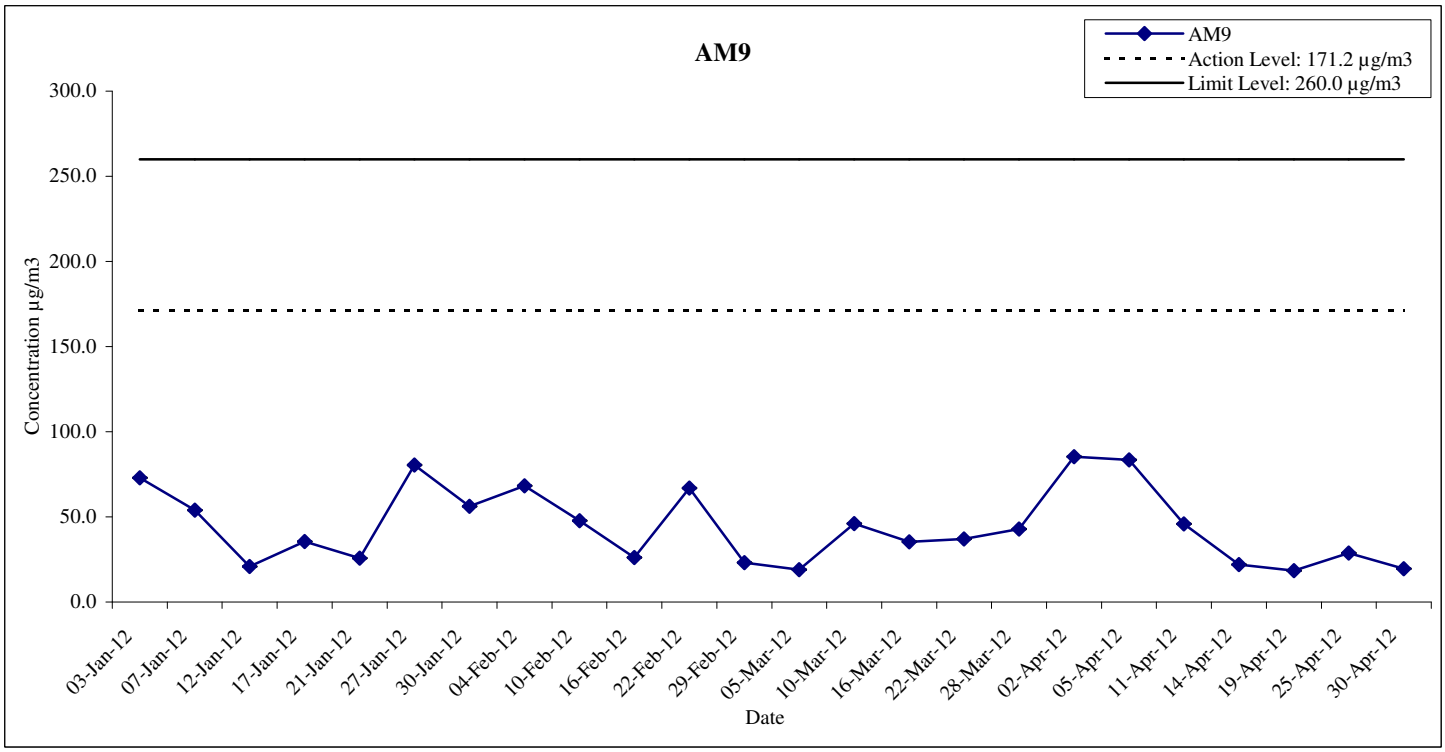
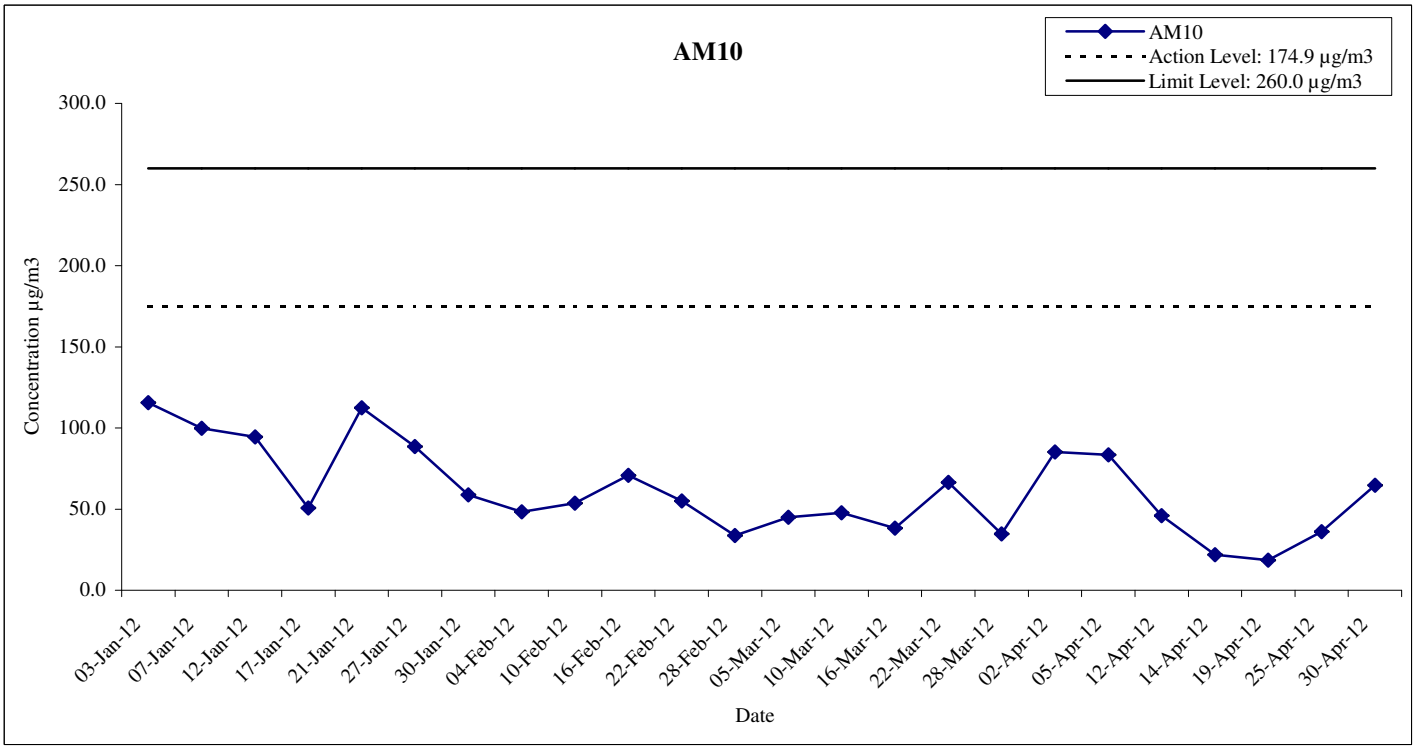
MTR	Hong Kong Section of Guangzhou-Shenzhen-Hong Kong Express Rail Link **Graphical Presentation of 24-hour TSP** **Monitoring Results for Location AM9 and AM10**	**Date**	**2012**
		APPENDIX	**F**

Remarks:
The reason causing the abnormal exceedance on 1 and 7 Nov 2011 is expected due to the excavation and pipe laying works by Towngas just next to AM10. It is not considered as XRL project related exceedance.

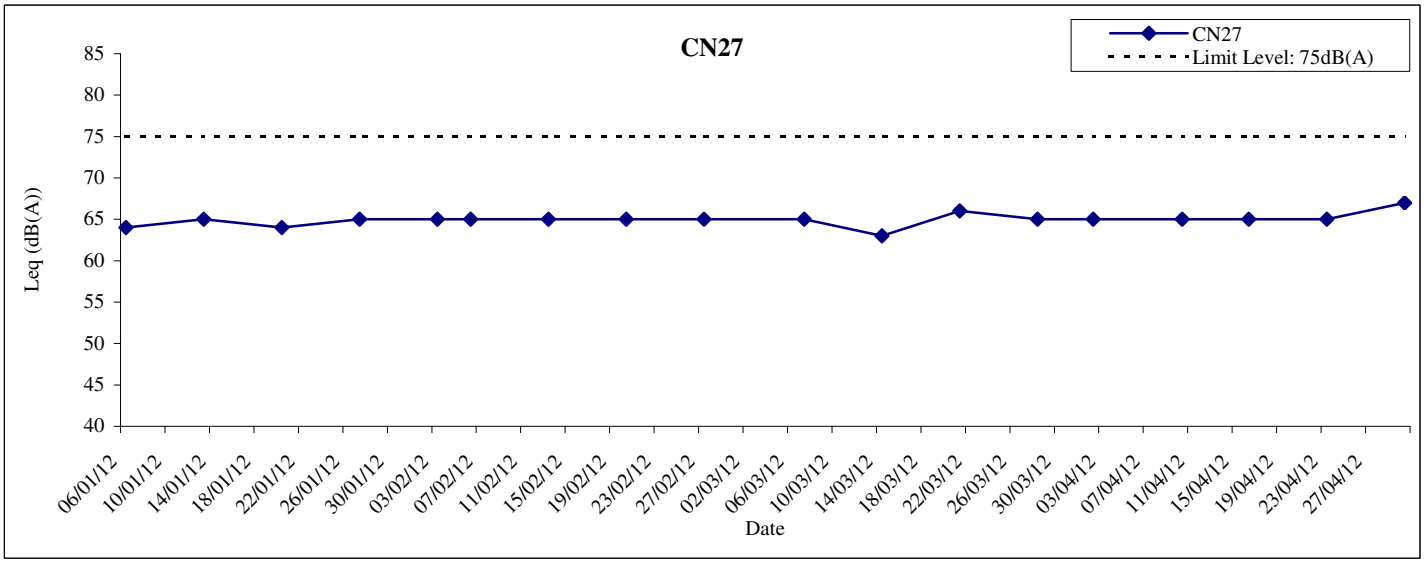
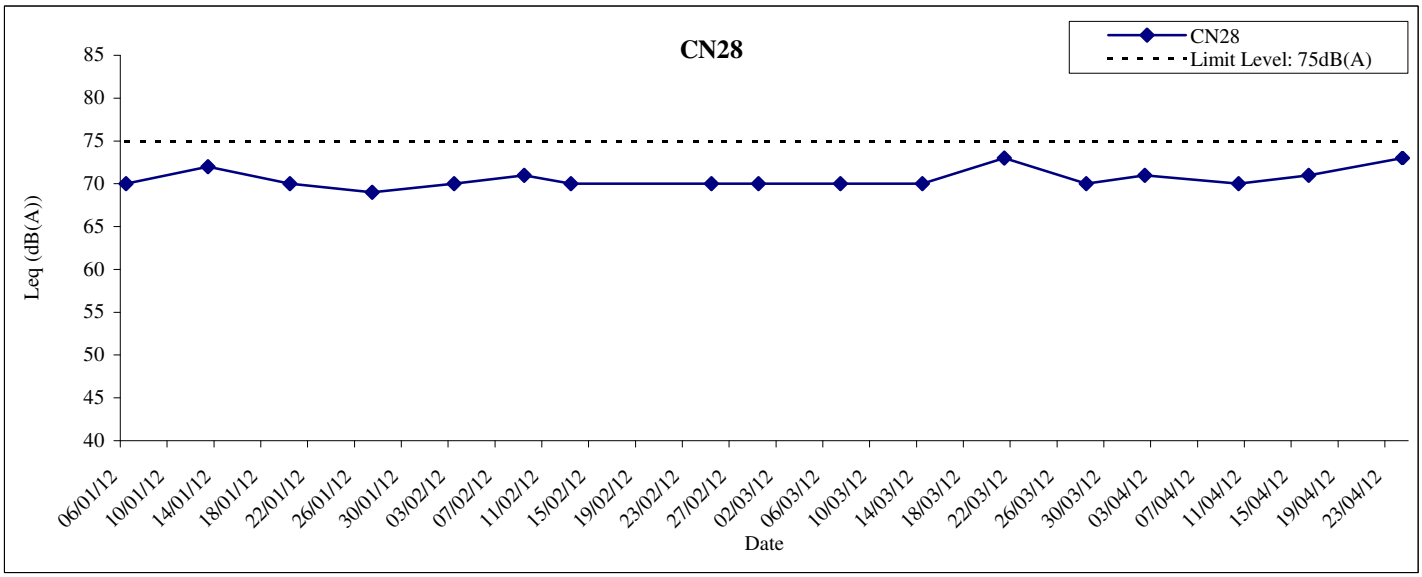
MTR	Hong Kong Section of Guangzhou-Shenzhen-Hong Kong Express Rail Link **Graphical Presentation of Noise** **Monitoring Results for Location CN26, CN27 and CN28**	**Date**	**2012**
		APPENDIX	**F**

Noise limit level of CN26, which is school, is 70dB(A) on normal weekdays and 65dB(A) during examination period.

For CN 26, the monitoring dates on 5, 11, 17, 25 & 31 August 2011 were school holiday. Noise level measured was for reference only.

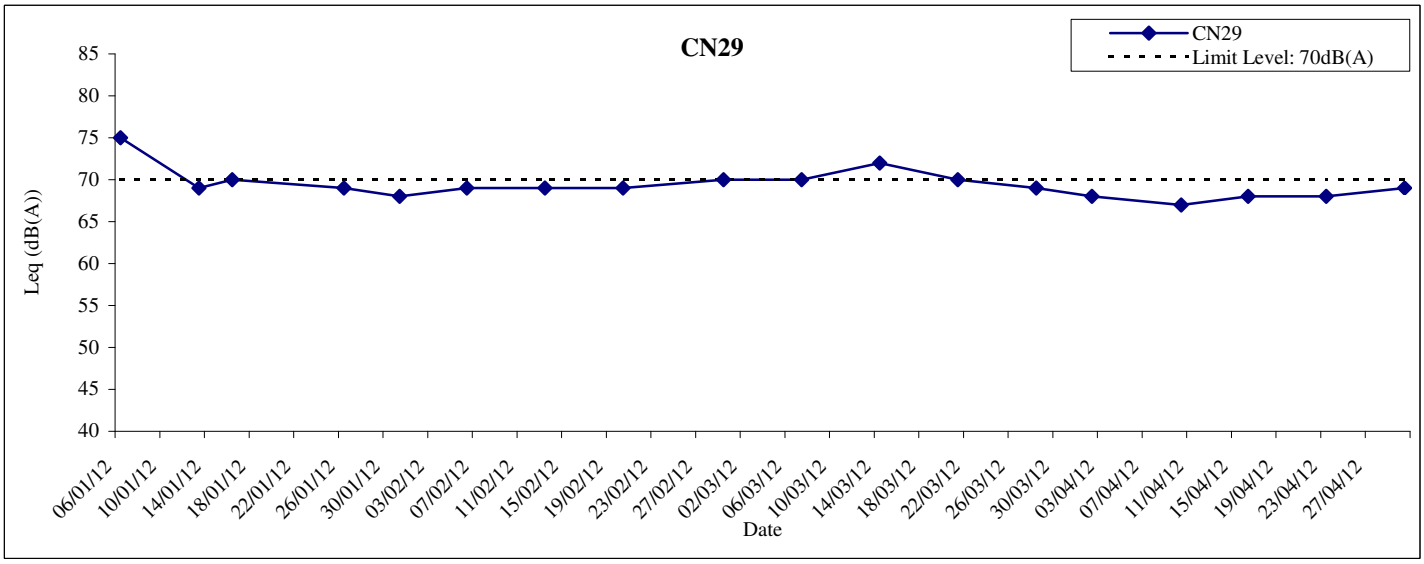
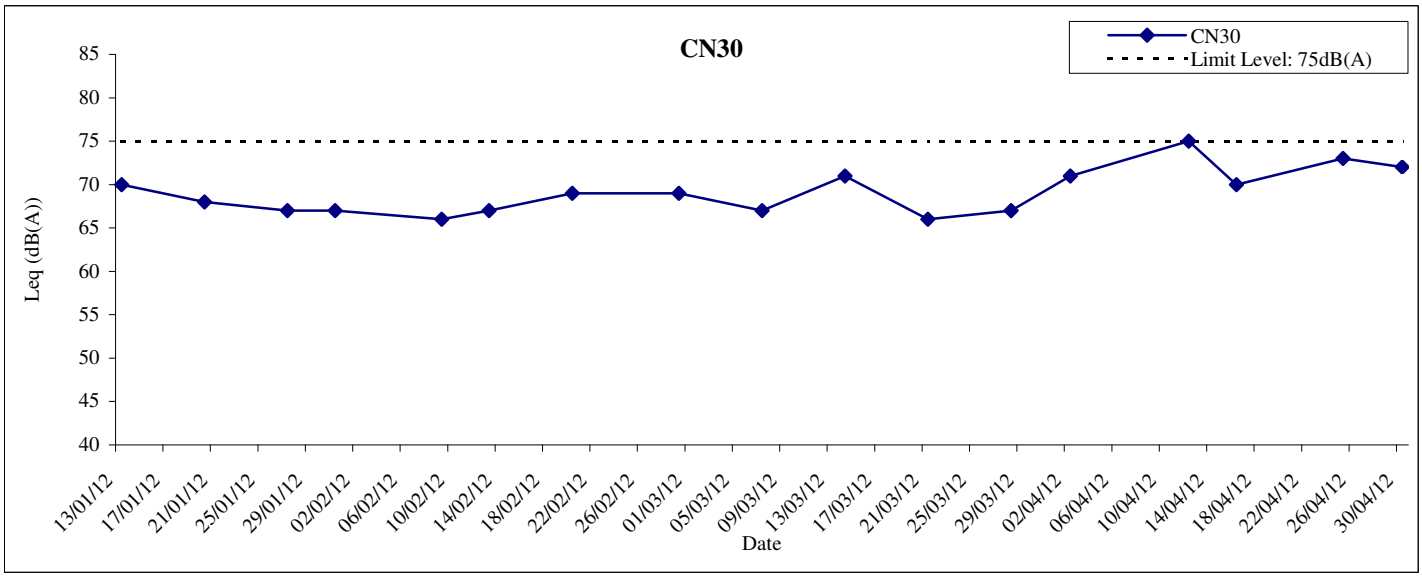
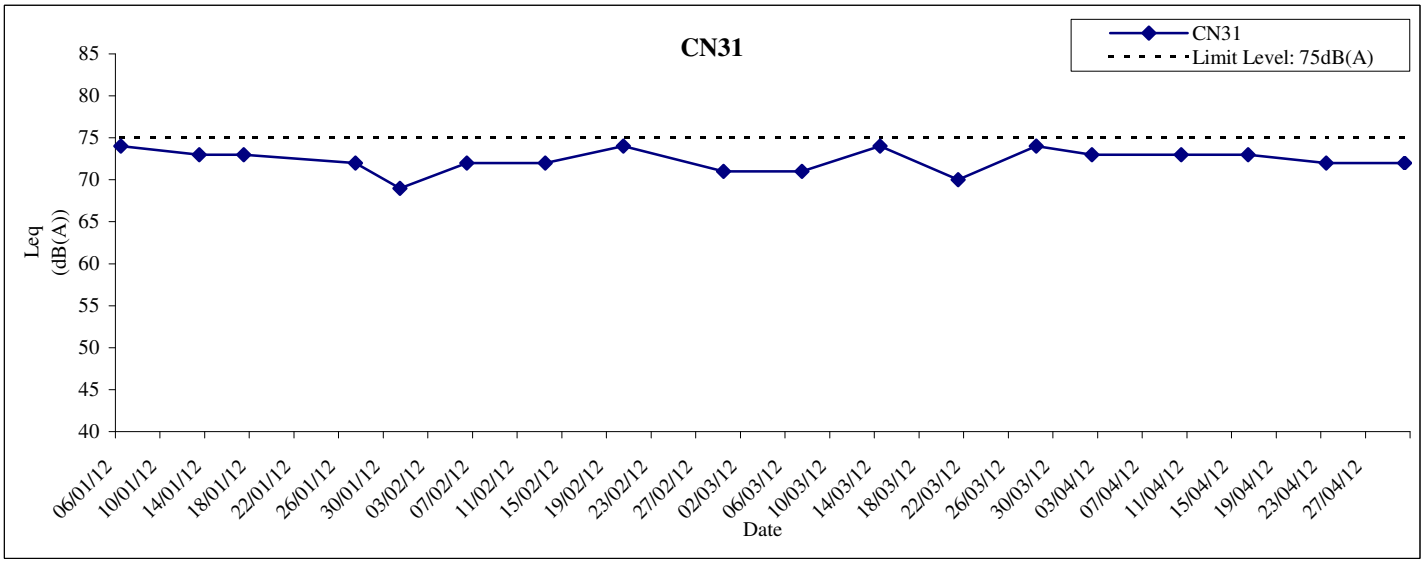
MTR	Hong Kong Section of Guangzhou-Shenzhen-Hong Kong Express Rail Link **Graphical Presentation of Noise** **Monitoring Results for Location CN29, CN30 and CN31**	**Date**	**2012**
		APPENDIX	**F**

Noise limit level of CN29, which is school, is 70dB(A) on normal weekdays and 65dB(A) during examination period.

- For CN 29, as the monitoring results on 15 Nov 11 is equal or lower than the background noise level of 68dB(A), it is not classified as noise exceedance..
