MTR Corporation Limited

HONG KONG SECTION OF GUANGZHOU – SHENZHEN – HONG KONG EXPRESS RAIL LINK

Environmental Monitoring and Audit Report No. 27 (May 2012)

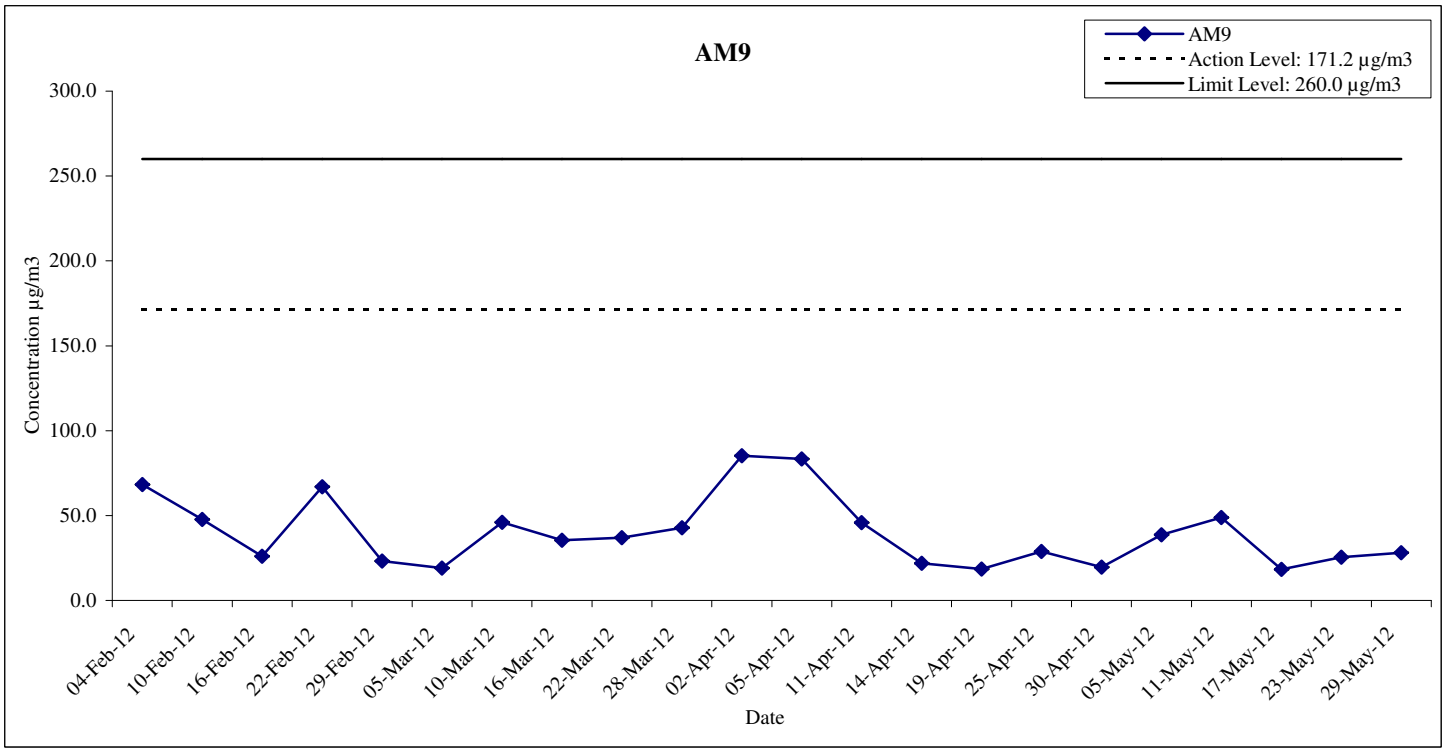
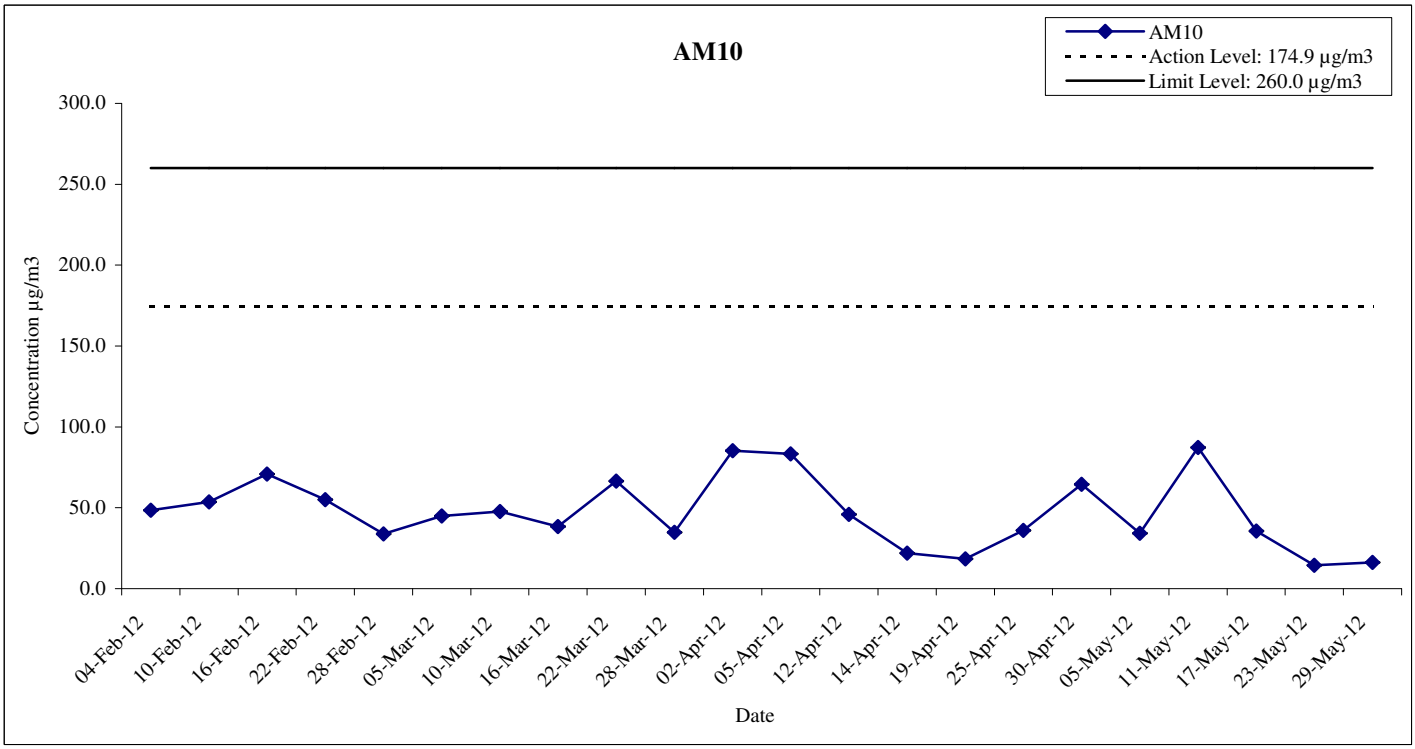
MTR	Hong Kong Section of Guangzhou-Shenzhen-Hong Kong Express Rail Link **Graphical Presentation of 24-hour TSP** **Monitoring Results for Location AM9 and AM10**	**Date**	**2012**
		APPENDIX	**F**

Remarks:
The reason causing the abnormal exceedance on 1 and 7 Nov 2011 is expected due to the excavation and pipe laying works by Towngas just next to AM10. It is not considered as XRL project related exceedance.
