Hong Kong Section of Guangzhou-Shenzhen-Hong Kong Express Rail Link

Environmental Monitoring and Audit Report

June 2015

Environmental Monitoring and Audit Report No. 64
(June 2015)

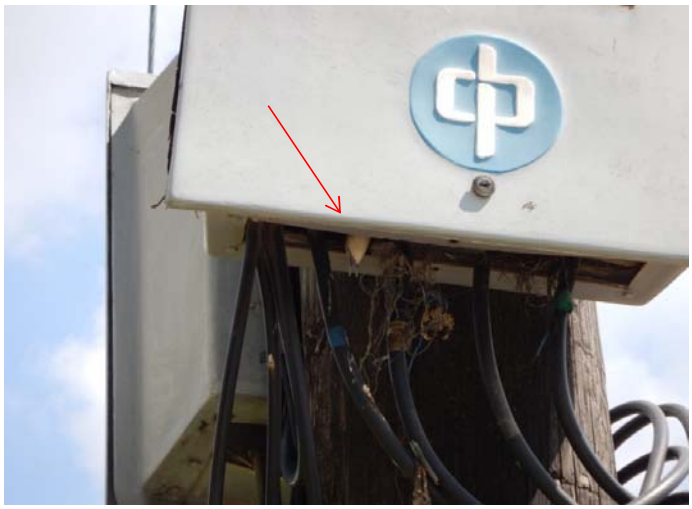
Plate 7 A nest of White-shouldered Starling observed near Point Count Location SSS-1/P1
