Hong Kong Section of Guangzhou-Shenzhen-Hong Kong Express Rail Link

Environmental Monitoring and Audit Report

August 2015

Environmental Monitoring and Audit Report No. 66 (August 2015)

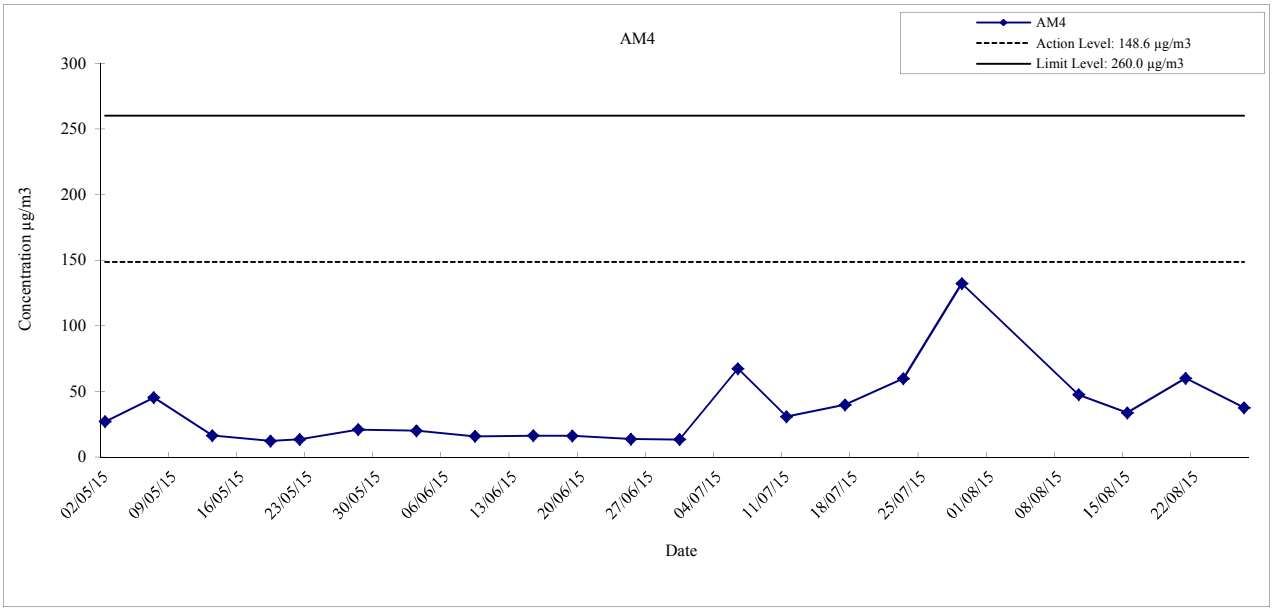
MTR	Hong Kong Section of Guangzhou-Shenzhen-Hong Kong Express Rail Link **Graphical Presentation of 24-hour TSP** **Monitoring Result for Location AM3 and AM4**	**Date**	**2015**
		APPENDIX	**F**

* Due to power supply problem at AM4 (the house was under renovation), monitoring on 4 August was suspended. Monitoring was resumed on 10 August as the electiricty supply was fixed.
