Hong Kong Section of Guangzhou-Shenzhen-Hong Kong Express Rail Link

Environmental Monitoring and Audit Report

October 2015

Environmental Monitoring and Audit Report No. 68 (October 2015)

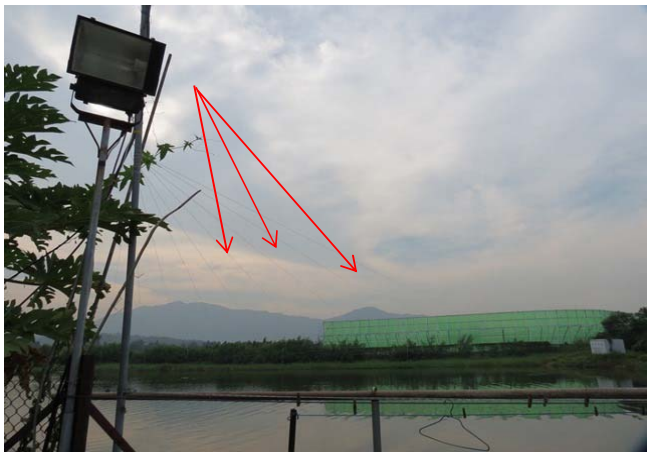
Plate 2 Overhead wire at Point Count Location MPV-1/P8
