Proposed Golf Course Development at Tai Po Lot No. 246 Shuen Wan

Tai Po Golf Club Limited

Monthly Environmental Monitoring and Audit (EM&A) Report No. 25

(for October 2026)

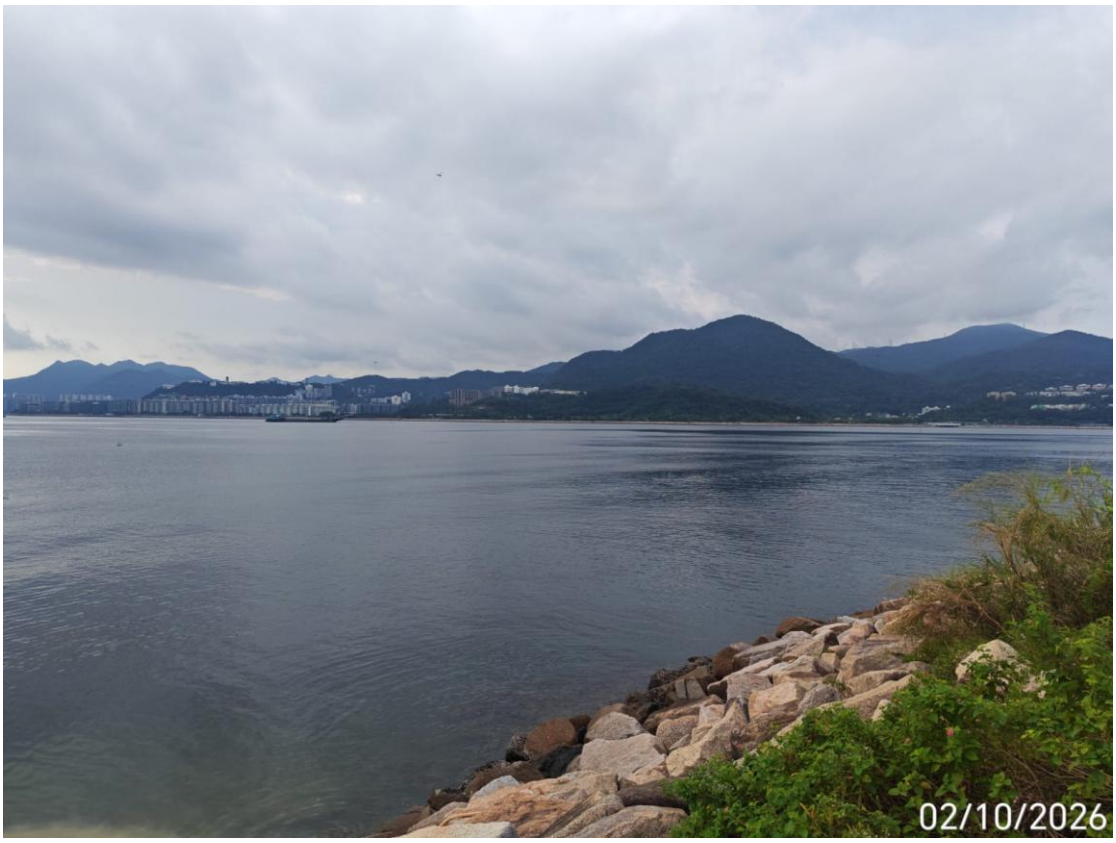
Photos taken by the Contractor on 02/10/2026

Photos taken by the Environmental Team on 02/10/2026

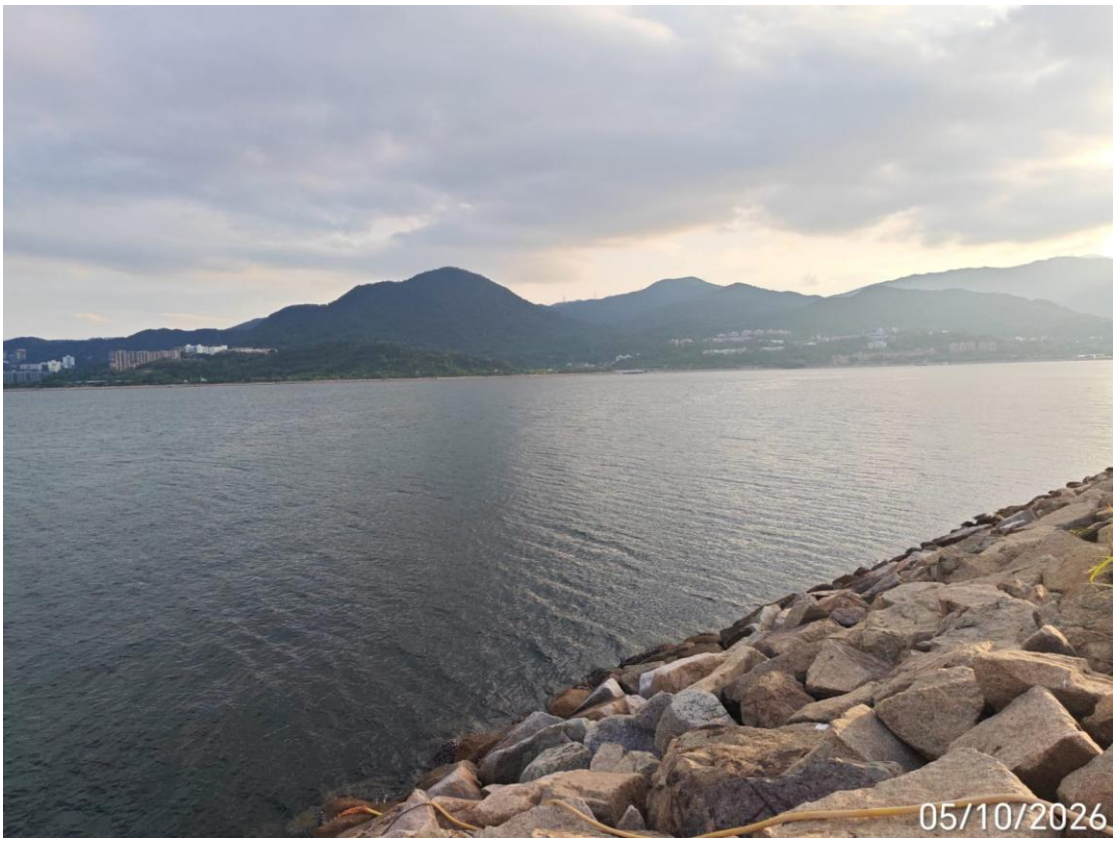
Photos taken by the Contractor on 05/10/2026

Photos taken by the Environmental Team on 05/10/2026

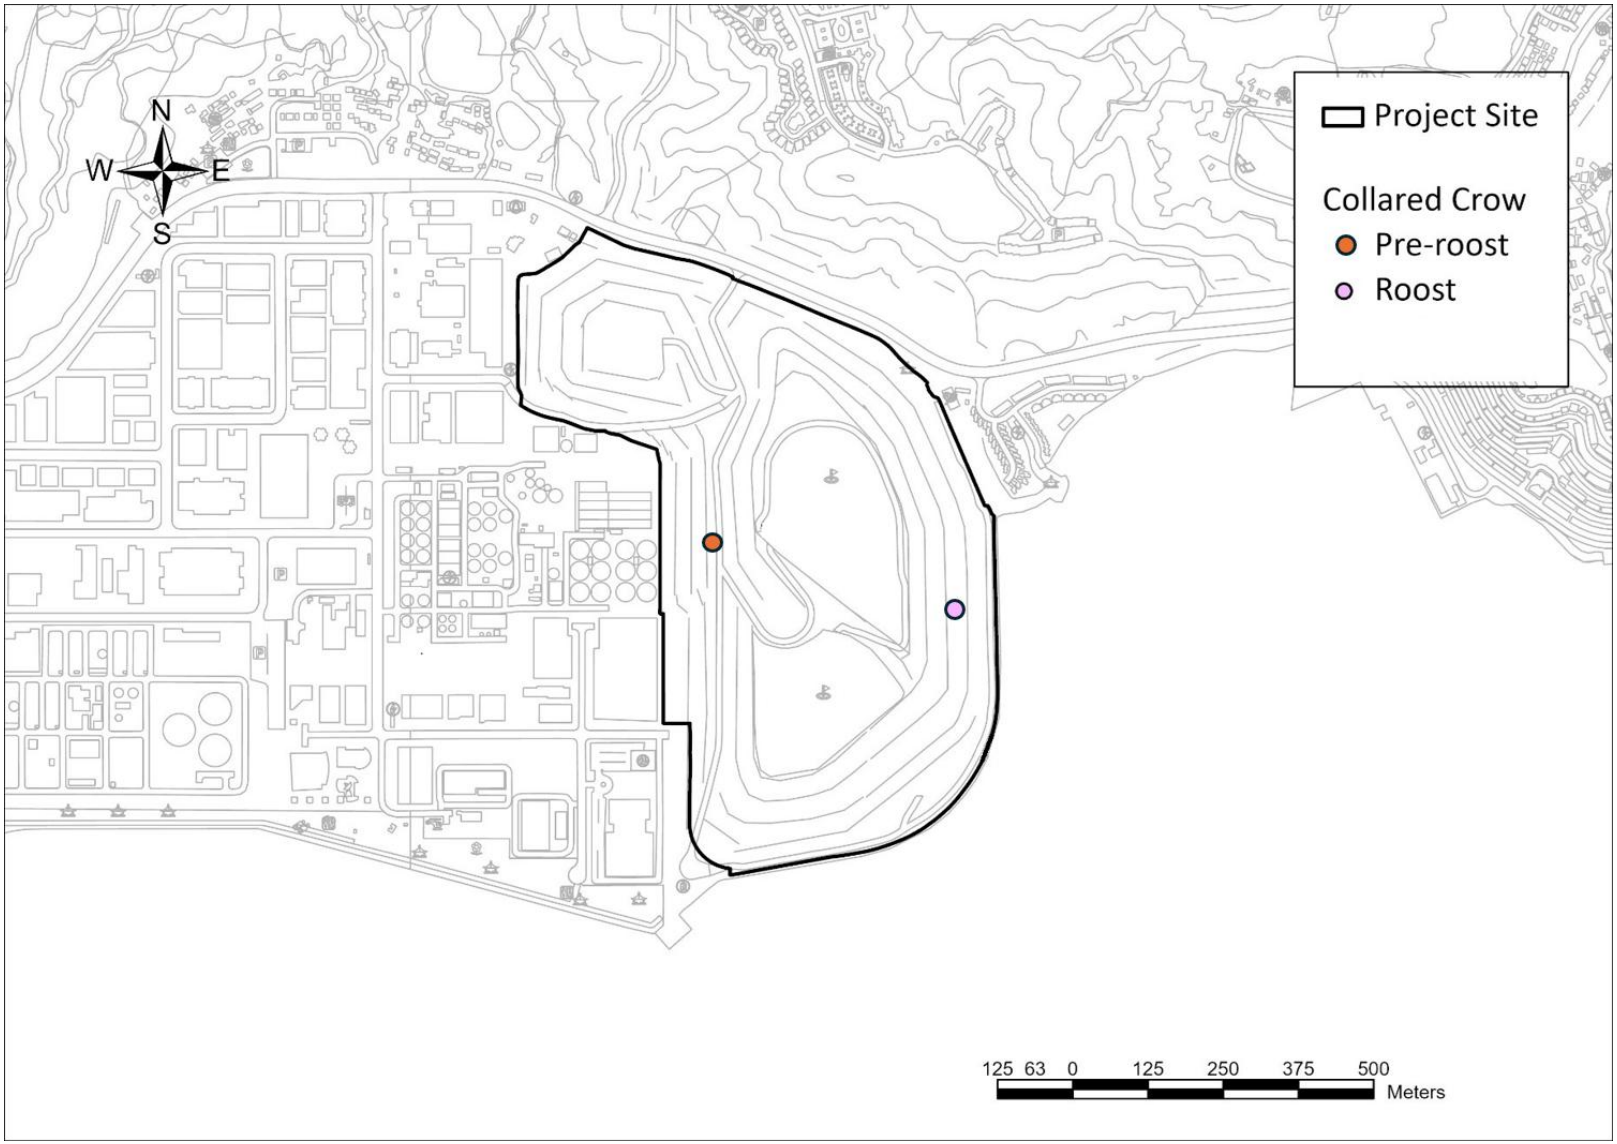
Figure 2 Locations of Collared Crow Recorded During the Monitoring

5.6.1.1 Survey of utilization of the preserved tree groups by Collared Crow and Black Kite was conducted on 21st October 2026. Pre-roost and roosting activity of Collared Crow were found within the Project Site. Collared Crows were found gathering at the southeast part of the Project Site for pre-roosting activity, with a maximum number of 60 individuals recorded at 18:07. The Collared Crow then migrated to the eastern part of the Project Site as final roosting location, with a total number of 60 individuals recorded at 18:15. Information of the roosting location of Collared Crow is summarized in **Table 5.8** while the vantage points for Collared Crow and Black Kite Monitoring and locations of pre-roost and roost of Collared Crow shown in **Appendix 5.5**.
