ATAL-DEGREMONT-CHINA HARBOUR JOINT VENTURE

CONTRACT NO. DC/2013/10 - DESIGN, BUILD AND OPERATE SAN WAI SEWAGE TREATMENT WORKS – PHASE 1

MONTHLY EM&A REPORT NO. 21

(01 JANUARY – 31 JANUARY 2019)

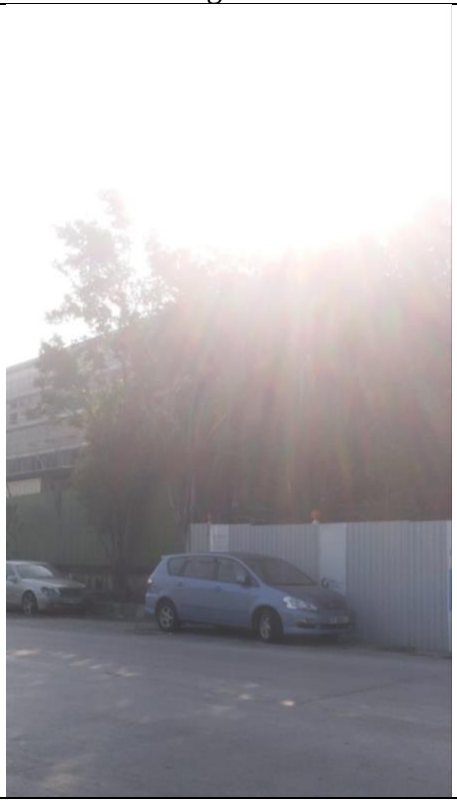
Figure 3	Figure 4

General condition of the existing trees at eastern boundary	General condition of the existing trees at eastern boundary
Figure 5	Figure 6
