CONTRACT NO. DC/2013/10 - DESIGN, BUILD AND OPERATE SAN WAI SEWAGE TREATMENT WORKS – PHASE 1

MONTHLY EM&A REPORT NO. 22

(01 FEBRUARY – 28 FEBRUARY 2019)

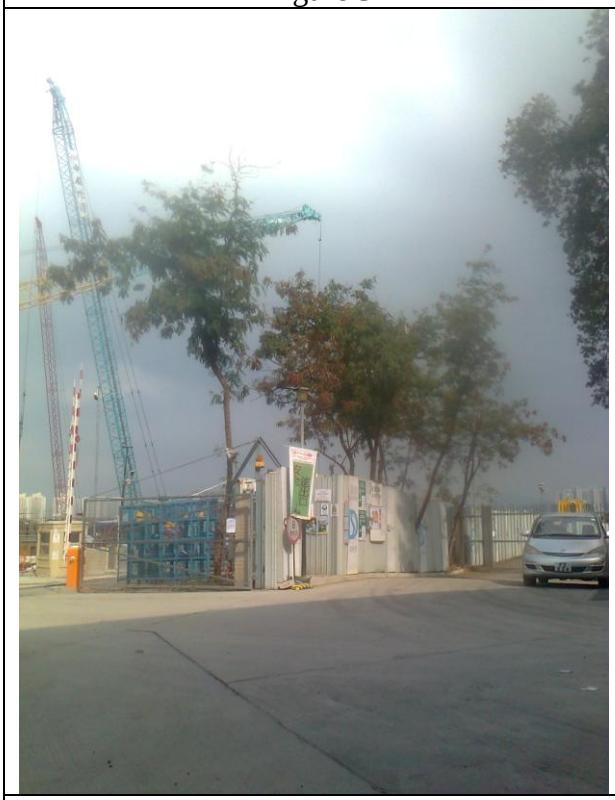
Figure 5	Figure 6

Existing trees at the site entrance protected by the fence wall
