CONTRACT NO. DC/2013/10 - DESIGN, BUILD AND OPERATE SAN WAI SEWAGE TREATMENT WORKS – PHASE 1

MONTHLY EM&A REPORT NO. 24

(01 APRIL – 30 APRIL 2019)

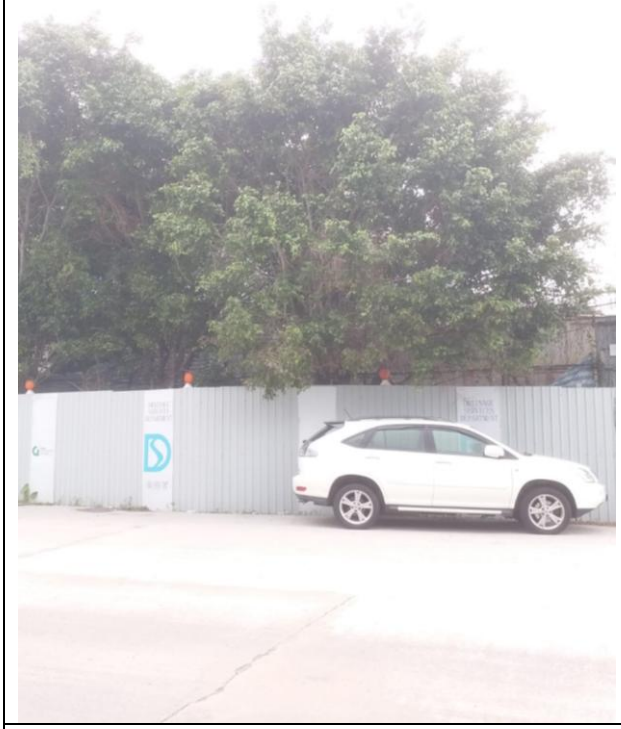
Figure 1	Figure 2

General condition of the existing trees at eastern boundary	General condition of the south-west corner of the site. Former trees are removed.
