ATAL-DEGREMONT-CHINA HARBOUR JOINT VENTURE

CONTRACT NO. DC/2013/10 - DESIGN, BUILD AND OPERATE SAN WAI SEWAGE TREATMENT WORKS – PHASE 1

MONTHLY EM&A REPORT NO. 37

(01 MAY – 31 MAY 2020)

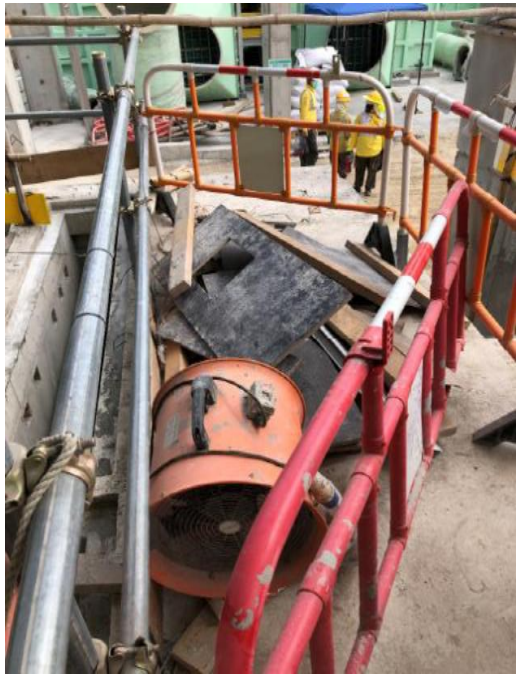
Unused C&D material and wastes were observed near UV.	To collect the C&D material and wastes properly	200508_001	Yes	08/05/2020

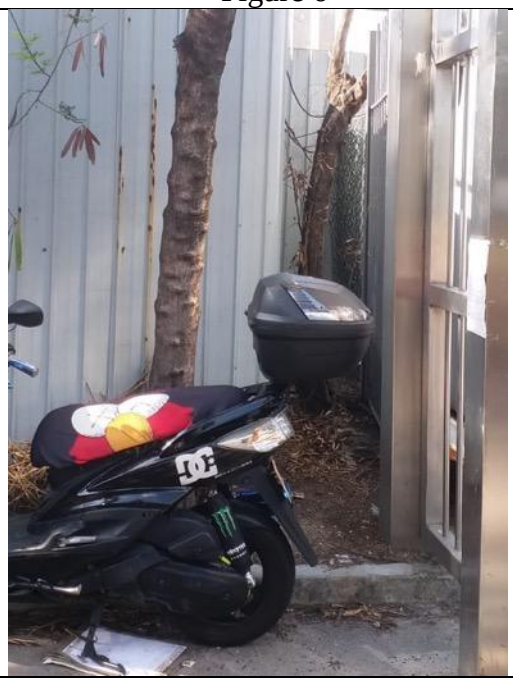
Existing trees at the site entrance near the hoarding fence	The tree in the tree protection area is drying and has peeling bark. It is in poor health condition. There is high risk of tree felling.
