ATAL-DEGREMONT-CHINA HARBOUR JOINT VENTURE

CONTRACT NO. DC/2013/10 - DESIGN, BUILD AND OPERATE SAN WAI SEWAGE TREATMENT WORKS – PHASE 1

QUARTERLY EM&A REPORT NO. 12

(01 FEBRUARY 2020 – 30 APRIL 2020)

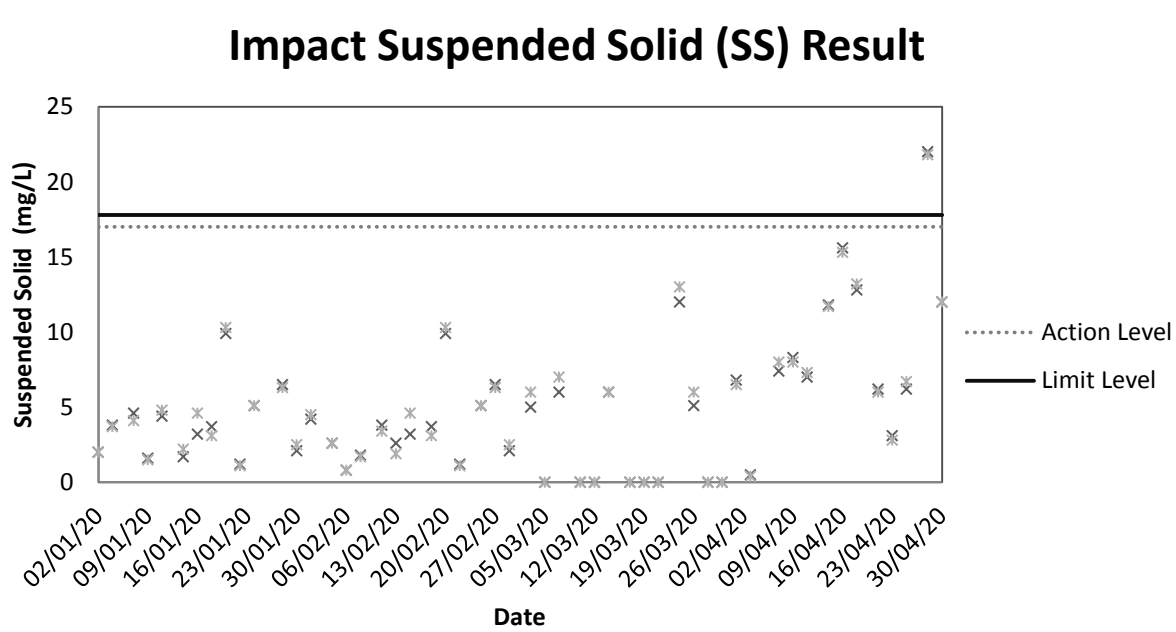
construction site was unlikely to deteriorate the water quality of Tin Shui Wai nullah and resulted in suspended solids exceedance at R1b. Besides, the surface runoff and wastewater generated from the construction activities in different sections of the construction sites was collected and stored in the temporary storage pool and then transferred to the Wetsep for proper treatment prior to discharge. Therefore, the exceedance of water samples taken from 13:20 to 13:34pm on 28 April 2020 was considered as non-Project related. The Investigation Reports No. 004 (including the causes of exceedance, action taken and recommendation for mitigation) for Action or Limit Level Non-compliance were provided in **Appendix K**. Other than the above exceedance, no exceedance of Action and Limit level was recorded in the reporting month. Graphical presentation of the monitoring results for the reporting period is shown in **Appendix F**.

4.1.3. According to the summary of water monitoring results, there was one limit level exceedance of suspended solid at station R1b on 28 April 2020. After investigation, there was concluded that the exceedance was not relevant to this Contract since the results of effluent water sample sampled on 28 April 2020 at both P1 and P8 complied with the discharge license requirement and thus the effluent discharged from the construction site was unlikely to deteriorate the water quality of Tin Shui Wai nullah and resulted in suspended solids exceedance at R1b. Besides, the surface runoff and wastewater generated from the construction activities in different sections of the construction sites was collected and stored in the temporary storage pool and then transferred to the Wetsep for proper treatment prior to discharge. Therefore, the exceedance of water samples taken from 13:20 to 13:34pm on 28 April 2020 was considered as non-Project related. The Investigation Reports No. 004 (including the causes of exceedance, action taken and recommendation for mitigation) for Action or Limit Level Non-compliance were provided in **Appendix K**.

Impact Suspended Solid (SS) Result
Suspended Solid (mg/L)
25
20
15
10
5
0
02/01/20
09/01/20
16/01/20
23/01/20
30/01/20
06/02/20
13/02/20
20/02/20
27/02/20
05/03/20
12/03/20
19/03/20
26/03/20
02/04/20
09/04/20
16/04/20
23/04/20
30/04/20
Date
Action Level
Limit Level

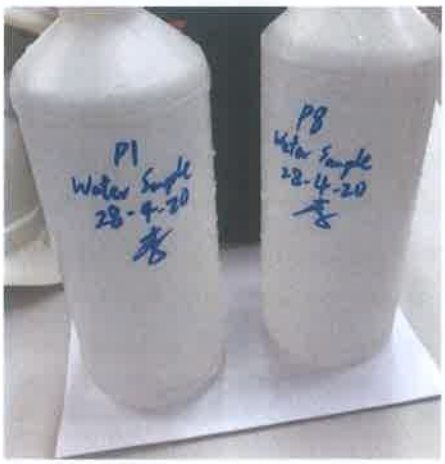
a) Causes of exceedances

Exceedance was not due to construction works under Contract No. DC/2013/10 because:

- The surface runoff and wastewater generated from the construction activities in different sections of the construction sites was collected and stored in the temporary storage pool and then transferred to the Wetsep for proper treatment prior to discharge as shown in **Appendix A**. The effluent was thus brought into an acceptable minimum level and also complied with the requirements specified in the discharge license before discharge.
- According to the monthly checklist of Wetsep provided by the contractor as shown in **Appendix B**, during 27 to 28 April 2020, there were no malpractice or abnormal performance recorded. Samples at effluent were compared with standard solution as shown in the following photos:

- Besides, effluent water sample was scheduled to be collected on 28 April 2020 at P1 and P8. As per the discharge license requirement, the results complied with the discharge license requirement. The effluent quality report was shown in **Appendix C**. Thus, the effluent discharged from the construction site was unlikely to deteriorate the water quality of Tin Shui Wai nullah and resulted in suspended solids exceedance at R1b.
- Thus, the exceedance of water samples taken from 13:20 to 13:34pm on 28 April 2020 was considered as non-Project related.
