DSD CONTRACT NO.: DC/2009/08

CONSTRUCTION OF YUEN LONG SOUTH BRANCH SEWERS AND EXPANSION OF HA TSUEN SEWAGE PUMPING STATION

41ST ENVIRONMENTAL MONITORING & AUDIT MONTHLY REPORT – JUNE 2013

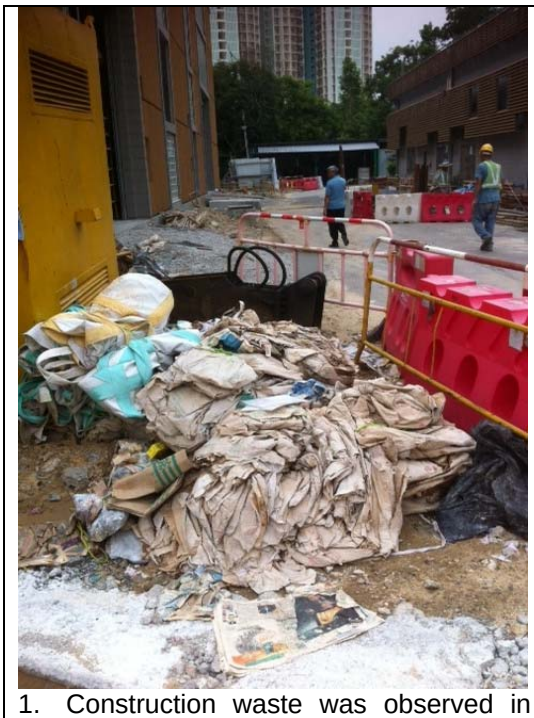
Observations recorded in this Site Inspection: (13-Jun-2013)

1. Construction waste was observed in the Ha Tsuen Sewage Pumping Station, the Contractor should sort and dispose the waste in regular basis.

2. Sandy trail was observed in the haul road of Ha Tsuen Sewage Pumping Station, the Contractor should sweep the sandy trail and apply water spray regularly to minimize fugitive dust.
