JOB NO.: TCS00491/09

CONSTRUCTION OF YUEN LONG SOUTH BRANCH SEWERS AND EXPANSION OF HA TSUEN SEWAGE PUMPING STATION

45TH ENVIRONMENTAL MONITORING & AUDIT MONTHLY REPORT – OCTOBER 2013

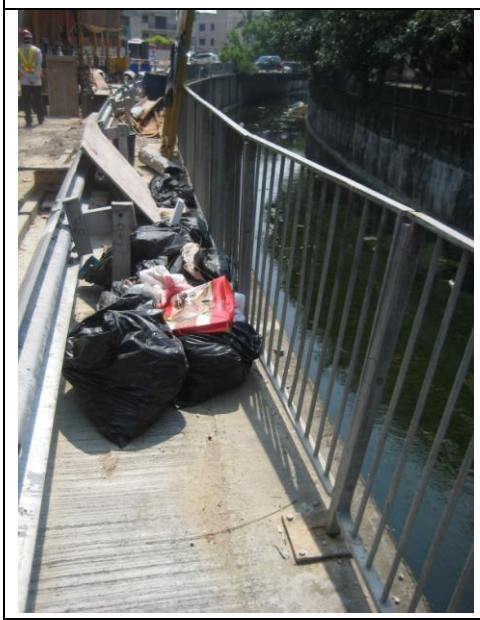
Photo 3 & 4: Scattered of general refuse was observed in the working area of Sham Chung Tsuen, the Contractor was reminded to improve the housekeeping of the site.
