DRAINAGE SERVICES DEPARTMENT (DSD) CONTRACT NO.: DC/2005/02

CONSTRUCTION OF SEWERS, RISING MAINS & SEWAGE PUMPING STATION AT KAM TIN, NAM SANG WAI AND AU TAU IN YUEN LONG

MONTHLY ENVIRONMENTAL MONITORING & AUDIT (EM&A) REPORT FOR SEPTEMBER 2008 (NO. 30) (DESIGNATED ELEMENTS)

Date	Reference No.
09 October 2008	TCS00310/06/600/R0635r2

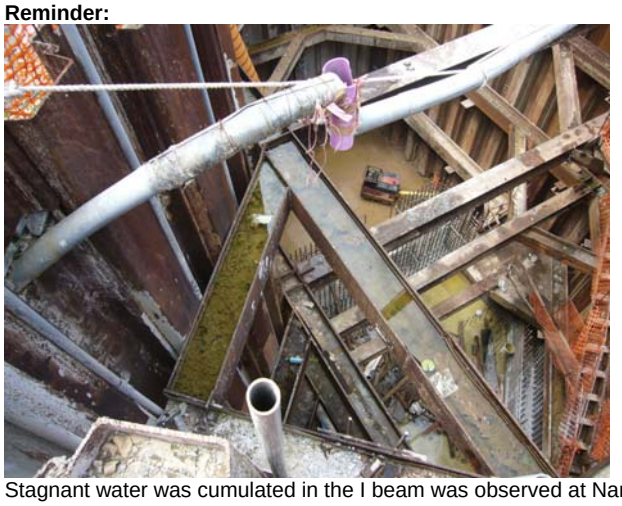
Stagnant water was cumulated in the I beam was observed at Nam San Wai pumping station, the contractor was reminded to clean,

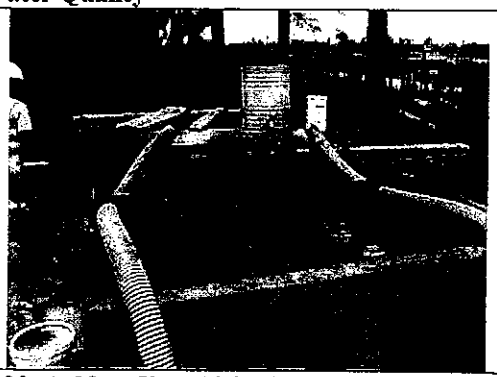
0929: At Nam Shan Wai Rd. site (towards Shan Pui River), U-channel was stained and the Contractor was reminded to clean the channel.	0932: Bags of rubbish and lunch boxes were noticed at Nam Shan Wai Rd. site (Portion F). The Contractor was recommended to remove all wastes immediately.
Water Quality	**Water Quality**

0930: At Nam Shan Wai Rd. site (Portion F), discharging of turbid effluent was noticed. The Contractor was recommended to add coagulant to sedimentation tank(s) to improve the settling of suspended particulates.	0935: At Kam Tin Pumping Room site, direct discharge was noticed while removal of waste water treatment facility (WWTF) was undertaking. The Contractor has immediately stopped the discharge and arranged for another sedimentation tank as WWTF replacement.
