PROJECT NO.: TCS/00408/08

DSD CONTRACT NO. DC/2007/17
DRAINAGE IMPROVEMENT WORKS IN CHEUNG PO, MA ON KONG, YUEN KONG SAN TSUEN AND TIN SAM TSUEN OF YUEN LONG DISTRICT AND SEWERAGE AT TSENG TAU CHUNG TSUEN, TUEN MUN

MONTHLY EM&A REPORT FOR KT13 (JANUARY 2010)

PREPARED FOR
CHINA ROAD & BRIDGE CORPORATION

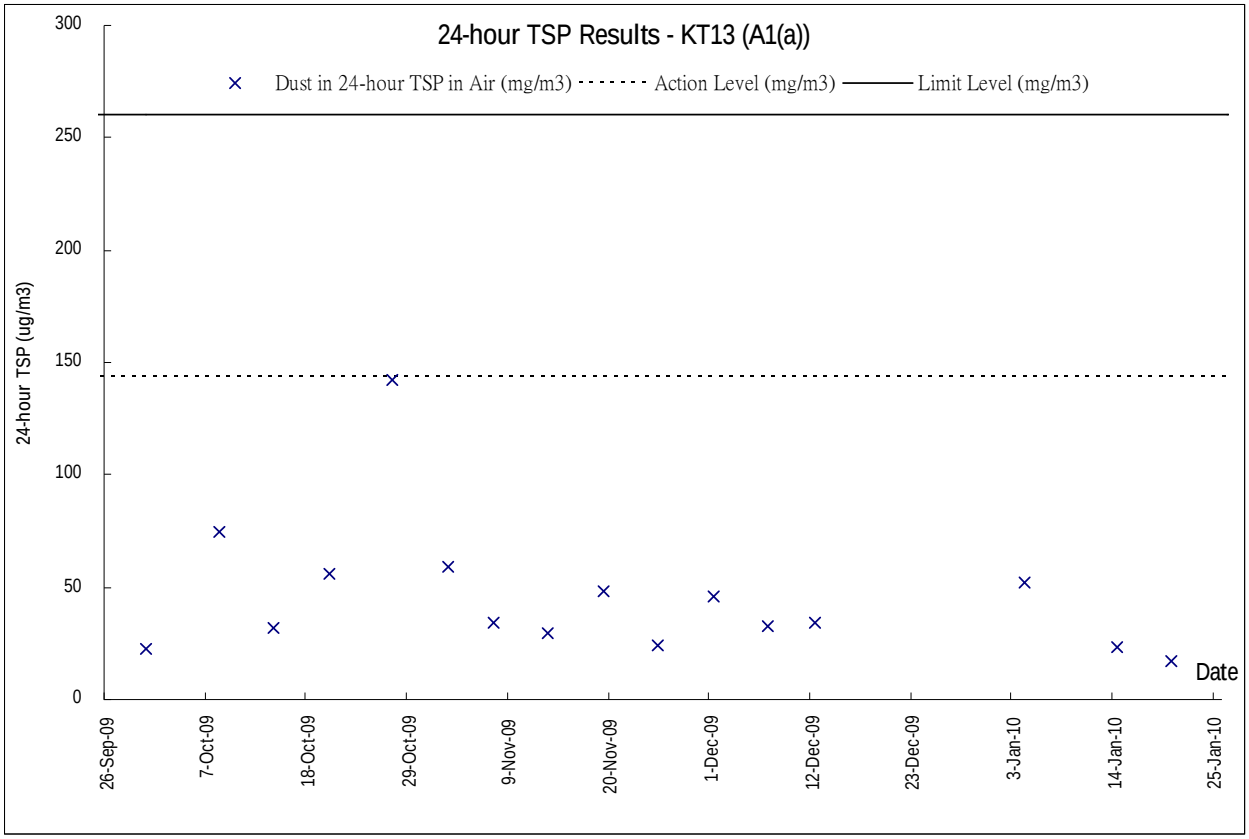
Results of air quality monitoring at the identified locations during the Reporting Period are summarized in ***Tables 3-1-3-1*** and ***3-1-3-2*** below. Power failure at KT13-A1(a) was occurred on 30 December 2009 and 8 January 2010 due to damage of technical parts by others. The monitoring team has been taking action to restore the problem.

at KT13A1(a) on 30 December 2009 and 8 January 2010, the two monitoring data was absent in this reporting month. We have liaised with the Contractor and it is advised that only channel excavation and construction of box culvert were conducted at Channel KT-13 in the entire December. Air pollution mitigation measures such as regular watering on haul roads and cover for the stockpile of excavated soil were provided to prevent fugitive dust generation due to construction work. As investigation figured out there were no significant changes to the condition of the construction site before and after the HVS power failure, we consider the 24-hour TSP monitoring results during HVS power failure would not have big variation in comparing with before.

*Power failure occurred at KT13-A1(a) on 18, 24, 30 December 2009 and 8 January 2010.

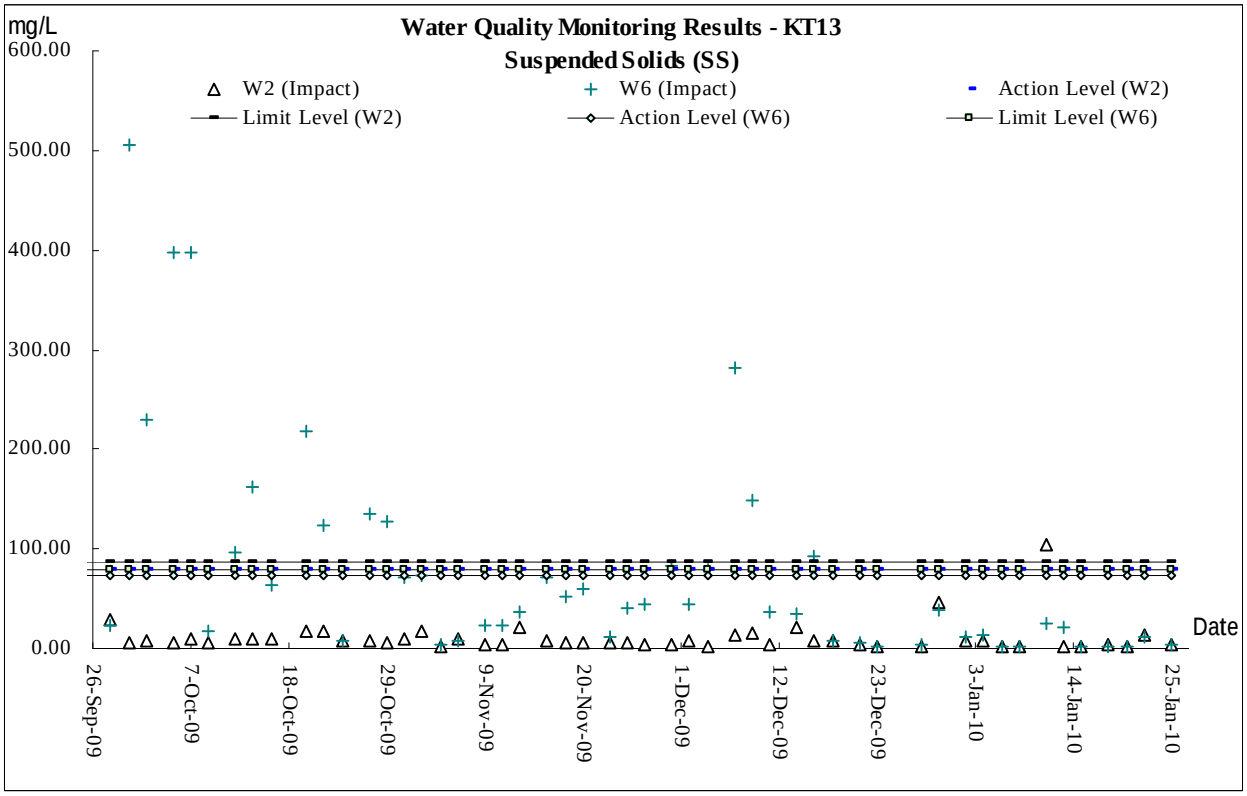
ES04 One Limit Level exceedance of water quality criteria, due to suspended solid (SS) was recorded at designated location W2 during the Reporting Period. The causes of the exceedance are still under investigation. In addition, the calibration record of the YSI 550A was expired on 17 January 2010, so the rest of results were served as reference only. As there were no significant changes to the condition of the construction site in the whole reporting period, we consider that the DO level would not have large fluctuation and exceed the A/L Level.

One Limit Level exceedance of water quality criteria, due to suspended solid (SS) was recorded at designated location W2 during the Reporting Period. during the Reporting Period as shown in ***Table 3-3-2***. NOEs were issued upon confirmation of the monitoring results, and investigation was conducted upon receipt of the information of construction activities and implementation status of mitigation measures provided by CRBC. The causes of the exceedances were being investigated.

During the Reporting Period, no excavation work was being carried out at downstream near Location W2 was undertaken. Water mitigation measures such as sedimentation tanks, temporary earth bunds and sand bags had been equipped on site properly. However, during regular site inspection, influx of discharge from the nearby pig farm into the channel which resulted in increased turbidity of the water body was observed. Preliminary investigation concluded that the exceedances were likely to be due to the discharge from the pig farm. CRBC was reminded to fully implement the required water quality mitigation measures during construction under the Project, in particular when excavation and the associated channel works are undertaken and construction wastewater is generated and discharged to the Channel KT13.
