PROJECT NO.: TCS/00408/08

DSD CONTRACT NO. DC/2007/17
DRAINAGE IMPROVEMENT WORKS IN CHEUNG PO, MA ON KONG, YUEN KONG SAN TSUEN AND TIN SAM TSUEN OF YUEN LONG DISTRICT AND SEWERAGE AT TSENG TAU CHUNG TSUEN, TUEN MUN

MONTHLY EM&A REPORT FOR KT13
(APRIL 2010)

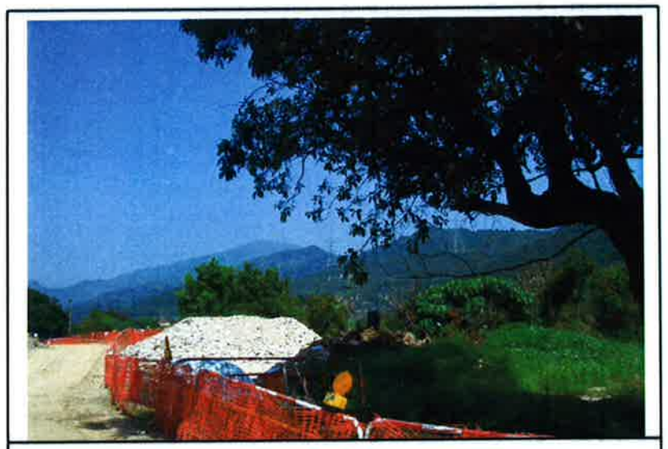
Photo No. C3—I3 Plant Nursery at the east of Ma On Kong Channel

10.7.23	I3	C3	Plant Nursery at the west of Ma On Kong Channel The VSRs is workers of the plant nursery. The number of individual is very few and their sensitivity to visual impacts is low.	Temporary stockpiling was observed
