PROJECT NO.: TCS/00512/09

DSD CONTRACT NO. DC/2009/13
CONSTRUCTION OF SEWAGE TREATMENT WORKS AT
YUNG SHUE WAN AND SOK KWU WAN

YUNG SHUE WAN PORTION AREA
MONTHLY ENVIRONMENTAL MONITORING AND AUDIT
(EM&A) REPORT (NO.42) – FEBRUARY 2014

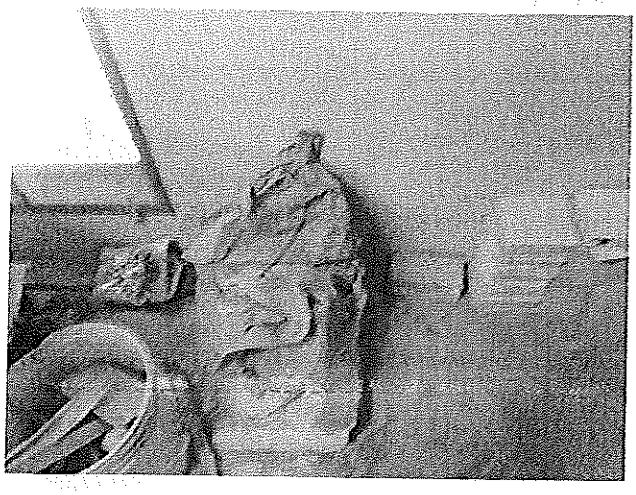
Findings of Site Inspection (11 February 2014):

The Contractor was reminded to dispose the used cement bag properly.

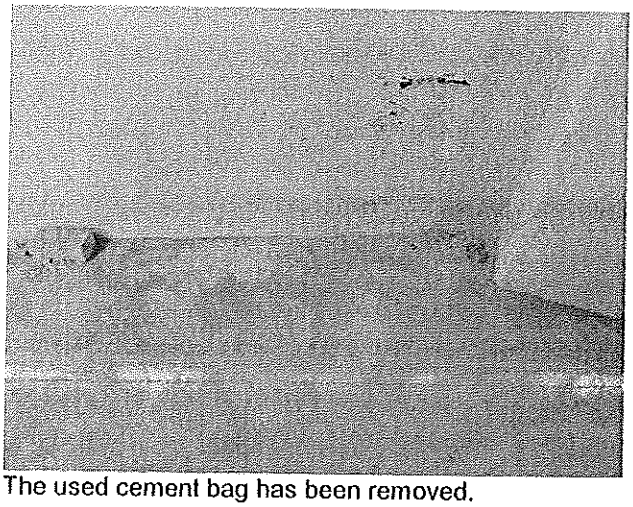
Follow up (11 February 2014):

The used cement bag has been removed.
