Drainage Service Department

Monthly Environmental Monitoring & Auditing report for

Contract No.DC/2009/22
Drainage Improvement in Shuen Wan, Tai Po – Contract 1

October 2011

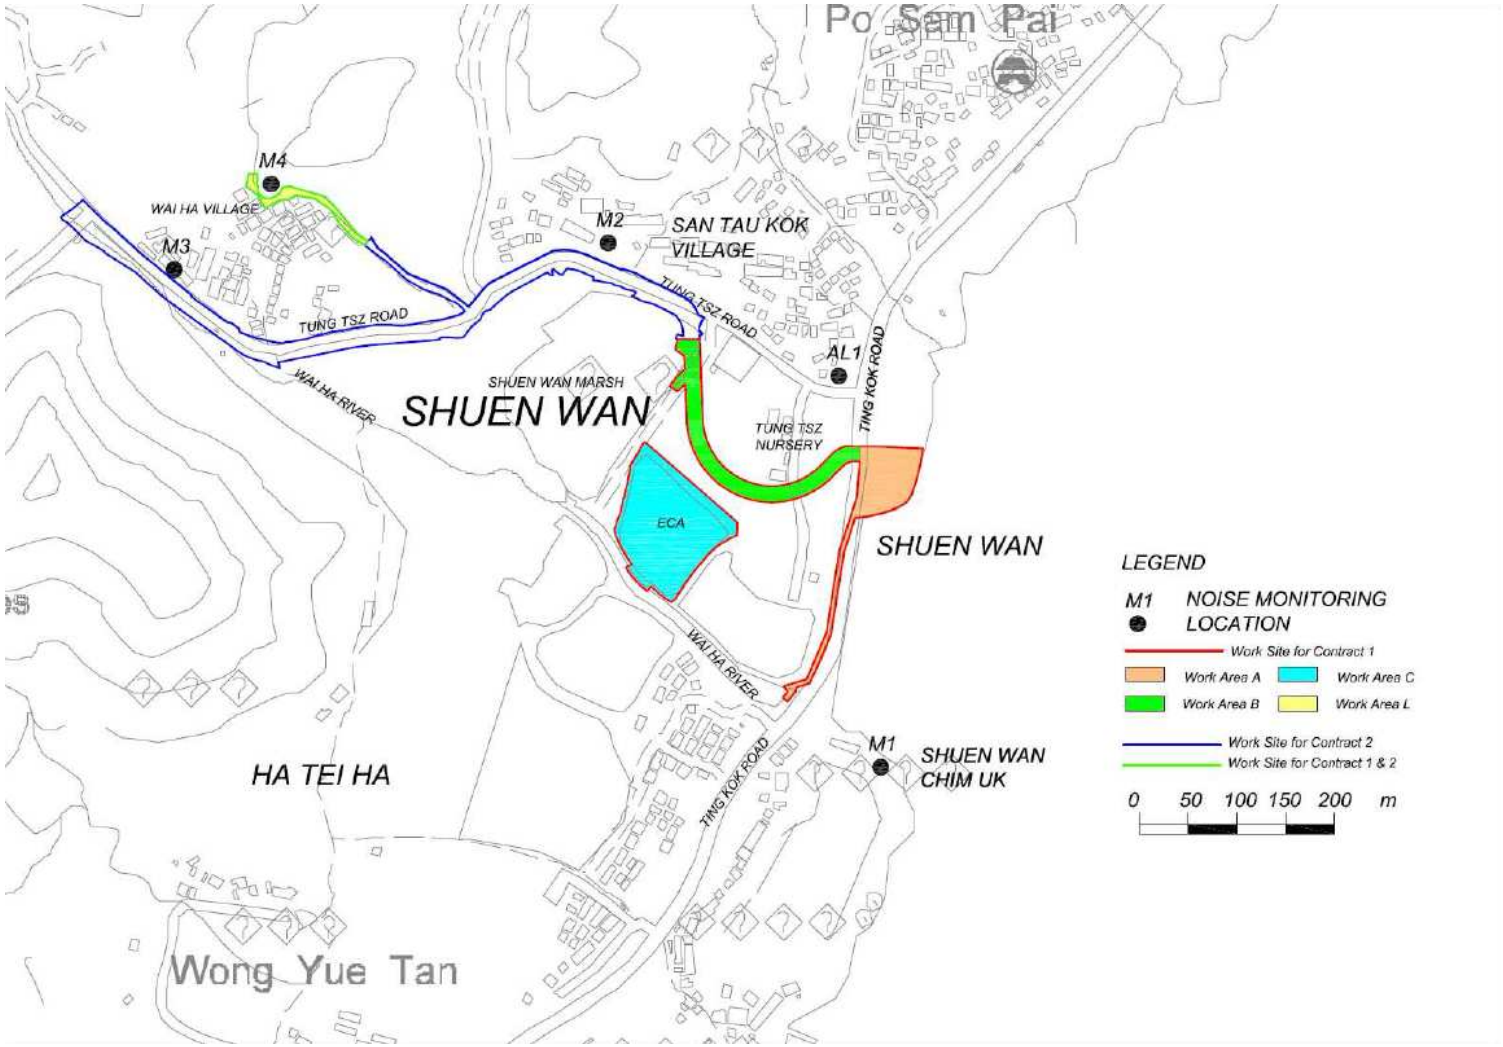
Figure 3.3.1 Impact noise monitoring locations

Relevant details of the noise monitoring results are presented in Table 3.4.1. The results of M1, ranged between 51.1dB (A) and 60.6dB (A), and AL1, ranged between 56.2dB (A) and 58.5dB (A), were within the limit levels and therefore, no exceedance was found.

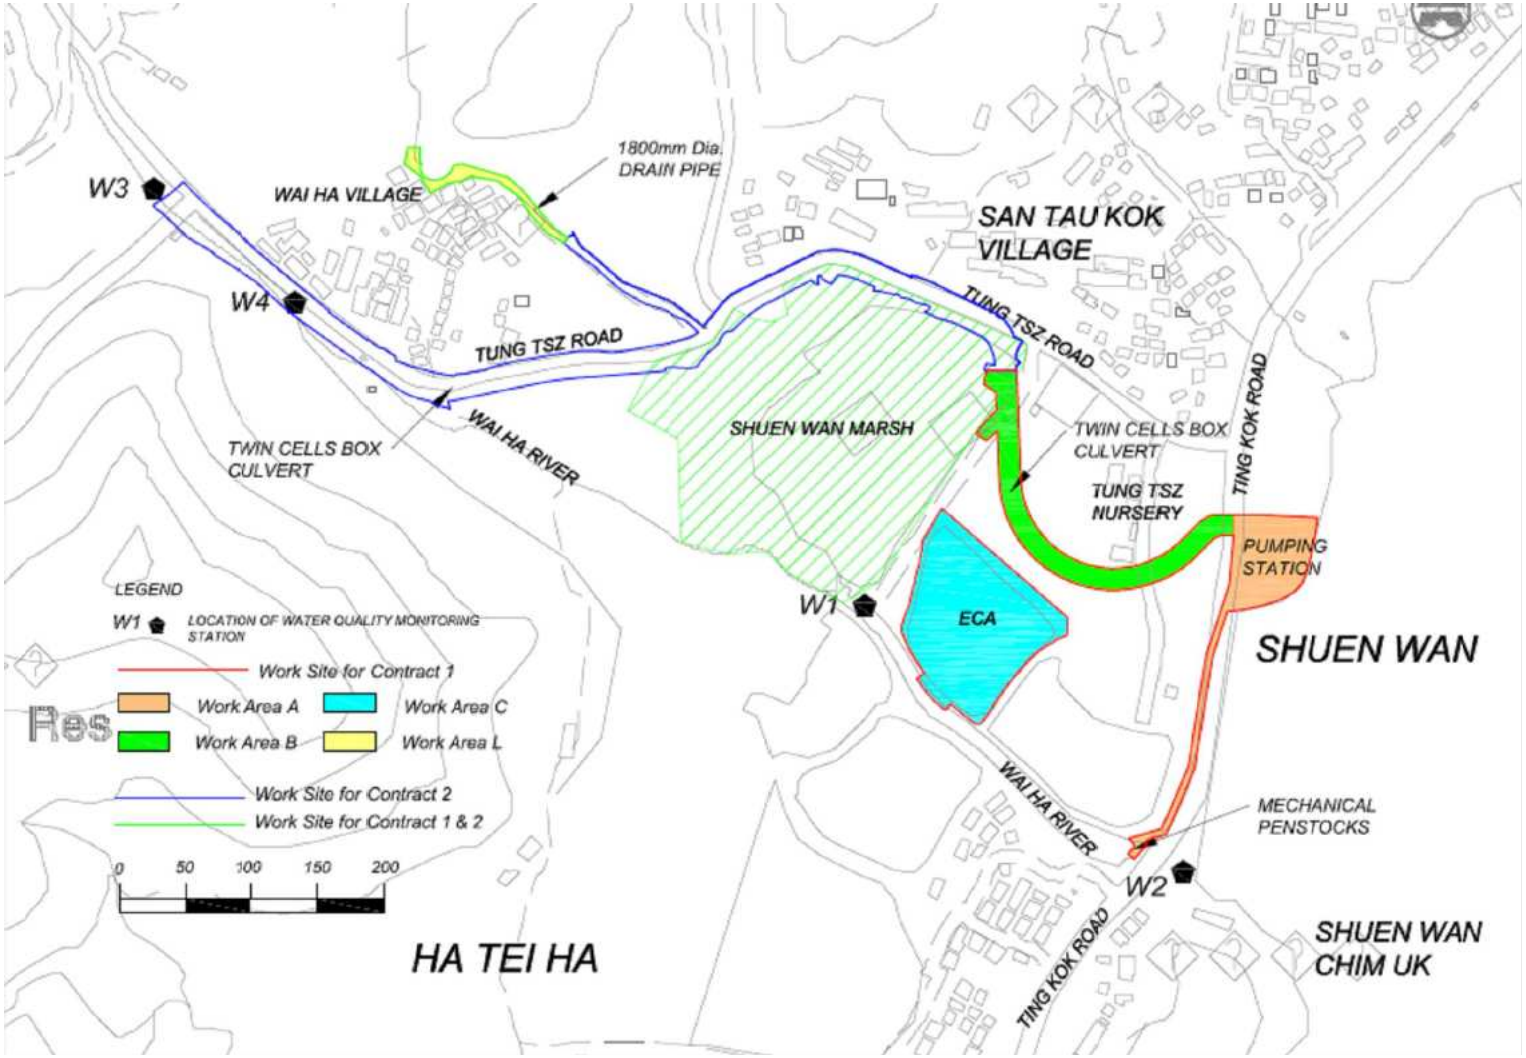
Figure 4.3.1 Water Quality Monitoring Locations

There were 9 abnormal incidents of water quality limits (Dissolved Oxygen, Suspended Solid and Turbidity) were recorded in this reporting month according to the established action and limit levels. ET has arranged site investigations for the abnormal incidents and finding from the investigations showed no particular observations of defective site activities were found. Therefore, such conditions were believed to be attributed by natural fluctuation and are not considered as non-compliance events.

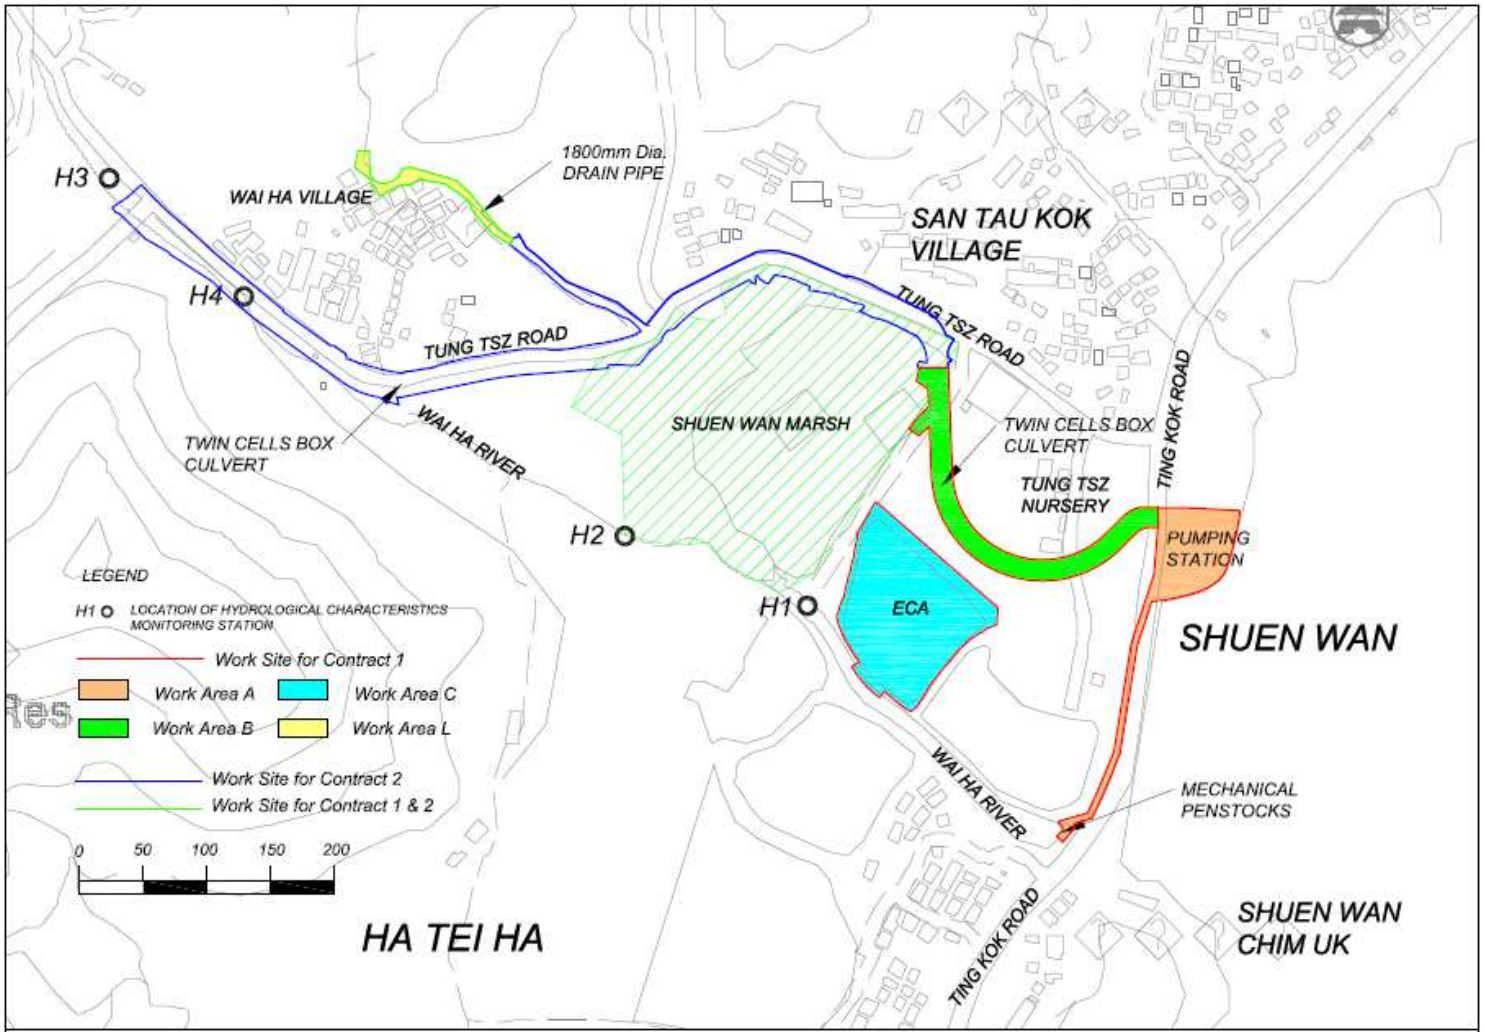
Figure 5.3.1 Hydrological Characteristics Monitoring Locations

Hydrological characteristics monitoring was carried out four times in this reporting period. The monitoring results are summarized in Table 5.5. All results were within the action and limit levels, therefore, no exceedance was found.

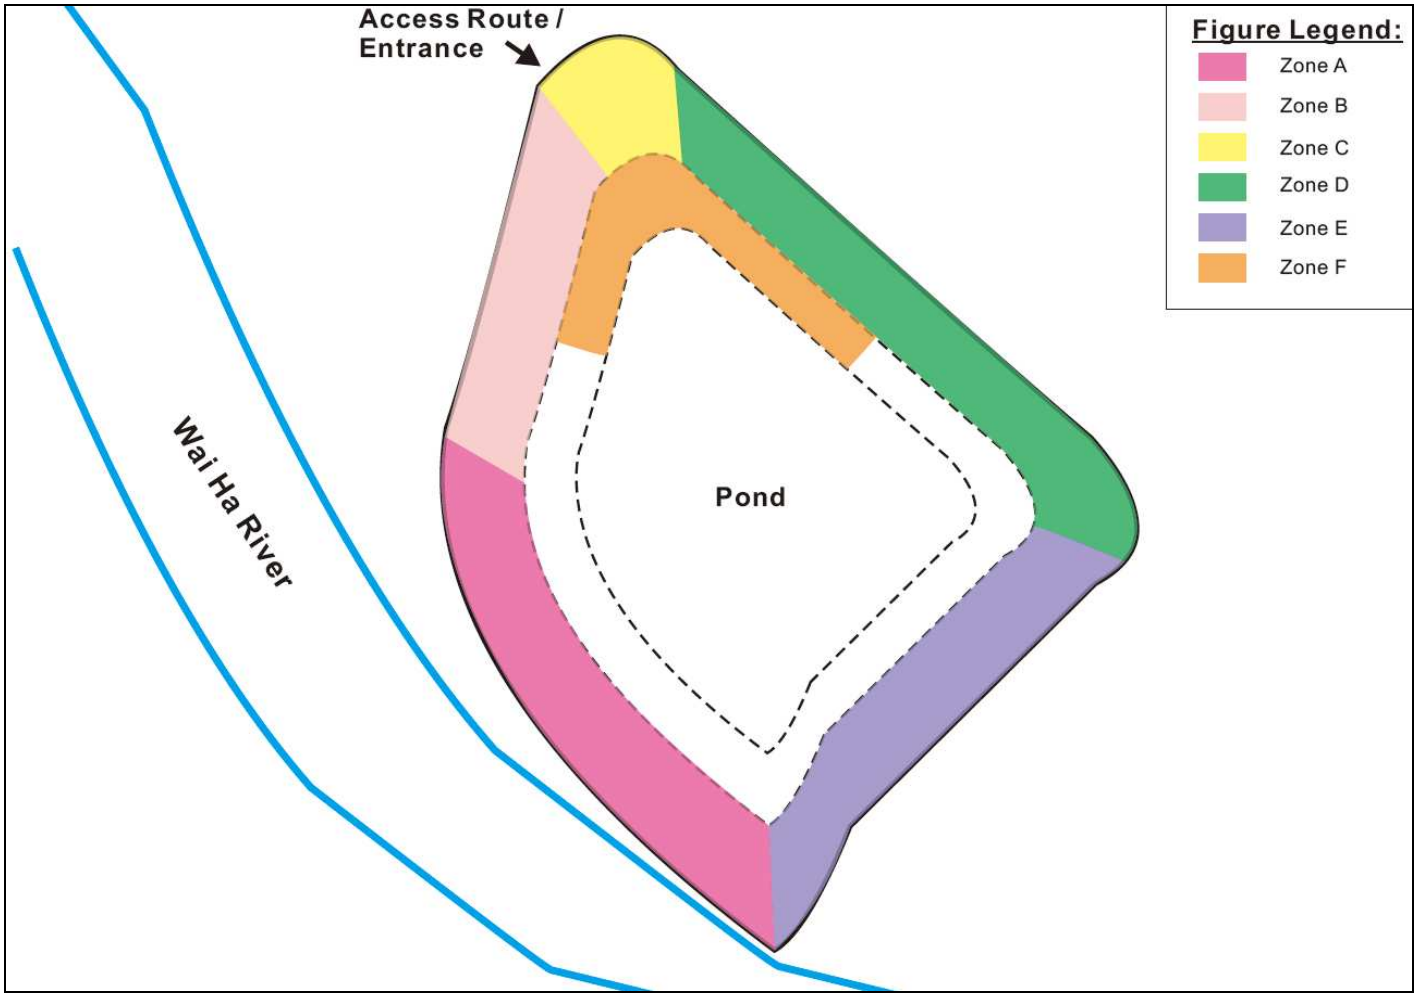
Figure 6.3.2.1 Landscape floor plan of ECA during establishment phase in October 2011.

A total of 370 trees were newly planted for amenity purpose within the ECA since September 2011. The 370 individual trees were randomly planted at different zones, except zone F, within ECA as showed in Figure **6.3.2.1**.

Mangrove seedlings were planted in Zone F, but most of them were in poor condition or almost wilting, in particular for those planted along the slope. Sandy soil and nutrient leaching during surface runoff appear to be the concerns. Regular irrigation and improving soil texture are recommended.

Sparse foliage with yellow and curl leaves were observed in several trees, including: *H. tiliaceus* with tag No. N238 – N241 at Zone D and those planted at Zone C near entrance; *C. sinensis* (tag no. N130) at Zone D.

Physical injury was found on the bark of *H. tiliaceus* (tag no. N218) at Zone A. Repairing of wound is recommended to prevent decay and protect against insects and fungus/virus infections.

A few of *H. tiliaceus* (N60, N61, N63, N64, N75 -77) planted near the edge of pond in Zone E were in poor condition with no foliage. Tidal change in water level of pond may impose stress on trees due to variation in soil moisture and salt content in soil. Regular watering is recommended to maintain soil moisture, and flush away excessive salt content in soil concurrently.

Regular watering is recommended to improve the condition of the newly planted trees. Relevant mitigation measures will be proposed when necessary.

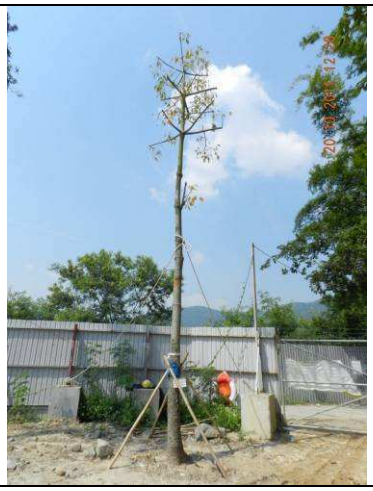
Photo 7 – Overall view of the newly transplanted tree T163 in Area C	**Photo 8** – A newly transplanted tree T168 from Area A to Area C
