Drainage Service Department

Monthly Environmental Monitoring & Auditing report for

Contract No.DC/2009/22
Drainage Improvement in Shuen Wan, Tai Po – Contract 1

February 2013

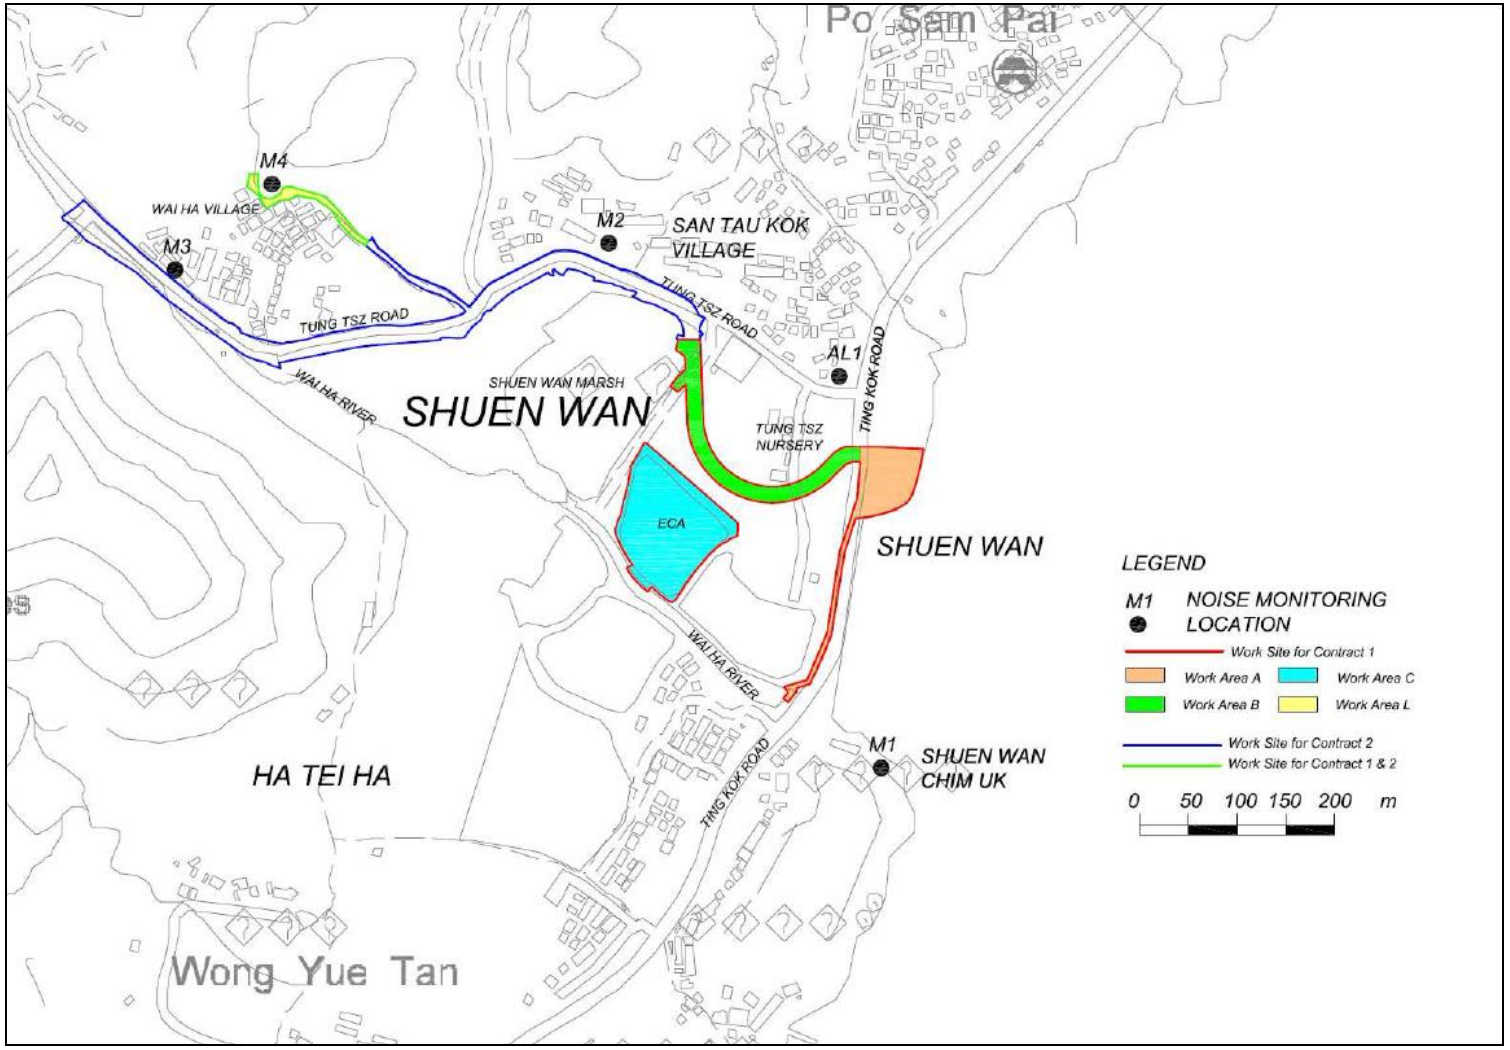
Figure 3.3.1 Impact noise monitoring locations

According to the Environmental Monitoring and Audit manual, impact noise monitoring for contract 1 was undertaken at two locations during the construction phase of the project. The proposed monitoring locations are summarized in Table 3.3.1. Figure 3.3.1 shows the Noise Monitoring Locations.

Relevant details of the noise monitoring results are presented in Table 3.4.1. The results of M1 ranged between 60.9dB (A) and 63.4dB (A), and AL1 ranged between 67.1dB (A) and 68.2dB (A), were within the limit levels and therefore, no exceedance was found.

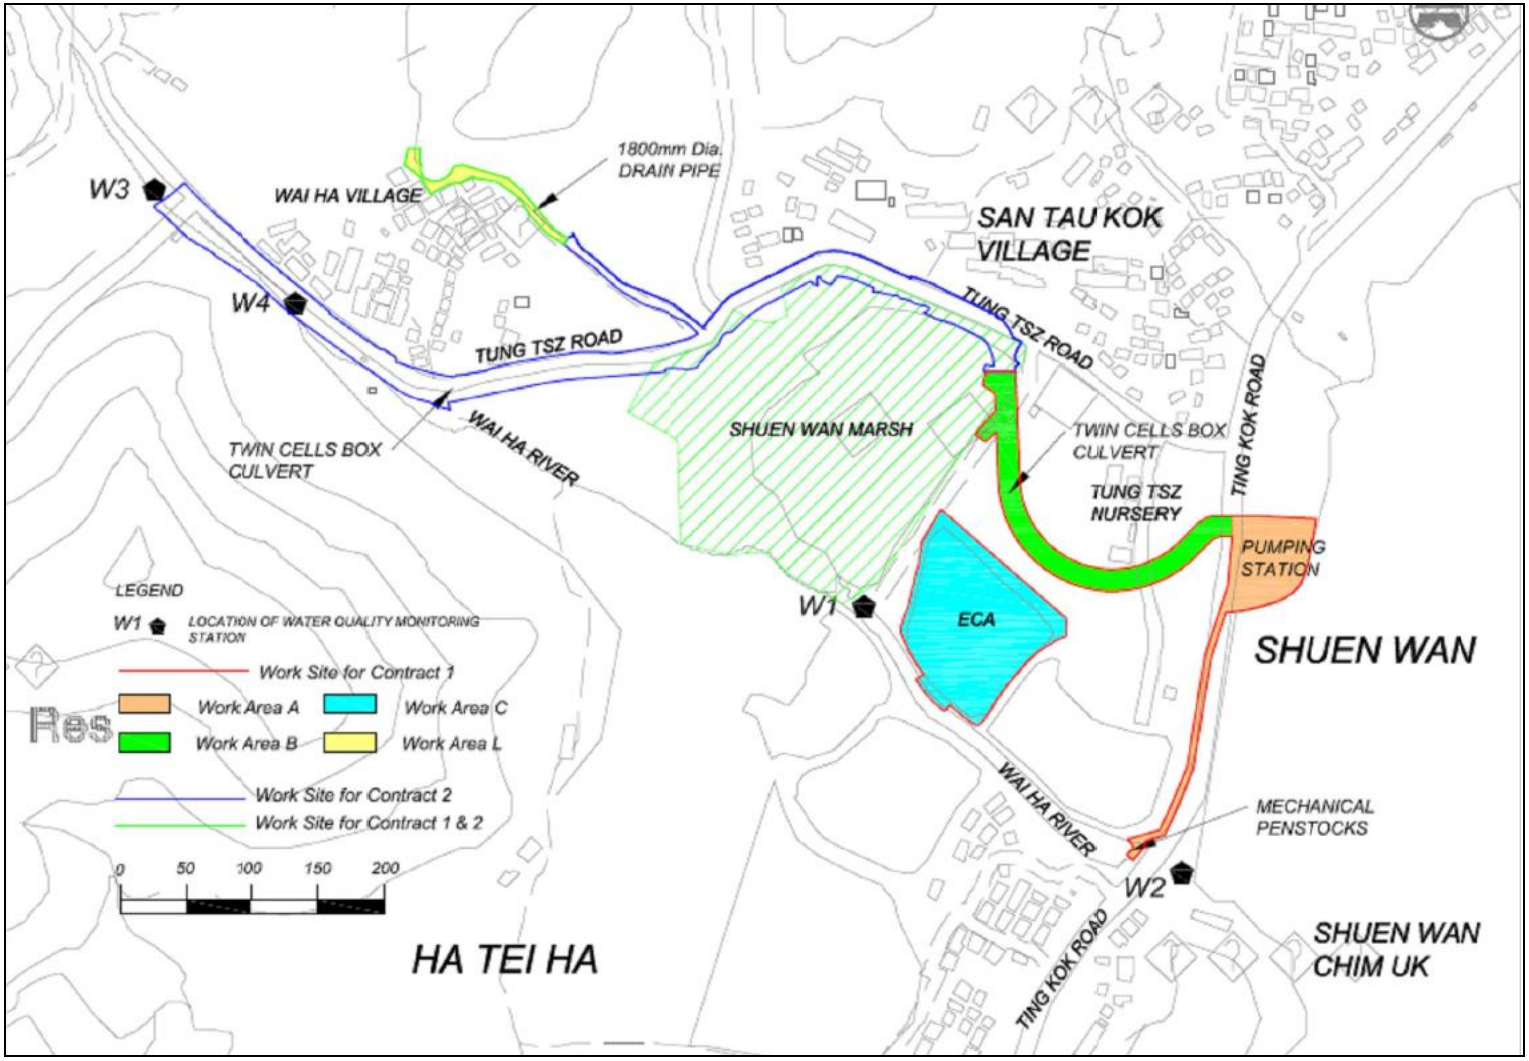
Figure 4.3.1 Water Quality Monitoring Locations

As illustrated in Figure 4.3.1, W1 served as the control station while W2 was the monitoring location of water quality.

There were 5 abnormal incidents of water quality limits (Turbidity) were recorded in this reporting month according to the established action and limit levels. ET has arranged site investigations for the abnormal incidents. Proper mitigation measures were implemented by contractor to avoid site water release to the Wai Ha river and no particular observation of defective site activities were found causing water contamination; The exceedances of Turbidity were believed to be mainly attributed by natural fluctuation, since the recorded levels of Turbidity at control station had also exceeded its baseline action/limit level, the exceedances recorded at W2 were unlikely to be related to the Project.

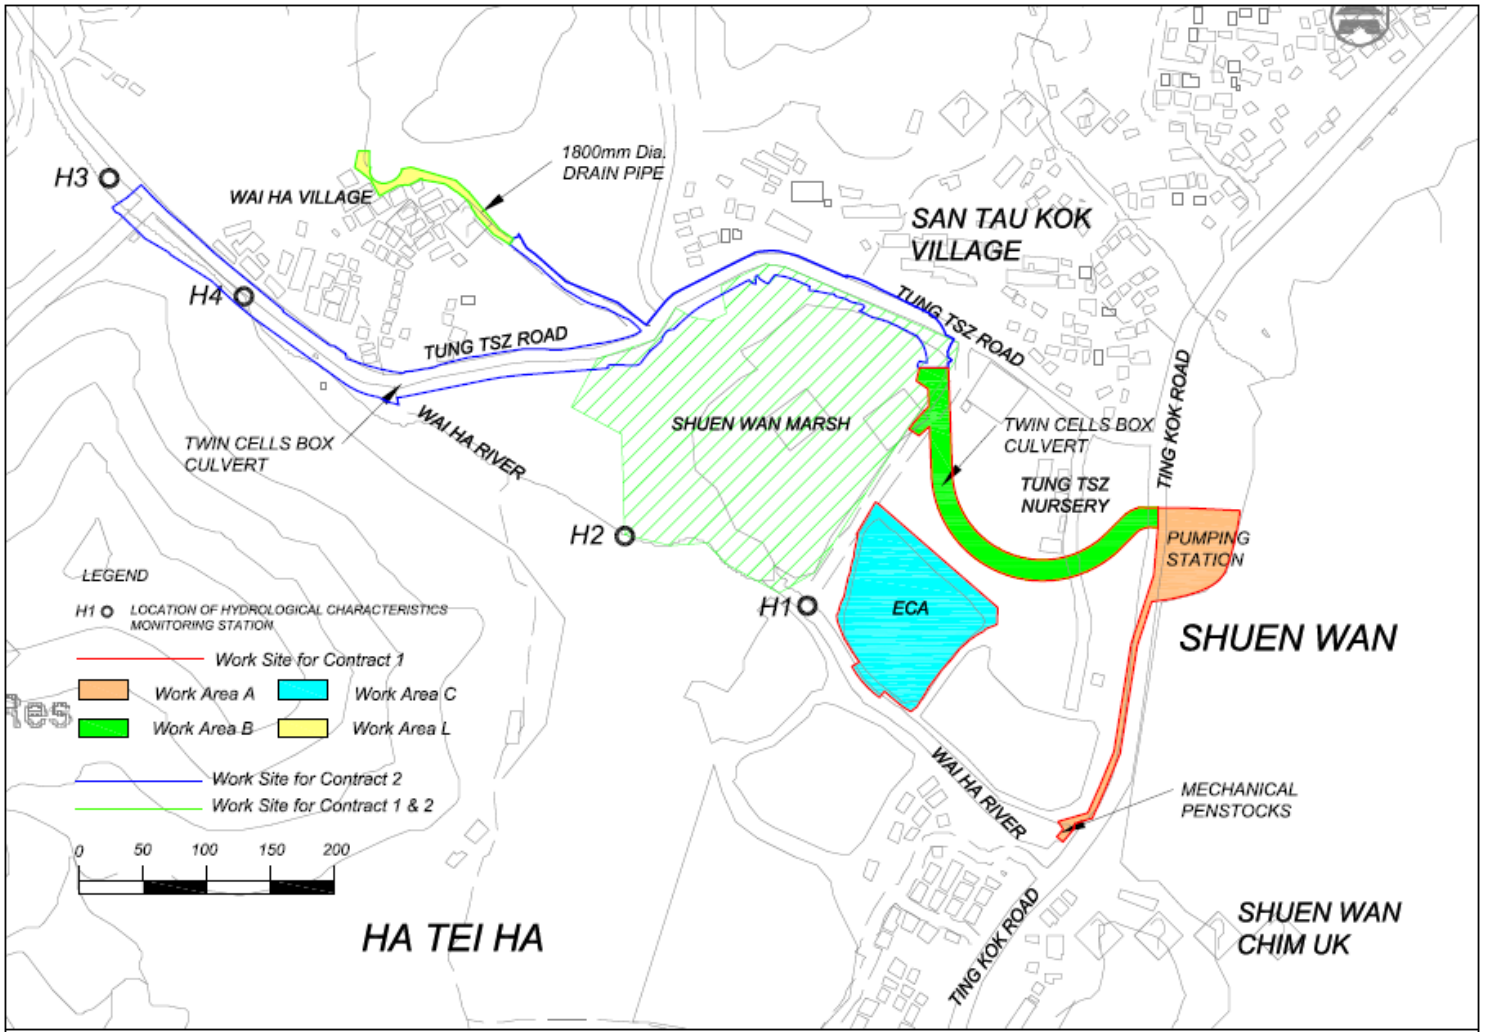
Figure 5.3.1 Hydrological Characteristics Monitoring Locations

As illustrated in Figure 5.3.1, H2 served as the control station while H1 was the monitoring location of hydrological characteristics.

Hydrological characteristics monitoring was carried out five times in this reporting period. The monitoring results are summarized in Table 5.5. All results were within the action and limit levels, therefore, no exceedance was found.

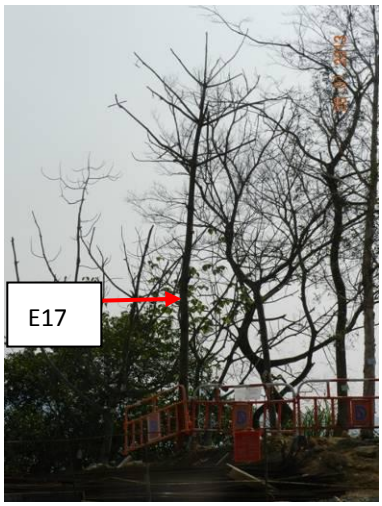
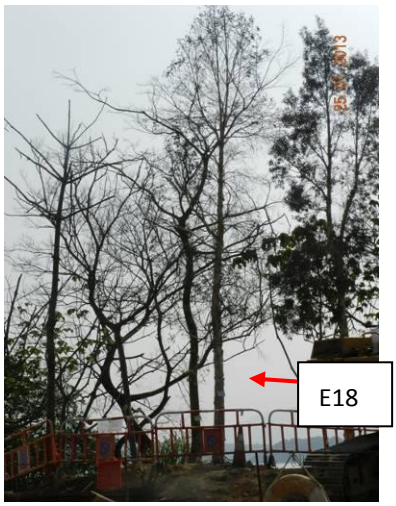
Since October 2012, E18 (*Melaleuca cajuputi* subsp. *cumingiana*) originally located within the TPZs nearby the main gate have been relocated to the northeastern part of Area A. However, these trees were relocated again in November 2012 due to the direct conflict with the adjacent excavation work at the northeastern part. As observed in February 2013, the tree was found in poor condition due to transplantation shock and poor planting skills (**Photo 6**).

Photo 5 – Translocated tree E19 and E20 (*Melaleuca cajuputi* subsp. *cumingiana*) during the monitoring on 11th January 2013.	Photo 6 – E19 (*Melaleuca cajuputi* subsp. *cumingiana*) was relocated again during the monitoring on 25th January 2013.

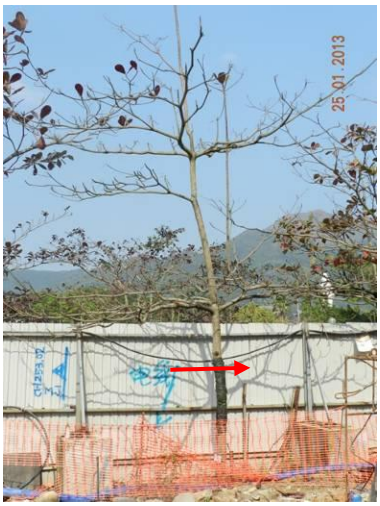
Photo 17 – Declining health condition of U34 in Area B.	Photo 18 – Declining health condition of U35 in Area B.
