9th CONSOLIDATED MONTHLY EM&A REPORT

July 2017

Client	**:**	Civil Engineering and Development Department, HKSAR
EP No.	**:**	EP-337/2009 – New Distributor Roads Serving the Planned Kai Tak Development Area
Contract No.	**:**	KLN/2016/05 – Independent Environmental Checker for Contract No. KL/2015/02 Kai Tak Development – Stage 5A Infrastructure at Former North Apron Area
Report No.	**:**	0087/16/ED/0460

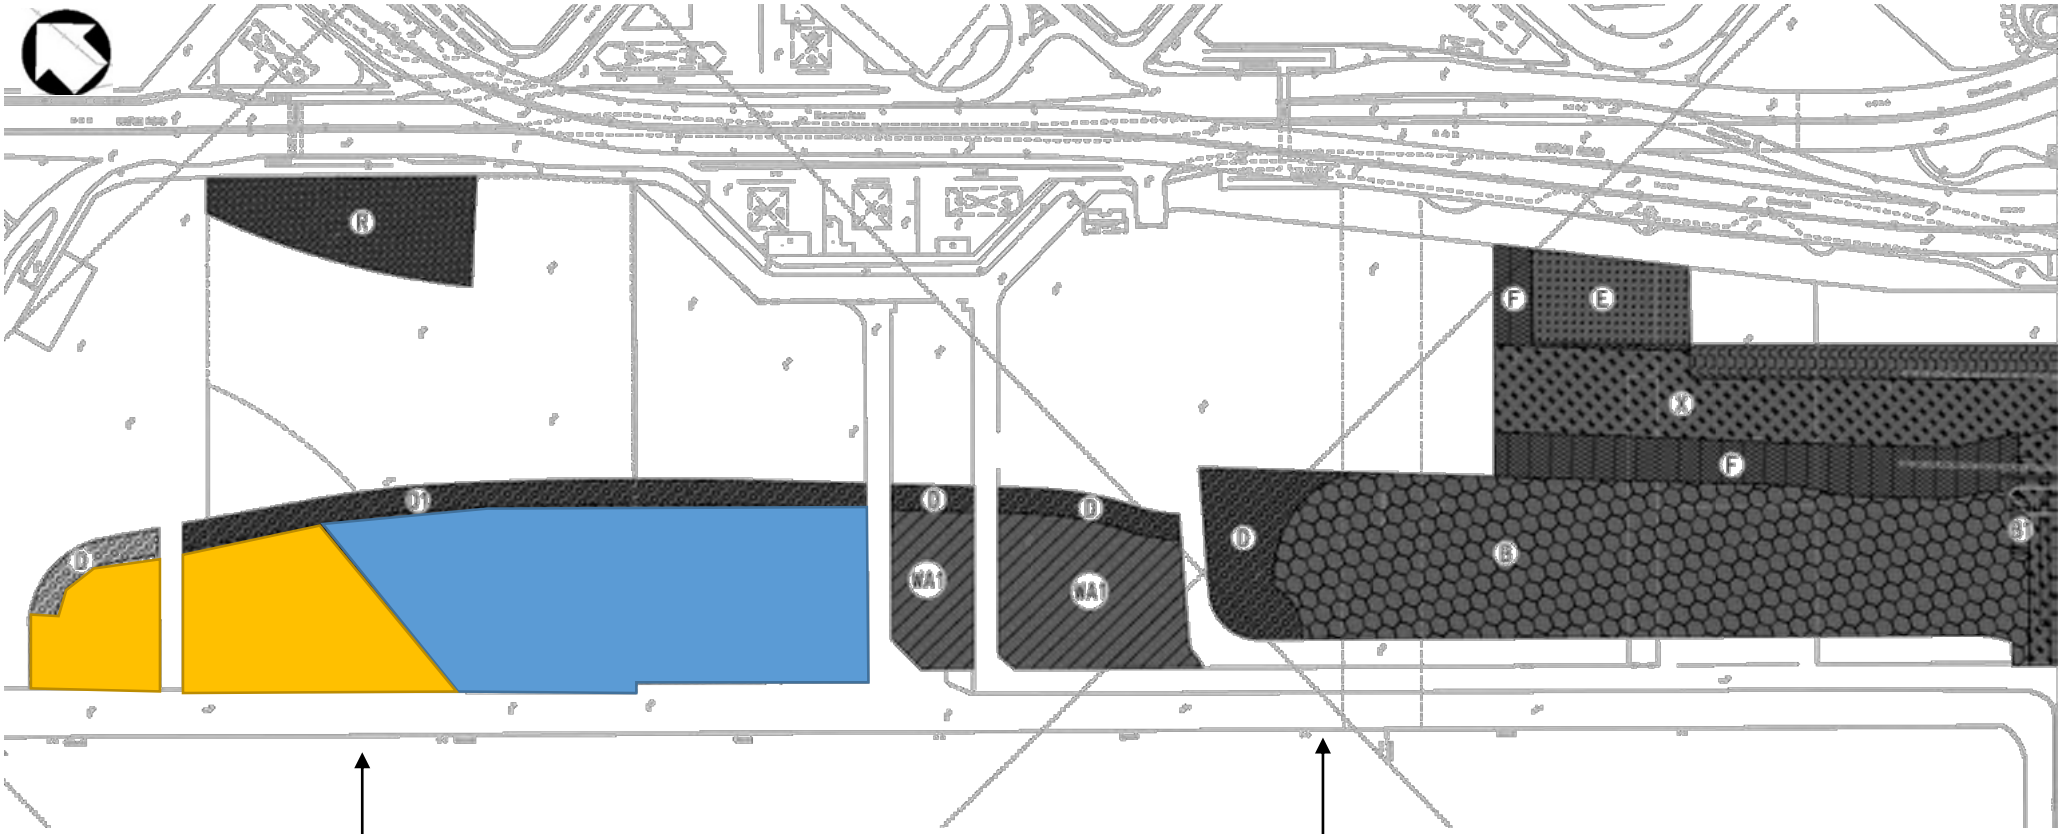
Portion I

The complainant's concerned outfall
