HIGHWAY CONTRACT NO. HY/2011/13 – IMPROVEMENT TO POK OI INTERCHANGE

ENVIRONMENTAL MONITORING AND AUDIT (EM&A) MONTHLY REPORT (NO.49) – MARCH 2017

PREPARED FOR
Build King Civil Engineering Limited

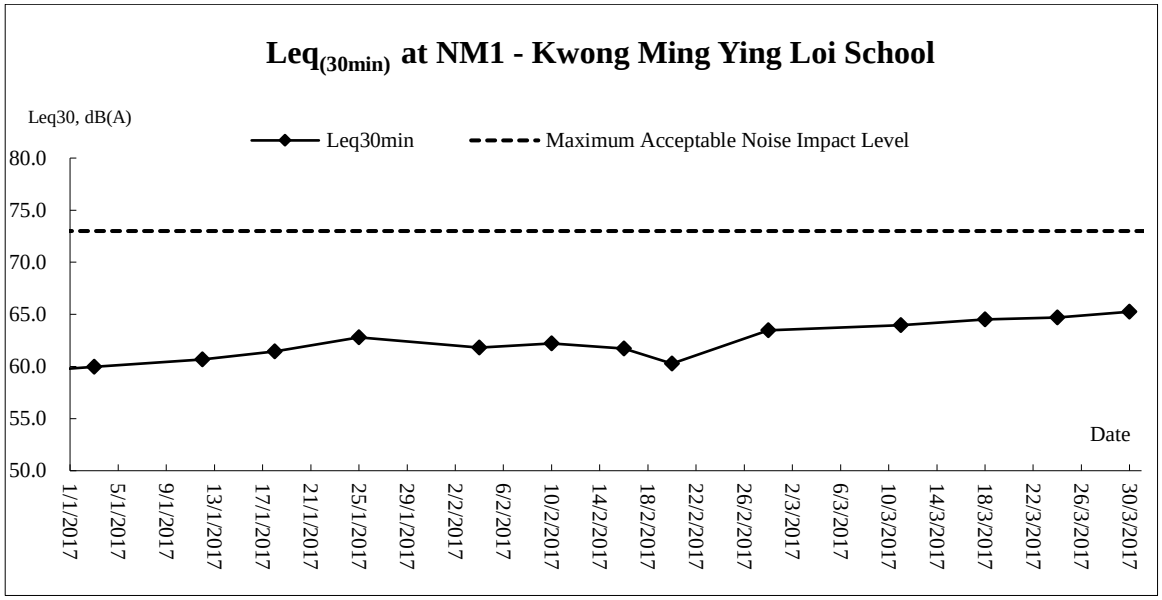
Leq(30min) at NM1 - Kwong Ming Ying Loi School
Leq30, dB(A)
Leq30min
Maximum Acceptable Noise Impact Level
80.0
75.0
70.0
65.0
60.0
55.0
50.0
Date
1/1/2017
5/1/2017
9/1/2017
13/1/2017
17/1/2017
21/1/2017
25/1/2017
29/1/2017
2/2/2017
6/2/2017
10/2/2017
14/2/2017
18/2/2017
22/2/2017
26/2/2017
2/3/2017
6/3/2017
10/3/2017
14/3/2017
18/3/2017
22/3/2017
26/3/2017
30/3/2017

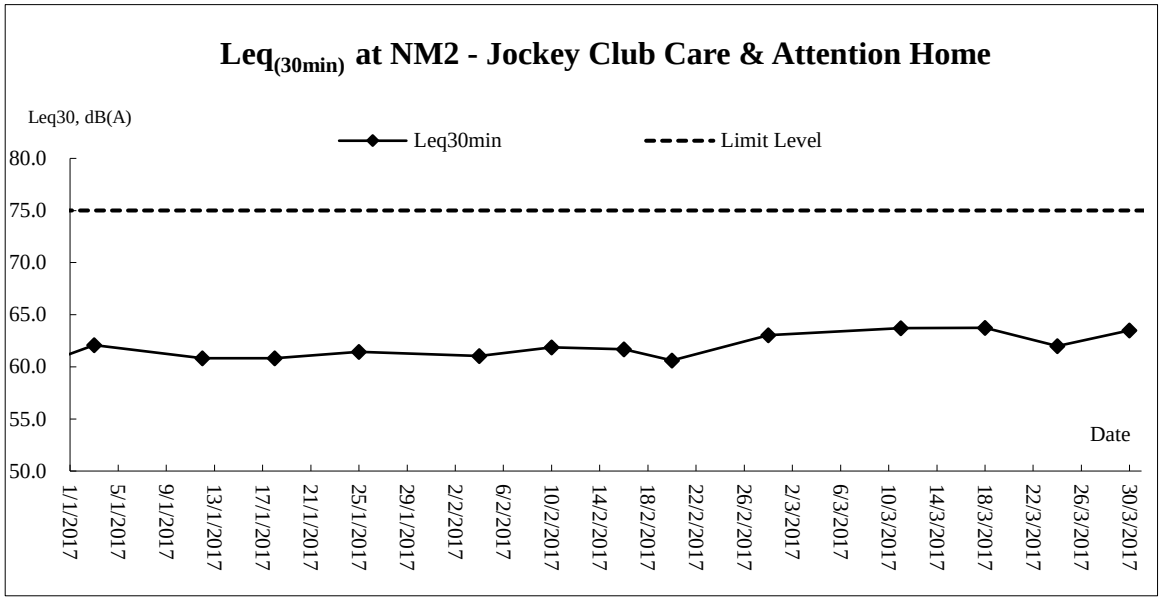
Leq(30min) at NM2 - Jockey Club Care & Attention Home
Leq30, dB(A)
Leq30min
Limit Level
80.0
75.0
70.0
65.0
60.0
55.0
50.0
Date
1/1/2017
5/1/2017
9/1/2017
13/1/2017
17/1/2017
21/1/2017
25/1/2017
29/1/2017
2/2/2017
6/2/2017
10/2/2017
14/2/2017
18/2/2017
22/2/2017
26/2/2017
2/3/2017
6/3/2017
10/3/2017
14/3/2017
18/3/2017
22/3/2017
26/3/2017
30/3/2017
