MTRCL Contract C3840-13C Tsim Sha Tsui Station Carnarvon Road Subway and Entrances Modification Works

Monthly EM&A Report (December 2014)

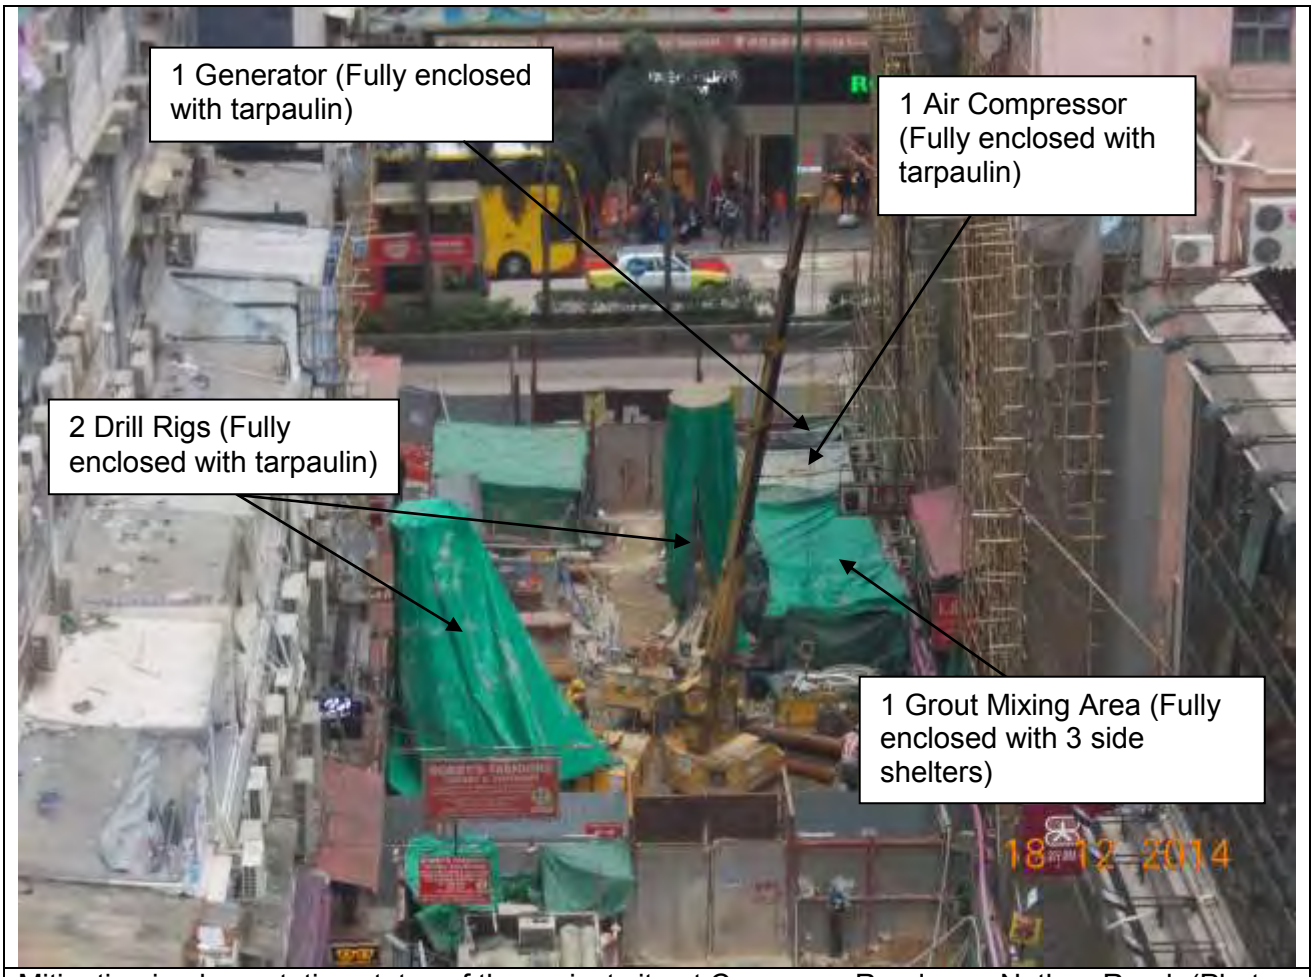
Photo(s) taken at the monitoring station at Rooftop 4/F K11 Art Mall on 18 December 2014

Mitigation implementation status of the project site at Carnarvon Road near Nathan Road. (Photo taken by the ET on 18 December 2014).

Mitigation implementation status of the project site at Carnarvon Road near Bristol Ave. (Photo taken by the ET on 18 December 2014).
