CONTRACT NO. DC/2013/10 - DESIGN, BUILD AND OPERATE SAN WAI SEWAGE TREATMENT WORKS – PHASE 1

MONTHLY EM&A REPORT
NO. 54
(For Construction Phase)

(01 OCTOBER – 31 OCTOBER 2021)

Issued Date: 08 November 2021 *Report No.: ENA15781*

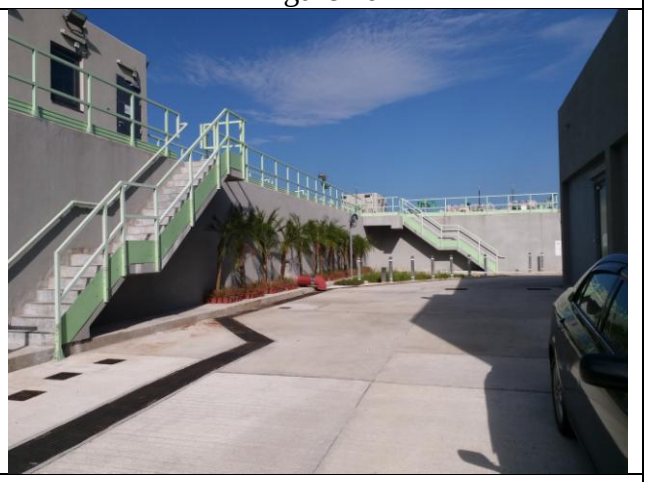
1. Generally, contractor was reminded to keep on planting works for the outstanding area.
2. Weeding of planting area, especially for the green roof, is needed.
3. Replacement of the dead plants are required.

Planting condition along boundary adjacent to the existing plant	Planting works- groundcovers and potted plants in front of the structure
