ATAL-DEGREMONT-CHINA HARBOUR JOINT VENTURE

CONTRACT NO. DC/2013/10 - DESIGN, BUILD AND OPERATE SAN WAI SEWAGE TREATMENT WORKS – PHASE 1

MONTHLY EM&A REPORT
NO. 61
(For Construction Phase)

(01 MAY – 31 MAY 2022)

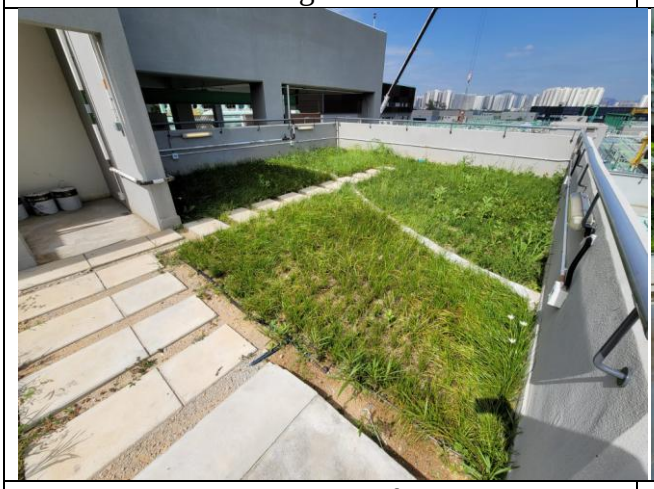
Planting condition at roof garden (UV)	Tree planting works near site boundary

1. Generally, contractor was reminded to keep on carrying out the outstanding planting works.
2. Weeding of planting area is required to keep.
3. Replacement of the dead plants are required.
