EP-510/2016 – Police Facilities in Kong Nga Po

Service Contract No. NDO 07/2019 Environmental Team for Site Formation and Infrastructure Works for Police Facilities in Kong Nga Po

Monthly Environmental Monitoring and Audit Report for April 2023

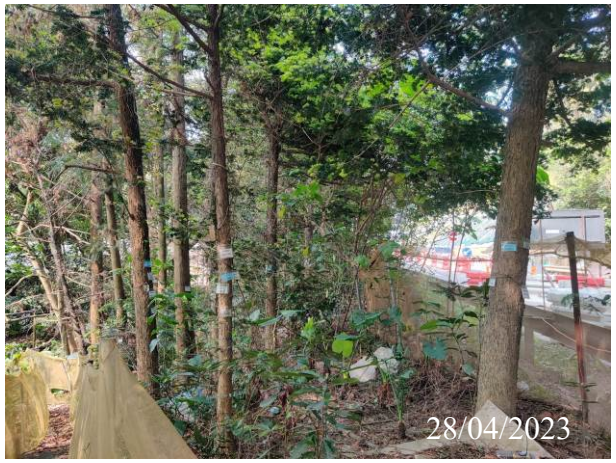
Photo 1  Description: Protective fence for *Keteleeria fortunei* are properly erected.	Photo 2  Description: Protective fence for *Keteleeria fortunei* are properly erected.
Photo 3  Description: General view of *Keteleeria fortunei*	Photo 4

Description: General view of *Keteleeria fortunei*

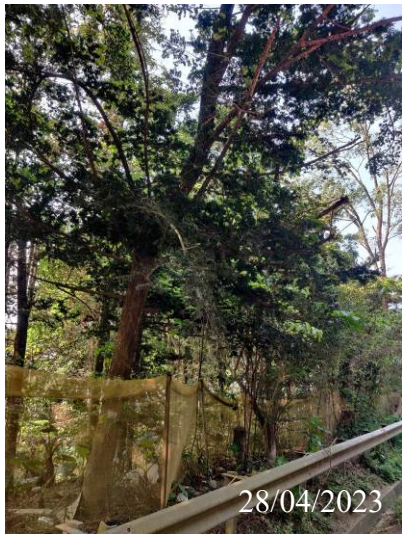
Photo 8

Description: Protective fence for undersized seedling of *Aquilaria sinensis* are properly erected.
